Contract #: 04-0120F4Cty: SF/ALA Rte: 80 PM: 13.2/13.9File #: 1.28**WELDING INSPECTION REPORT**

Report No: WIR-027350
Date Inspected: 23-Mar-2012

Project Name: SAS Superstructure
Prime Contractor: American Bridge/Fluor Enterprises, a JV
Contractor: American Bridge/Fluor Enterprises, a JV

CWI Name:	As noted below	CWI Present:	Yes	No	
Inspected CWI report:	Yes No N/A	Rod Oven in Use:	Yes	No	N/A
Electrode to specification:	Yes No N/A	Weld Procedures Followed:	Yes	No	N/A
Qualified Welders:	Yes No N/A	Verified Joint Fit-up:	Yes	No	N/A
Approved Drawings:	Yes No N/A	Approved WPS:	Yes	No	N/A
		Delayed / Cancelled:	Yes	No	N/A
Bridge No:	34-0006	Component:	SAS OBG

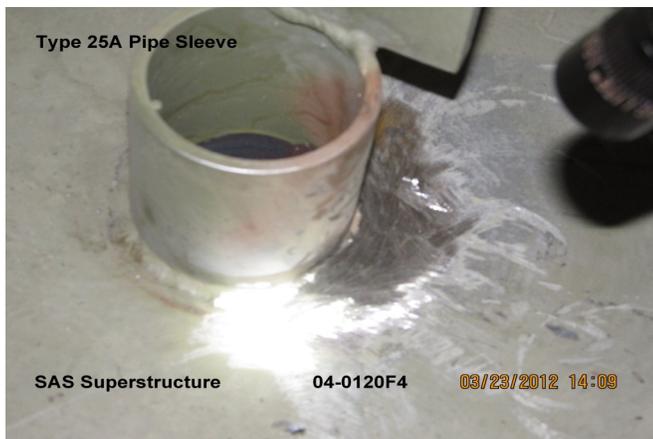
Punch list Items; 3470, 3479, 3480, 3502.

This QA Inspector observed QC Inspectors Sal Merino and Steve McConnell performing Visual welding Inspections (VT) of type 25A, 27C and 27E Pipe Sleeves installed in flame cut holes in floor beams for the punch list items listed above (See photo below). This QA Inspector observed QC identify indications of cold lap, undercut in base metal, undercut in pipe, inadequate fusion; overlap and underfill in and on each of the items inspected and was annotated for repair instructions.
