DEPARTMENT OF TRANSPORTATION

Contract #: 04-0120F4Cty: SF/ALA Rte: 80 PM: 13.2/13.9File #: 1.28**WELDING INSPECTION REPORT****Resident Engineer:** Casey, William**Address:** 333 Burma Road**City:** Oakland, CA 94607**Report No:** WIR-027375**Date Inspected:** 27-Mar-2012**Project Name:** SAS Superstructure**OSM Arrival Time:** 700**Prime Contractor:** American Bridge/Fluor Enterprises, a JV**OSM Departure Time:** 1730**Contractor:** American Bridge/Fluor Enterprises, a JV**Location:** Job Site**CWI Name:** As noted below**CWI Present:** Yes No**Inspected CWI report:** Yes No N/A**Rod Oven in Use:** Yes No N/A**Electrode to specification:** Yes No N/A**Weld Procedures Followed:** Yes No N/A**Qualified Welders:** Yes No N/A**Verified Joint Fit-up:** Yes No N/A**Approved Drawings:** Yes No N/A**Approved WPS:** Yes No N/A**Delayed / Cancelled:** Yes No N/A**Bridge No:** 34-0006**Component:** SAS OBG**Summary of Items Observed:**

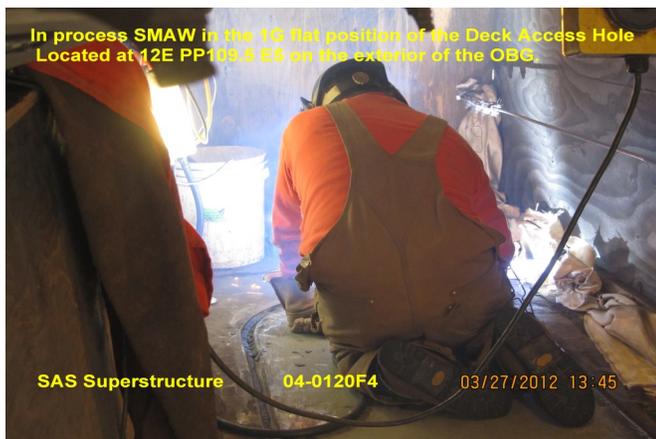
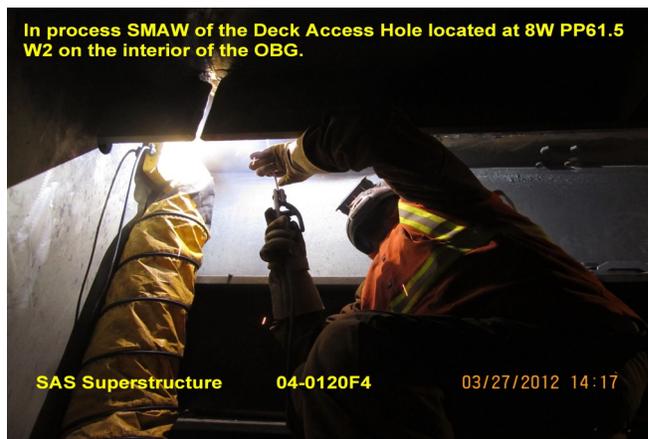
This QA Inspector randomly observed ABF welder Mike Jimenez (ID 4671) perform the SMAW process in the 4G overhead position on the Deck Access Hole (DAH) located at 8W PP61.5 W2 on the interior of the OBG. Prior to welding Mr. Jimenez was observed pre-heating the B-U2a CJP joint to a minimum temperature of 20°C which was verified by the QC Inspector. This QA Inspector randomly observed the welder employing 3.2mm E7018-H4R electrodes drawing amperage of 119. QC Inspector Steve Jensen was observed monitoring the welding to insure the parameters were in accordance with ABF-WPS-D15-1010-Revision 1. The welder was also observed cleaning the work utilizing a small disc grinder, brushes and compressed air to clean to shiny metal so as to not introduce additional indications. This QA Inspector made subsequent observations throughout the shift to monitor quality and noted that the work is in progress and appeared to be in general accordance with the contract documents.
