Contract #: 04-0120F4Cty: SF/ALA Rte: 80 PM: 13.2/13.9File #: 1.28**WELDING INSPECTION REPORT**

Report No: WIR-027376
Date Inspected: 28-Mar-2012

Project Name: SAS Superstructure
Prime Contractor: American Bridge/Fluor Enterprises, a JV
Contractor: American Bridge/Fluor Enterprises, a JV

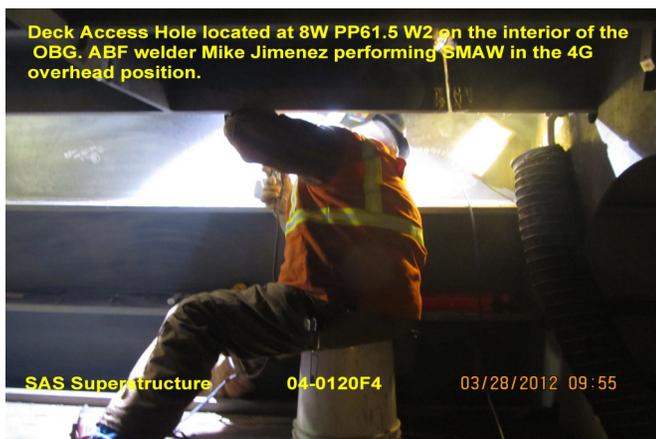
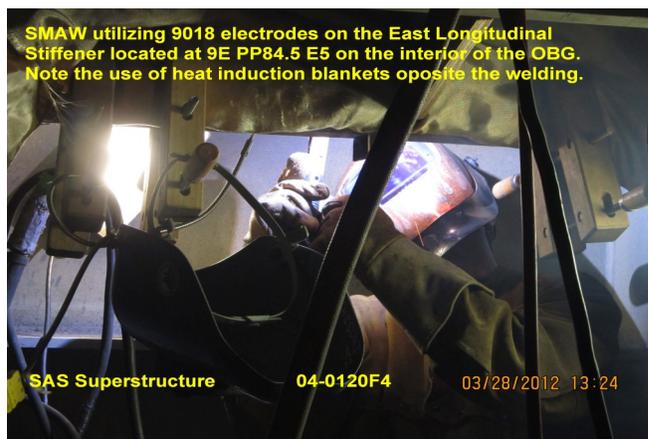
This QA Inspector randomly observed ABF welder Rick Clayborn (ID 2773) performing the excavation operations on the "A" deck, DAH located at 9E PP84.5 E5. The welder was observed utilizing the Carbon Air Arc method to remove material from the joint to repair four (4) ultrasonic rejectable indications. Mr. Clayborn utilized a small disc grinder to clean the excavations in preparation for MT testing and inspection. QC Inspector Steve McConnell performed MT inspection on the excavations and noted that no rejectable indications were found. The

dimensions of the excavations were recorded as; y+710mm: 85mm in length, 25mm wide and 14mm deep, y+2795mm: 165mm in length, 25mm wide and 14mm deep, y+3120mm: 130mm in length, 25mm wide and 16mm deep and y+3450mm: 80mm in length, 25mm wide and 14mm deep. The welder was observed performing welding as per the SMAW process in the (1G) flat position on the "A" deck, DAH located at 9E PP84.5 E5. The welder was observed utilizing pre-heat to bring the B-U2a CJP to a minimum temperature of 20°C and this QA Inspector verified the temperature by employing a Tempilstik and observed the use of E7018-H4R electrodes obtained from a remote baking oven. QC Inspector Steve McConnell was observed monitoring the welding and the parameters (Amps=140) so they were in accordance with WPS D1.5-1001- Repair. The welder was also observed cleaning the work utilizing a small disc grinder, brushes and compressed air to clean to shiny metal so as to not introduce additional indications. This QA Inspector made subsequent observations throughout the shift and noted that the work was completed on this date and appeared to be in general compliance with the contract documents.
