DEPARTMENT OF TRANSPORTATION

Contract #: 04-0120F4Cty: SF/ALA Rte: 80 PM: 13.2/13.9File #: 1.28**WELDING INSPECTION REPORT****Resident Engineer:** Casey, William**Address:** 333 Burma Road**City:** Oakland, CA 94607**Report No:** WIR-027395**Date Inspected:** 02-Apr-2012**Project Name:** SAS Superstructure**OSM Arrival Time:** 700**Prime Contractor:** American Bridge/Fluor Enterprises, a JV**OSM Departure Time:** 1730**Contractor:** American Bridge/Fluor Enterprises, a JV**Location:** Job Site

Bridge No: 34-0006**Summary of Items Observed:**

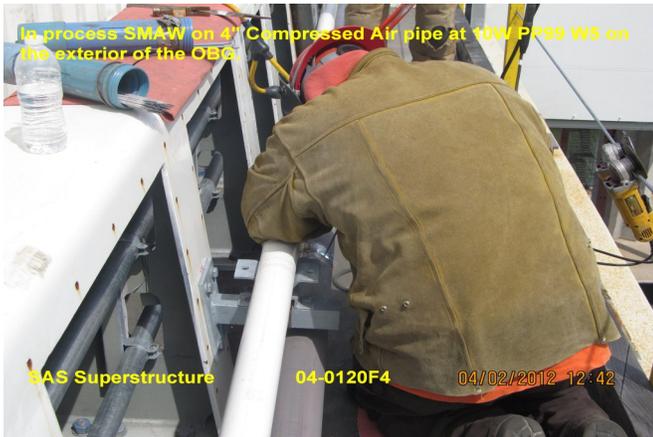
10W PP98 W5-Domestic water/Compressed Air (Exterior)

This QA Inspector observed F.W. Spencer welder Damian LLanos ID# (6645) performing SMAW in all positions on schedule 80, 4" domestic water pipe and 2.5" compressed air pipe at the locations listed below. This QA Inspector verified the fit up of the joints and found it to be satisfactory and randomly observed QC Inspector Steve Jensen monitoring the welding to ensure the welding parameters were in compliance pertaining to WPS-1-12-1 Revision 2 (1.12). The welder was observed utilizing 6010 electrodes in the root pass with the balance using 7018 electrodes and cleaning the weld after each pass utilizing a wire wheel on a small disc grinder. The QA inspector made subsequent observations throughout the shift to monitor quality and noted that the work appears to be in general conformance with the contract documents.
