Contract #: 04-0120F4Cty: SF/ALA Rte: 80 PM: 13.2/13.9File #: 1.28**WELDING INSPECTION REPORT**

Report No: WIR-027397
Date Inspected: 03-Apr-2012

Project Name: SAS Superstructure
Prime Contractor: American Bridge/Fluor Enterprises, a JV
Contractor: American Bridge/Fluor Enterprises, a JV

12W PP109.5 W5-DAH (Exterior)

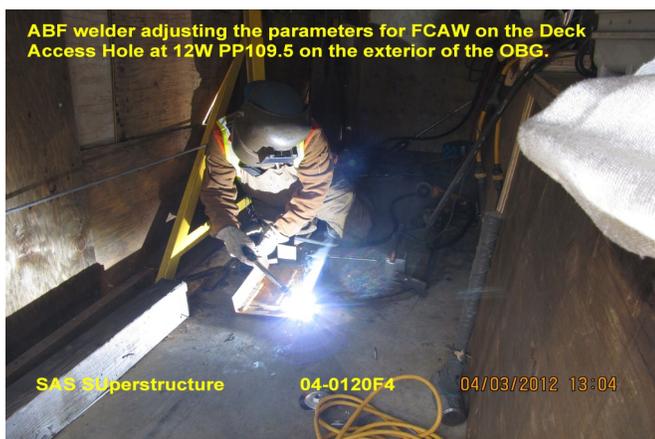
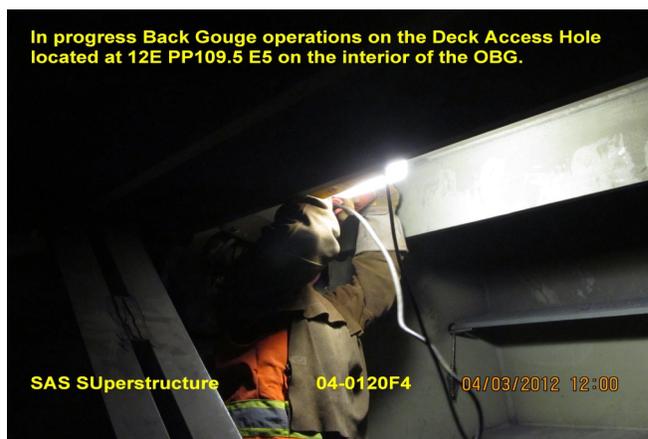
This QA Inspector randomly observed the Shielded Metal Arc Welding (SMAW) process in the 1F flat position on the Deck Access Hole (DAH) located at 12W PP109.5 W5 on the exterior of the OBG. ABF welder Salvador Sandoval (ID 2202) was observed cleaning the weld between passes utilizing a small disc grinder and compressed air to blend the start/stop edges for a smooth transition. The welder was observed utilizing E7018-H4R electrodes and this QA Inspector verified that the electrodes were recently obtained from a baking oven. QC Inspector Steve Jensen was observed measuring the inter-pass temperatures by employing an infra-red temperature gun as well as monitoring the welding and the parameters. It was noted that the welder was drawing amperage of 127 utilizing 3.2mm electrodes. The welder was observed running multiple pass stringers while adhering to ABF-WPS-D1.5-F1200A. On a subsequent observation, the welder was observed continuing work on the B-U2a Complete penetration Joint (CJP) and was employing the same routine to clean the work. This QA Inspector made subsequent observations throughout the shift to monitor quality and noted that the work is in progress and appeared to be in general conformance with the contract specifications.

This QA Inspector performed an MT Inspection on the “A” Deck Longitudinal Stiffener (LS) supports at LS#4, 5 and 6 at 12E/13E on the interior of the OBG. This QA Inspector performed the yoke method in conformance with ASTM E 709 and the standard of acceptance with D1.5 section 6.26. This QA Inspector noted that no rejectable indications were found at the time of testing. This QA Inspector generated a TL-6028 MT report on this date. The completed work at this location appeared to be in general conformance with the contract specifications.

This QA Inspector made random observations of ABF welder Kit Lounechany (ID 4895) utilizing the Carbon Air Arc method to remove weld metal from the weld root side of the joint (back gouge) on the Deck Access Hole (DAH) located at 12E PP109.5 E5 on the interior of the OBG. The welder was observed cleaning the joint by employing a small disc grinder, rotary drill with grinding bit and compressed air to achieve the desired joint dimensions. On a subsequent observation, the welder was noted as continuing the back gouging process and cleaning the joint. This QA Inspector made subsequent observations throughout the shift to monitor quality and noted that the work is in progress and appeared to be in general conformance with the contract specifications.

On random observations, this QA Inspector observed ABF welder Rory Hogan utilizing a cutting torch to penetrate the floor beam in the vicinity of 13W PP118.5 W4 on the interior of the OBG. The welder was observed performing the layout and cutting for the 73mm x 160mm schedule 80 pipe sleeve. CCO19151 and RFI2769RO was referenced as a time and materials project and all pertinent information was documented. ABF welding personnel was observed cleaning the penetration with a small disc grinder to smooth the edges of the hole and allow the pipe fit-up. This QA Inspector made subsequent observations and noted that the work was in progress and appeared to be in general conformance with CCO19151 and RFI2769RO.
