Contract #: 04-0120F4Cty: SF/ALA Rte: 80 PM: 13.2/13.9File #: 1.28**WELDING INSPECTION REPORT**

Report No: WIR-027420
Date Inspected: 09-Apr-2012

Project Name: SAS Superstructure
Prime Contractor: American Bridge/Fluor Enterprises, a JV
Contractor: American Bridge/Fluor Enterprises, a JV

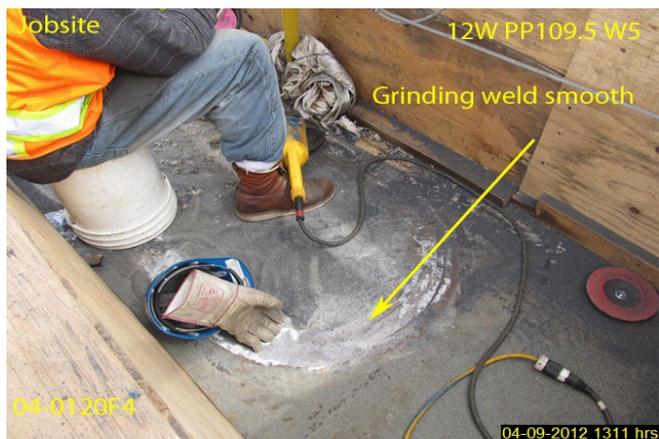
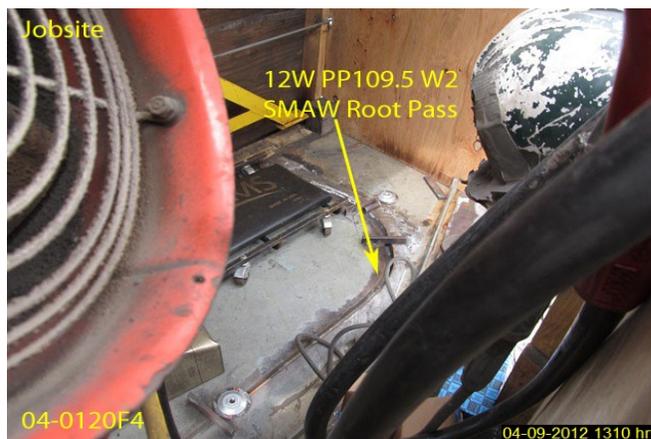
This QAI observed that the contractor had fit up the DAH at 12W PP109.5 W2. Salvador Sandoval was observed as placing the Shielded Metal Arc Welding (SMAW) root pass at this location. The electrode being used was a 3.0mm diameter E7018 for the Complete Joint Penetration (CJP) weld. The Welding Procedure Specification (WPS) used was ABF-WPS-D15-1040C with a measured welding amps of 135 F. The pre-heat for this location was measured at 65 degrees C (150 degrees F) using a weed burner which were verified using a tempstik and infrared gun by the QC. This QAI was informed that the fit up was checked and accepted on Friday the 6th of April by QC inspector Steve McConnell. The welder was also observed by this QAI as using a chipping hammer, power grinder and power wire wheel for the interpass cleaning. The QC inspector for this location was Salvador Merino and was observed verifying and documenting the welding parameters for this location, along with overseeing the welding operations. At the time of the observations no issues were noted by the QAI.

This QAI observed that the contractor had completed the weld at DAH at 12E PP109.5 E5 and in the process of grinding the weld flush for the proper weld profile to within 1 mm of flush. The welder Khit Lounechaney was observed as being in the overhead position on the interior (inside) using a power grinder. The QC inspector for this location was Salvador Merino and was observed in the area overseeing this operation being performed. Also noted

was location 12W PP109.5 W5 were the contractor had an apprentice performing the grinding function on the exterior (outside) of the weld for this DAH. At the time of the observations no issues were noted by the QAI.
