Contract #: 04-0120F4Cty: SF/ALA Rte: 80 PM: 13.2/13.9File #: 1.28**WELDING INSPECTION REPORT**

Report No: WIR-027433
Date Inspected: 11-Apr-2012

Project Name: SAS Superstructure
Prime Contractor: American Bridge/Fluor Enterprises, a JV
Contractor: American Bridge/Fluor Enterprises, a JV

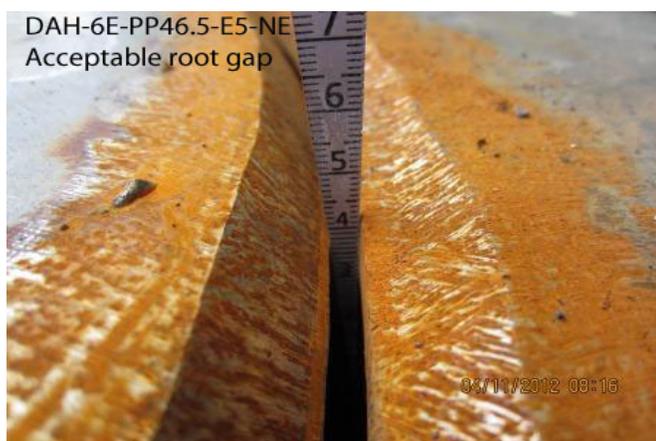
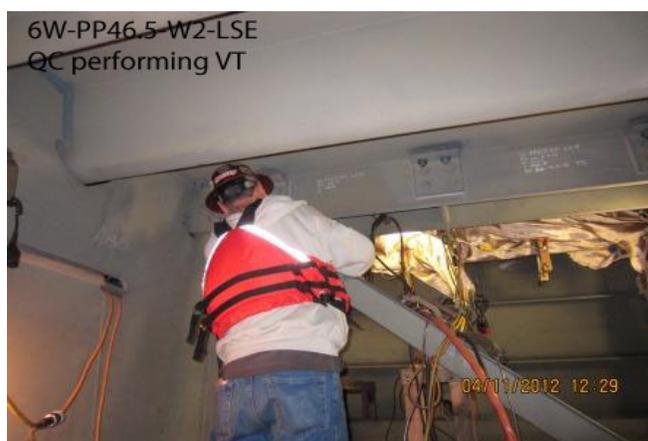
Work performed appears to be in general compliance with contract documents.
