DEPARTMENT OF TRANSPORTATION

Contract #: 04-0120F4Cty: SF/ALA Rte: 80 PM: 13.2/13.9File #: 1x.28**WELDING INSPECTION REPORT****Resident Engineer:** Casey, William**Address:** 333 Burma Road**City:** Oakland, CA 94607**Report No:** WIR-027441**Date Inspected:** 11-Apr-2012**Project Name:** SAS Superstructure**OSM Arrival Time:** 700**Prime Contractor:** American Bridge/Fluor Enterprises, a JV**OSM Departure Time:** 1530**Contractor:** American Bridge/Fluor Enterprises, a JV**Location:** On Site**CWI Name:** Bernie Docena**CWI Present:** Yes No**Inspected CWI report:** Yes No N/A**Rod Oven in Use:** Yes No N/A**Electrode to specification:** Yes No N/A**Weld Procedures Followed:** Yes No N/A**Qualified Welders:** Yes No N/A**Verified Joint Fit-up:** Yes No N/A**Approved Drawings:** Yes No N/A**Approved WPS:** Yes No N/A**Delayed / Cancelled:** Yes No N/A**Bridge No:** 34-0006**Component:** Skyway portion of SFOBB**Summary of Items Observed:**

WELDING INSPECTION REPORT

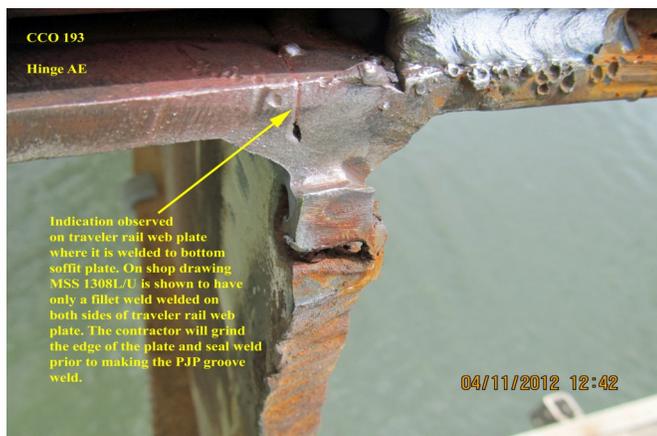
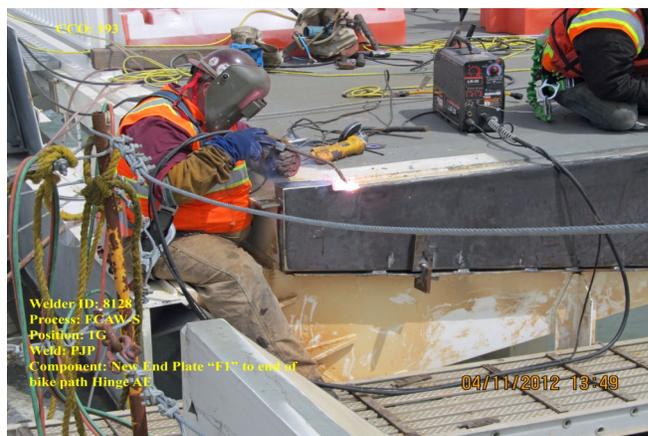
Afterwards, this QA Inspector observed a linear indication on the bottom soffit plate where the traveler rail plate piece mark no. ab1308 is fillet welded to the bottom soffit plate. The linear indication was formed where the bottom soffit plate is fitted to the traveler rail plate mark no. ab1308 as a square-butt and only fillet welded to the exterior side of the soffit only. The traveler rail plate mark no. ab1308 was partially removed so the new end plate "F1" could be fit and welded to seal the end of the bike path at expansion joint Hinge AE.

This QA Inspector observed welder Jason Collins (Welder ID 8128) performing the partial-joint penetration groove welding per the Flux Cored Arc Welding (FCAW) process in the (1G) flat position connecting the bike path top plate to the new end plate at the expansion joint Hinge "A" as per ABF Submittal no. 2549R2 of Contract Change Order (CCO) 193.

The partial-joint penetration groove welding of the new end plate "F1" to the top plate of the bike path panel was still in process at the end of this QA Inspectors' shift.

The disposition was to grind into the edge of the soffit plate and add weld metal to fuse the traveler rail plate mark no. ab1308 to the soffit plate to ensure sound metal prior to completing the partial-joint penetration groove weld of the new end plate "F1" to the end of the bike path.
