DEPARTMENT OF TRANSPORTATION

Contract #: 04-0120F4Cty: SF/ALA Rte: 80 PM: 13.2/13.9File #: 1.28**WELDING INSPECTION REPORT**

Report No: WIR-027445
Date Inspected: 11-Apr-2012

Project Name: SAS Superstructure
Prime Contractor: American Bridge/Fluor Enterprises, a JV
Contractor: American Bridge/Fluor Enterprises, a JV

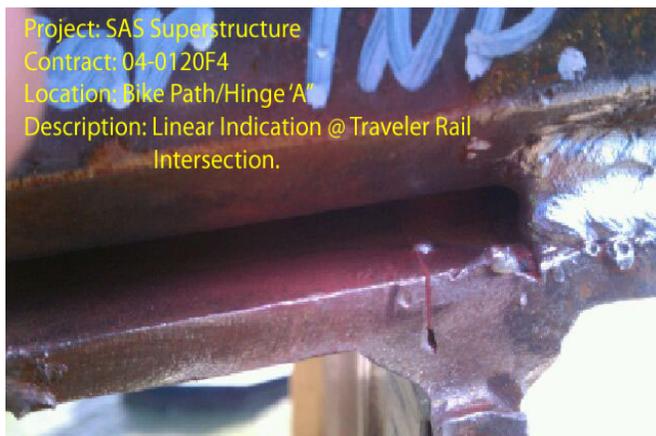
At approximately 0900, this QALI was informed by QAI, Art Peterson that there appeared to be a linear indication at the bike path panel (bottom plate) to end plate connection located approximately at the area of the traveler rail. Upon the arrival of this QALI at the east bound bike path panel at Hinge "A", this QALI performed a visual observation of this area and it did appear that the indication exhibited the characteristic of a plate interface (2 plates butted together). The indication was found during the MPT of the tack weld and the testing was performed by the QC inspector Bernard Docena. At approximately 0930, AB/F Welding Quality Control Manager (WQCP)

James Bowers and Mets personnel, Robert Mertz, arrived at this location and Mr. Bowers also performed a visual observation of this area and in conclusion he informed Mr. Mertz and this QALI that it appeared to be an interface between two plates. He also said that he would review the shop drawing details prior to determining any resolution.

See digital photograph below in regards to the bike path issue.
