DEPARTMENT OF TRANSPORTATION

Contract #: 04-0120F4Cty: SF/ALA Rte: 80 PM: 13.2/13.9File #: 1x.28**WELDING INSPECTION REPORT****Resident Engineer:** Casey, William**Address:** 333 Burma Road**City:** Oakland, CA 94607**Report No:** WIR-027455**Date Inspected:** 16-Apr-2012**Project Name:** SAS Superstructure**OSM Arrival Time:** 700**Prime Contractor:** American Bridge/Fluor Enterprises, a JV**OSM Departure Time:** 1730**Contractor:** American Bridge/Fluor Enterprises, a JV**Location:** On Site**CWI Name:** Steve Jensen**CWI Present:** Yes No**Inspected CWI report:** Yes No N/A**Rod Oven in Use:** Yes No N/A**Electrode to specification:** Yes No N/A**Weld Procedures Followed:** Yes No N/A**Qualified Welders:** Yes No N/A**Verified Joint Fit-up:** Yes No N/A**Approved Drawings:** Yes No N/A**Approved WPS:** Yes No N/A**Delayed / Cancelled:** Yes No N/A**Bridge No:** 34-0006**Component:** SAS OBG Components**Summary of Items Observed:**

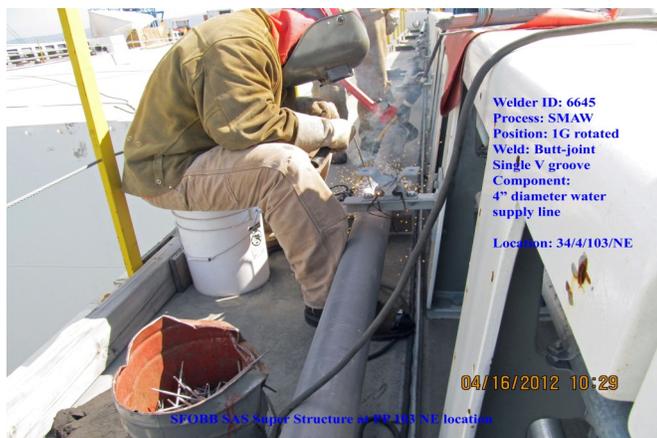
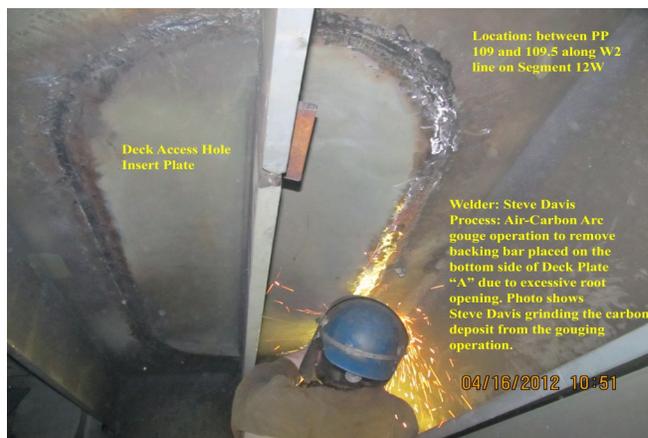
This QA Inspector observed ABF welder Damien LLanos (Welder ID 6645) performing the complete-joint penetration (CJP) butt-joint groove weld operation per the Shielded Metal Arc Welding (SMAW) process in the (1G) rotated flat position on four (4") diameter pipe for the water supply line at weld splice locations identified as 33/4/101/NE, 34/4/103/NE and 35/4/105/NE.

This QA Inspector observed that the CJP butt-joint groove weld operation on the (3) four (4") diameter pipe welds were completed at the end of this QA Inspectors' shift.
