DEPARTMENT OF TRANSPORTATION

Contract #: 04-0120F4Cty: SF/ALA Rte: 80 PM: 13.2/13.9File #: 1.28**WELDING INSPECTION REPORT****Resident Engineer:** Casey, William**Address:** 333 Burma Road**City:** Oakland, CA 94607**Report No:** WIR-027459**Date Inspected:** 13-Apr-2012**Project Name:** SAS Superstructure**OSM Arrival Time:** 700**Prime Contractor:** American Bridge/Fluor Enterprises, a JV**OSM Departure Time:** 1530**Contractor:** American Bridge/Fluor Enterprises, a JV**Location:** Job Site**CWI Name:** As noted below**CWI Present:** Yes No**Inspected CWI report:** Yes No N/A**Rod Oven in Use:** Yes No N/A**Electrode to specification:** Yes No N/A**Weld Procedures Followed:** Yes No N/A**Qualified Welders:** Yes No N/A**Verified Joint Fit-up:** Yes No N/A**Approved Drawings:** Yes No N/A**Approved WPS:** Yes No N/A**Delayed / Cancelled:** Yes No N/A**Bridge No:** 34-0006**Component:** SAS OBG**Summary of Items Observed:**

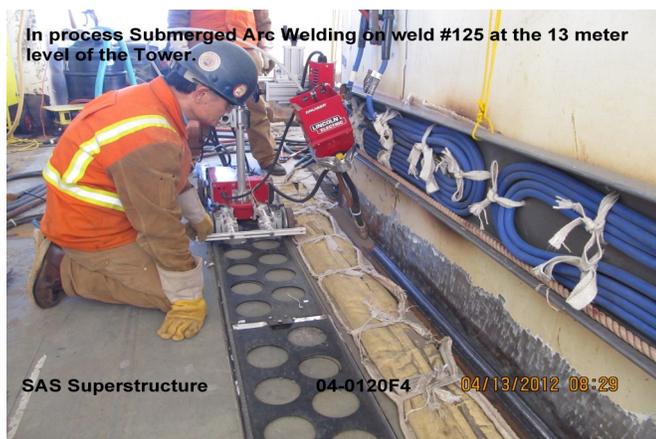
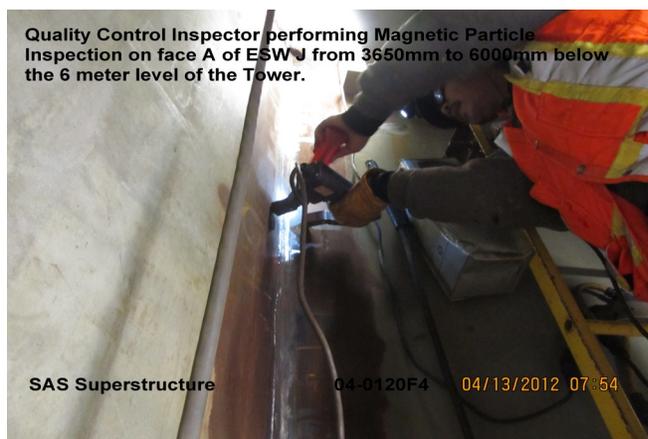
This QA Inspector at random intervals, observed ABF welder James Zhen (ID 6001) performing Submerged Arc Welding (SAW) by operating a Lincoln track mounted wire feeder on diaphragm weld #125 at the 13 meter elevation of the Tower. This QA Inspector observed heat induction blankets to provide pre-heat for the single bevel joint and verified the temperature was the required minimum of 225° F. It was also noted that the remote oven for the ESAB EN 760 Flux was in the on position with the dial set at 250° F. This QA Inspector verified that the prior electrode spool was discarded and replaced with a new F7A2-EM12KH8 electrode spool. QC Inspector Fred Von Hoff measured the parameters for amperage, volts, travel speed and the heat input as ABF welder James Zhen (ID 6001) adjusted the controls on the Lincoln track mounted wire feeder. On a subsequent observation, this QA Inspector observed ABF welding personnel recycle the flux utilizing a vacuum hose and cleaning the edge of the work with a chipping hammer between passes. Mr. Zhen was observed adjusting the path of the feeder prior to each consecutive pass during the ongoing process and inspected each completed pass for indications and workmanship. QC Inspector Fred Von Hoff was present to monitor the welding and the parameters so they remain within the requirements of WPS-D1.5-4062-1. The welder was observed completing the SAW portion of weld #125. Heat Induction Blankets were placed over the weld for three (3) hours at 450°F. Mr. Zhen was observed performing Shielded Metal Arc Welding (SMAW) on the east end of weld #112 between the weld access holes.

This QA Inspector made subsequent observations throughout the shift to monitor quality and noted that the work was completed on the east end of weld #112 and appeared to be in general conformance with the ABF-WPS-D1. 5-1160.
