DEPARTMENT OF TRANSPORTATION

Office of Structural Materials

Contract #: 04-0120F4Cty: SF/ALA Rte: 80 PM: 13.2/13.9File #: 1x.28**WELDING INSPECTION REPORT****Resident Engineer:** Casey, William**Address:** 333 Burma Road**City:** Oakland, CA 94607**Report No:** WIR-027477**Date Inspected:** 20-Apr-2012**Project Name:** SAS Superstructure**OSM Arrival Time:** 700**Prime Contractor:** American Bridge/Fluor Enterprises, a JV**OSM Departure Time:** 1730**Contractor:** American Bridge/Fluor Enterprises, a JV**Location:** On Site**CWI Name:** Sal Marino**CWI Present:** Yes No**Inspected CWI report:** Yes No N/A**Rod Oven in Use:** Yes No N/A**Electrode to specification:** Yes No N/A**Weld Procedures Followed:** Yes No N/A**Qualified Welders:** Yes No N/A**Verified Joint Fit-up:** Yes No N/A**Approved Drawings:** Yes No N/A**Approved WPS:** Yes No N/A**Delayed / Cancelled:** Yes No N/A**Bridge No:** 34-0006**Component:** SAS OBG Components**Summary of Items Observed:**

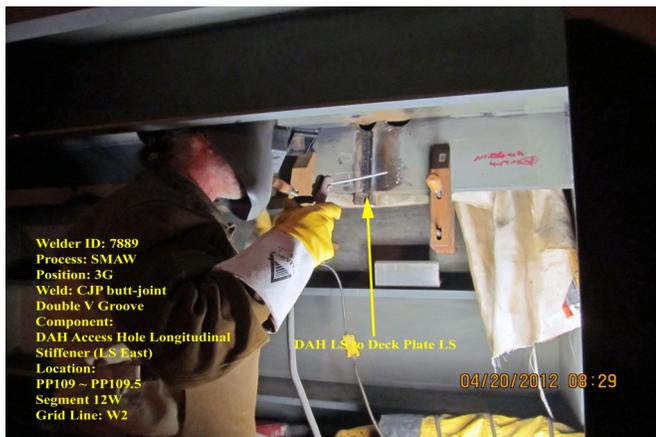
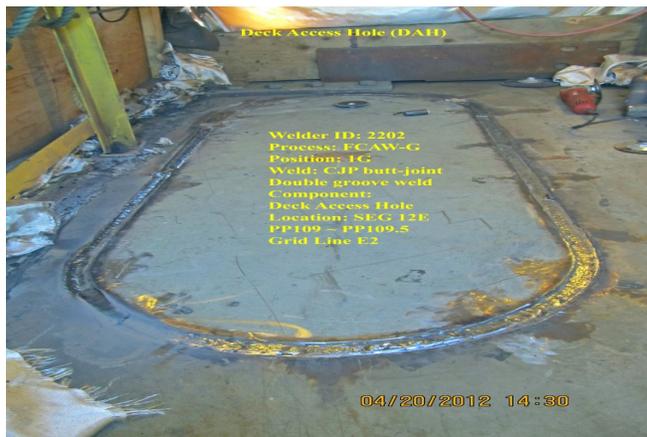
This QA Inspector observed ABF welder Eddie Brown (Welder ID 9331) performing the non-critical repair weld operation of a complete-joint penetration groove weld per the Shielded Metal Arc Welding (SMAW) process in the (4G) overhead position after the repair areas (2) locations were gouged to sound metal to remove the ultrasonic rejectable indications on the Deck Access Hole (DAH) insert plate welded to the Deck "A" plate between panel point PP109 and PP109.5 along Grid Line E5.

This QA Inspector observed that the non-critical repair weld operation of the DAH insert plate at the aforementioned location was completed at the end of this QA Inspectors' shift.
