DEPARTMENT OF TRANSPORTATION

Quality Assurance and Source Inspection

Contract #: 04-0120F4Cty: SF/ALA Rte: 80 PM: 13.2/13.9File #: 1.28**WELDING INSPECTION REPORT****Resident Engineer:** Casey, William**Address:** 333 Burma Road**City:** Oakland, CA 94607**Report No:** WIR-027494**Date Inspected:** 25-Apr-2012**Project Name:** SAS Superstructure**OSM Arrival Time:** 700**Prime Contractor:** American Bridge/Fluor Enterprises, a JV**OSM Departure Time:** 1530**Contractor:** American Bridge/Fluor Enterprises, a JV**Location:** Skyway**CWI Name:** See below**CWI Present:** Yes No**Inspected CWI report:** Yes No N/A**Rod Oven in Use:** Yes No N/A**Electrode to specification:** Yes No N/A**Weld Procedures Followed:** Yes No N/A**Qualified Welders:** Yes No N/A**Verified Joint Fit-up:** Yes No N/A**Approved Drawings:** Yes No N/A**Approved WPS:** Yes No N/A**Delayed / Cancelled:** Yes No N/A**Bridge No:** 34-0006**Component:** Skyway**Summary of Items Observed:**

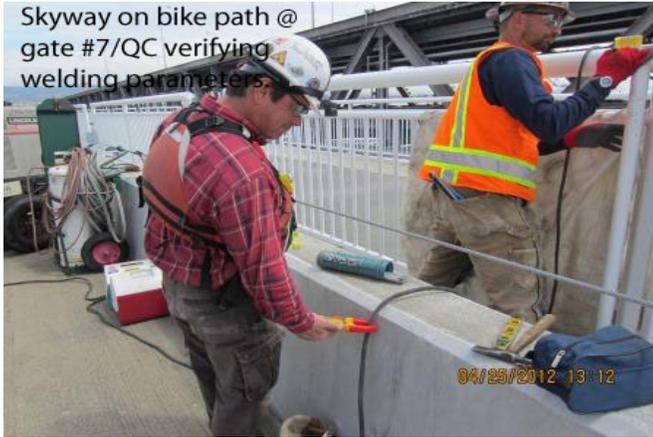
The QA Inspector at random intervals, observed ABF personnel straighten the guard rails on the Bike Bath after welding. The QA Inspector observed preheat did not exceed the maximum allowable temperature. The QA

Inspector observed the metal was not rapidly quenched above 600 degrees F°.

Work appears to be in general conformance with contract documents.
