DEPARTMENT OF TRANSPORTATION

Contract #: 04-0120F4Cty: SF/ALA Rte: 80 PM: 13.2/13.9File #: 1x.28**WELDING INSPECTION REPORT****Resident Engineer:** Casey, William**Address:** 333 Burma Road**City:** Oakland, CA 94607**Report No:** WIR-027496**Date Inspected:** 24-Apr-2012**Project Name:** SAS Superstructure**OSM Arrival Time:** 700**Prime Contractor:** American Bridge/Fluor Enterprises, a JV**OSM Departure Time:** 1730**Contractor:** American Bridge/Fluor Enterprises, a JV**Location:** On Site**CWI Name:** Bernie Docena**CWI Present:** Yes No**Inspected CWI report:** Yes No N/A**Rod Oven in Use:** Yes No N/A**Electrode to specification:** Yes No N/A**Weld Procedures Followed:** Yes No N/A**Qualified Welders:** Yes No N/A**Verified Joint Fit-up:** Yes No N/A**Approved Drawings:** Yes No N/A**Approved WPS:** Yes No N/A**Delayed / Cancelled:** Yes No N/A**Bridge No:** 34-0006**Component:** SAS OBG Components**Summary of Items Observed:**

WELDING INSPECTION REPORT

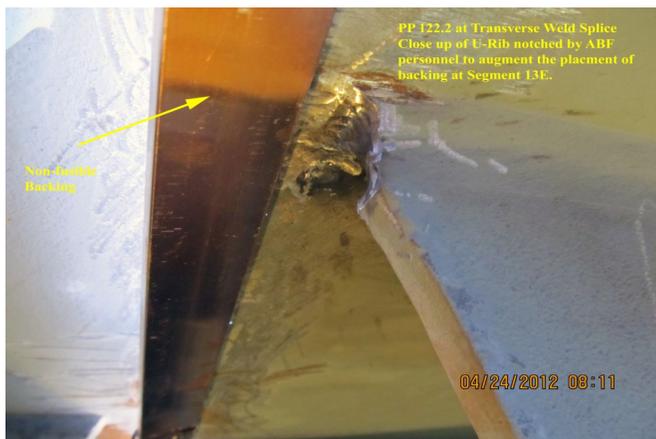
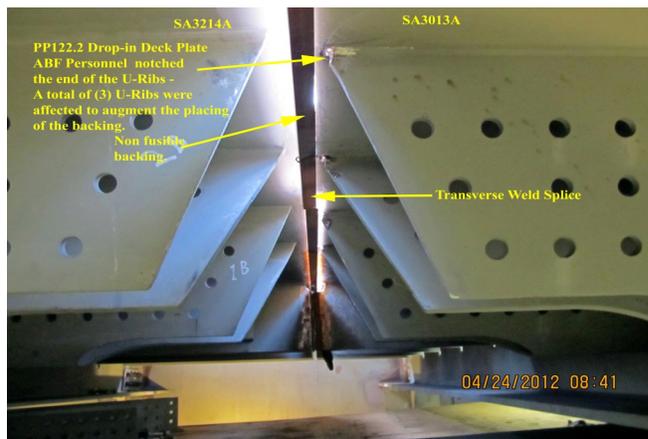
Segment 13E PP 122.2:

This QA Inspector observed that the ABF personnel ground into and coped a section out of (3) three Closed U-Ribs with a die grinder where the Closed U-Ribs are PJP welded to the Deck Plate to augment the placement of the unfusible copper backing in preparation for welding the transverse weld splice at PP122.2 on Segment 13E. The ends of the (3) Closed Rib welds interfered with the unfusible backing bar being placed flush to the underside of the deck plate due to the width of the backing bar. The amount of weld and base metal removed was between (6) six and (10) ten millimeters at each location where the Closed U-Ribs are welded to the underside of the deck plate.

non-compliance with AWS D1.5-2002 - Section 3.7.5 - Workmanship which states that "The Engineer shall be notified before improperly fitted and welded members are cut apart". See attached photos for further details.

This QA Inspector generated an Incident Report on this date and notified METS QA Lead Inspector Danny Reyes and METS QA Task Leader Bill Levell via email for review and disposition of the report due to the
