DEPARTMENT OF TRANSPORTATION

Contract #: 04-0120F4Cty: SF/ALA Rte: 80 PM: 13.2/13.9File #: 1.28**WELDING INSPECTION REPORT****Resident Engineer:** Casey, William**Address:** 333 Burma Road**City:** Oakland, CA 94607**Report No:** WIR-027502**Date Inspected:** 24-Apr-2012**Project Name:** SAS Superstructure**OSM Arrival Time:** 700**Prime Contractor:** American Bridge/Fluor Enterprises, a JV**OSM Departure Time:** 1200**Contractor:** American Bridge/Fluor Enterprises, a JV**Location:** Job Site

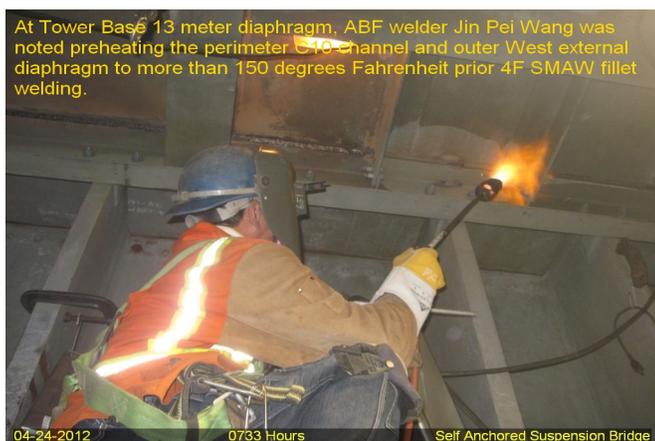
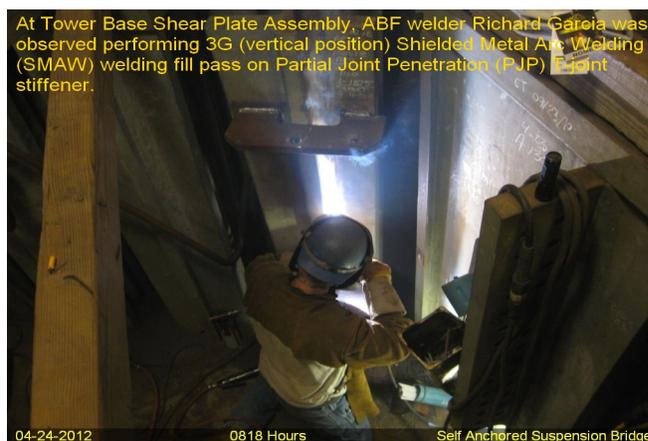
At Tower Base 13 meter diaphragm, this QA together with ABF QC Fred Von Hoff performed a joint verification on the fit up of the 80mm thick shear plate to 45mm thick outer East external diaphragm Partial Joint Penetration T-joint. The shear plate side has a 45 degree bevel with approximate land of 40mm. During the verification, there was root gap of 2.5mm minimum to 12mm maximum to a spread length of 2060mm at the North end while the South end was also having a 3.0mm minimum to 12mm maximum to a spread length 2230mm. This information was brought to the attention of Lead QA Danny Reyes who also conveyed the same information to Lead QC Bonifacio Daquinag. The information was relayed to ABF/JV QC Manager Jim Bowers who made the decision to perform buttering where the unacceptable gap was noted according to Mr. Danny Reyes.
