Contract #: 04-0120F4Cty: SF/ALA Rte: 80 PM: 13.2/13.9File #: 1.28**WELDING INSPECTION REPORT**

**Report No:** WIR-027503  
**Date Inspected:** 25-Apr-2012

**Project Name:** SAS Superstructure  
**Prime Contractor:** American Bridge/Fluor Enterprises, a JV  
**Contractor:** American Bridge/Fluor Enterprises, a JV

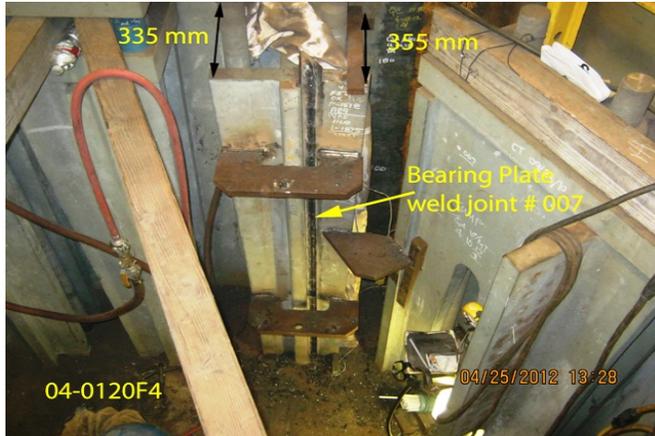
This QA Inspector observed later this morning an induction heat blanket had been placed behind the weld joint and was providing preheat. This QA Inspector observed additional restraints had been added to help hold the plate into position in an effort to control distortion. While ABF welding personnel Richard Garcia (#5892) was on break this QA Inspector took several measurements to help determine the amount of distortion already in the plate.

Below are the measurements:

The distance between the outer edges of the stiffener plates, where welding was not being performed, was approximately 335 mm.

The distance between the outer edges of the stiffener plates, where welding was being performed, was approximately 355 mm.

The width of the top bearing plate was approximately 350 mm.

The measurements were taken at the top of the plates, the areas measurements could be taken were limited due to the placement of induction heat blanket. The welding was approximately 80% complete at this time.

ABF welding personnel Richard Garcia (#5892) and Danny Ieraci (#3232) were both aware there was some distortion in the weld joint. This QA Inspector notified Lead QA Inspector Danny Reyes of the measurements noted above. See photo below of bearing plate weld.
