Contract #: 04-0120F4Cty: SF/ALA Rte: 80 PM: 13.2/13.9File #: 1.28**WELDING INSPECTION REPORT**

Report No: WIR-027509
Date Inspected: 26-Apr-2012

Project Name: SAS Superstructure
Prime Contractor: American Bridge/Fluor Enterprises, a JV
Contractor: American Bridge/Fluor Enterprises, a JV

Self Anchored Suspension (SAS) Tower: This QA Inspector observed work and/or performed QA verifications at the locations noted below.

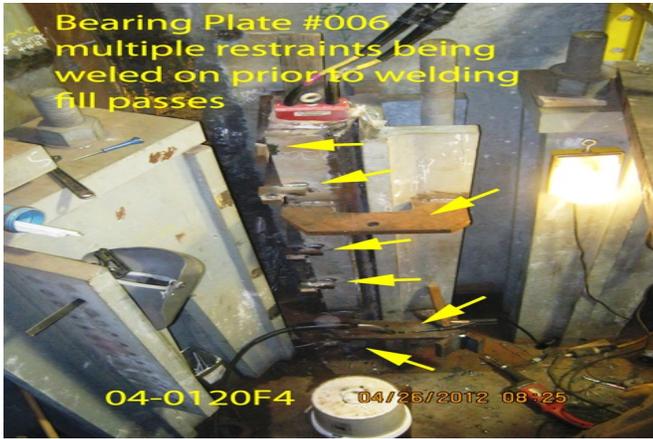
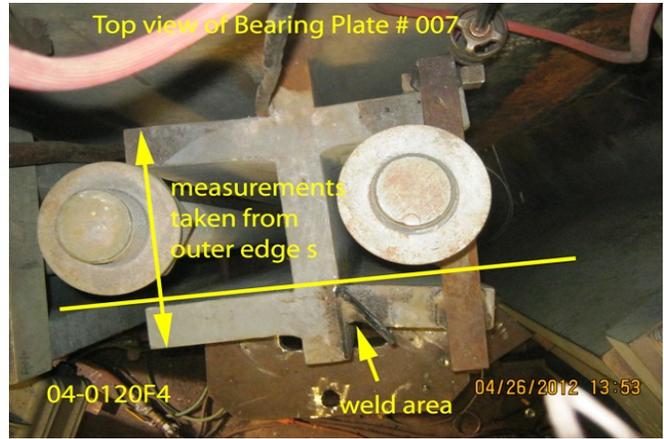
3-meter elevation, Bearing Plate # 007: This QA Inspector observed welding was not being performed at this location and was informed by ABF Welding Supervisor Danny Ieraci it was due to the distortion of the plate in the weld joint and that the plate will most likely be cut out and replaced with a new plate.

This QA Inspector measured the distance between the outer edges of the bearing plates on the side where welding was not performed and then at the same elevation on the side where welding was performed.

Elevation	Plates Not Welded	Welded Plate	Difference
Plate Elevation- 465 mm	318	347 mm	29 mm
Plate Elevation- 935 mm	318	350 mm	32 mm
Plate Elevation- 1400 mm	320	350 mm	30 mm
Plate Elevation- 1870 mm (top)	325	352 mm	27 mm

This QA Inspector observed what appeared to be slight distortion at the top of the plates not welded and took a measurement 150 mm from the end (towards center) and observed there appeared to be approximately 7 mm of distortion at this location. See photo below for more details.
