**DEPARTMENT OF TRANSPORTATION**

Contract #: 04-0120F4Cty: SF/ALA Rte: 80 PM: 13.2/13.9File #: 1.28**WELDING INSPECTION REPORT****Resident Engineer:** Casey, William**Address:** 333 Burma Road**City:** Oakland, CA 94607**Report No:** WIR-027512**Date Inspected:** 27-Apr-2012**Project Name:** SAS Superstructure**OSM Arrival Time:** 700**Prime Contractor:** American Bridge/Fluor Enterprises, a JV**OSM Departure Time:** 1730**Contractor:** American Bridge/Fluor Enterprises, a JV**Location:** jobsite**CWI Name:** Steve McConnell**CWI Present:** Yes No**Inspected CWI report:** Yes No N/A**Rod Oven in Use:** Yes No N/A**Electrode to specification:** Yes No N/A**Weld Procedures Followed:** Yes No N/A**Qualified Welders:** Yes No N/A**Verified Joint Fit-up:** Yes No N/A**Approved Drawings:** Yes No N/A**Approved WPS:** Yes No N/A**Delayed / Cancelled:** Yes No N/A**Bridge No:** 34-0006**Component:** SAS project**Summary of Items Observed:**

# WELDING INSPECTION REPORT

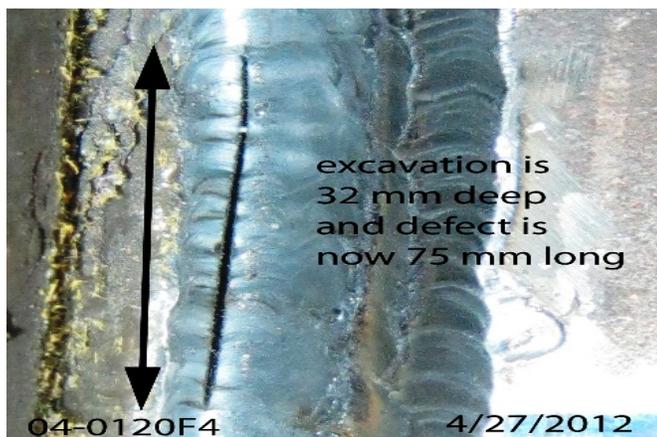
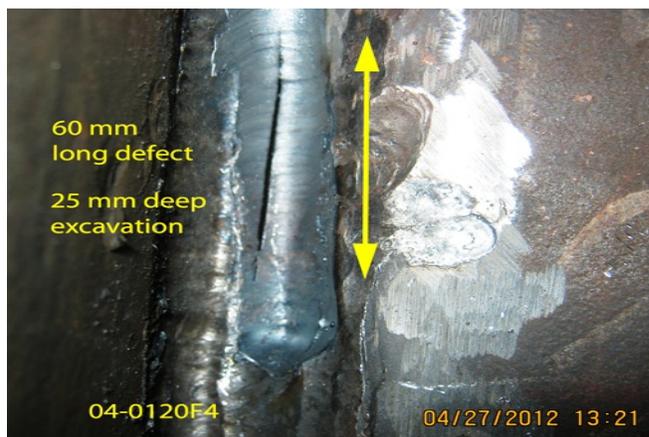
9-meter elevation: This QA Inspector observed ABF welding personnel Jin Pei Wang (#7299) using the Shielded Metal Arc Welding (SMAW) process to fillet weld the doubler plate, removed for Ultrasonic Testing (UT) the previous day, adjacent to Electro Slag Welding (ESW) weld joint C on face-A. This QA Inspector observed QC Inspector Steve McConnell verify the following welding parameters; 123 amperes using a 3.2 mm diameter E7018 electrode. The welding observed appeared to comply with ABF-WPS-D15-1200 Rev-2, being used by QC. Adjacent to the welding this QA Inspector observed QC personnel had marked next to the ESW weld joint it had passed a visual, Magnetic Particle Testing and Ultrasonic Testing for a length of approximately 600 mm.

9-meter elevation: This QA Inspector randomly observed as ABF welding personnel Rory Hogan (#3186) using the carbon arc process to excavate a UT defect located at ESW weld joint F from face A at Y-7330. This QA Inspector observed after several minutes the excavation was approximately 25 mm deep and the defect was visible. The defect was approximately 65 mm long and appeared to be approximately 2 mm wide. The weld joint was a Tee joint and the defect ran parallel to the member. This QA Inspector reviewed the UT report generated 6/27/11 by QC personnel regarding this defect and observed the following; the indication rating was +2 therefore a Class C indication for the thickness of the material and the testing angle (70°) used. It appears the only reason this indication was rejected was because it had a reported length of 100 mm, according to table 6.4 a Class C indication must have a length greater than 50 mm to be rejected. If the indication would have been a +3 (only 1db more) then it would have been a Class D indication and accepted regardless of length. See photos below noting the orientation of the defect in regards to the UT inspection angle and the standard technique being used.
