**DEPARTMENT OF TRANSPORTATION**

Contract #: 04-0120F4Cty: SF/ALA Rte: 80 PM: 13.2/13.9File #: 1.28**WELDING INSPECTION REPORT**

**Report No:** WIR-027518  
**Date Inspected:** 27-Apr-2012

**Project Name:** SAS Superstructure  
**Prime Contractor:** American Bridge/Fluor Enterprises, a JV  
**Contractor:** American Bridge/Fluor Enterprises, a JV

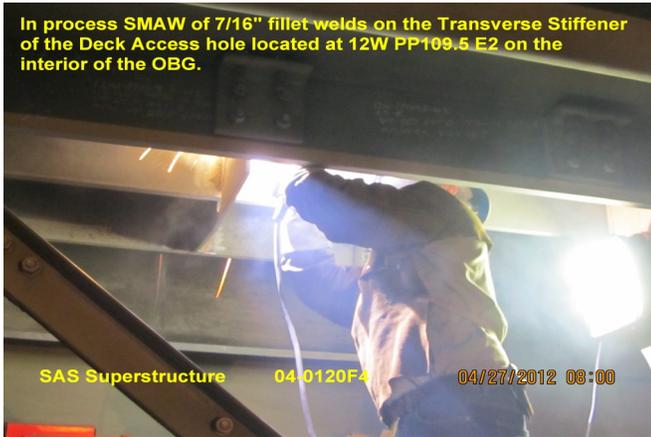
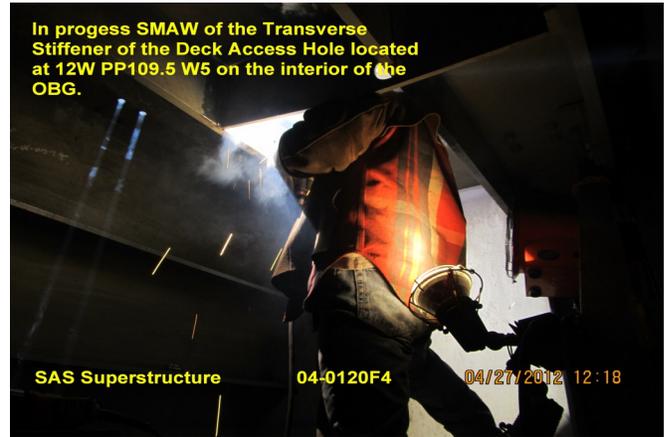
This QA Inspector made random observations of Shielded Metal Arc Welding (SMAW) in the 3G vertical position by ABF welder Edward Brown (ID 9331) on the East Longitudinal Stiffener (LSE) of the Deck Access Hole (DAH) on the interior of the OBG. The welder was observed utilizing 3.2mm E7018-H4R electrodes drawing amperage of 127. QC Inspector John Pagliero was observed monitoring the welding and the parameters to ensure compliance with ABF-WPS-D1.5-1012-3. On a subsequent observation, the welder was observed employing a small disc grinder to blend and smooth the work. The QC Inspector was present to continue observance of the welding to maintain the parameters set at the beginning of the shift. This QA Inspector made subsequent observations throughout the shift to monitor quality and noted that the work at this location is in progress and appeared to be in general compliance with the contract specifications.

commenced welding in the 3G vertical position utilizing the SMAW process. QC Inspector John Pagliero was observed setting the parameters to comply with ABF-WPS-D1.5-F1200A for the E7018-H4R electrodes. During subsequent observations the welder was observed cleaning the start/stop edges of the work with a small disc grinder and brushes. The QC Inspector was present to measure the required 7/16" fillet welds and consecutive passes were made to achieve the correct size. The work at this location was completed on this date and this QA Inspector noted that the work appeared to be in general conformance with the contract documents. This QA Inspector performed MT testing on the East Longitudinal Stiffener (LSE) located at 12W PP109.5 W2 on the interior of the OBG. This QA Inspector performed MT testing utilizing the yoke method in conformance with ASTM E 709 and the standard of acceptance with D1.5 section 6.26. This QA Inspector noted that no rejectable indications were found at the time of testing. This QA Inspector generated a TL-6028 MT report on this date. The completed work at this location appeared to be in general conformance with the contract specifications. This QA Inspector performed a UT inspection on approximately 10% of the welds on the LSE and these welds were previously accepted by QC Ultrasonic technicians in accordance with AWS D1.5-2002, section 6, table 6.3. This QA observed no rejectable indications at the time of testing. This QA generated a TL-6027 UT report on this date. The completed work observed at this location appeared to be in compliance with the contract specifications.

This QA Inspector performed MT testing on the Deck Access Hole located at 12W PP109.5 W5 on the exterior of the OBG. This QA Inspector performed MT testing utilizing the yoke method in conformance with ASTM E 709 and the standard of acceptance with D1.5 section 6.26. This QA Inspector noted that no rejectable indications were found at the time of testing. This QA Inspector generated a TL-6028 MT report on this date. The completed work at this location appeared to be in general conformance with the contract specifications. This QA Inspector performed a UT inspection on approximately 10% of the welds on the DAH and these welds were previously accepted by QC Ultrasonic technicians in accordance with AWS D1.5-2002, section 6, table 6.3. This QA observed no rejectable indications at the time of testing. This QA generated a TL-6027 UT report on this date. The completed work observed at this location appeared to be in compliance with the contract specifications. This QA Inspector made random observations of ABF welder Khit Lounechaney (ID 4985) performing the fit up of the Transverse Stiffener (TS) of the DAH at 12W PP109.5 W5 on the interior of the OBG. The welder was observed pre-heating the "T" joint to 150°F which this QA Inspector verified utilizing a 150°F Tempilstik and commenced welding in the 3G vertical position utilizing the SMAW process. QC Inspector John Pagliero was observed setting the parameters to comply with ABF-WPS-D1.5-F1200A for the E7018-H4R electrodes. During subsequent observations the welder was observed cleaning the start/stop edges of the work with a small disc grinder and brushes. The QC Inspector was present to measure the required 7/16" fillet welds. This QA Inspector noted that the work at this location was in progress and appeared to be in general conformance with the contract documents.
