**DEPARTMENT OF TRANSPORTATION**

Contract #: 04-0120F4Cty: SF/ALA Rte: 80 PM: 13.2/13.9File #: 1.28**WELDING INSPECTION REPORT****Resident Engineer:** Casey, William**Address:** 333 Burma Road**City:** Oakland, CA 94607**Report No:** WIR-027525**Date Inspected:** 01-May-2012**Project Name:** SAS Superstructure**OSM Arrival Time:** 700**Prime Contractor:** American Bridge/Fluor Enterprises, a JV**OSM Departure Time:** 1730**Contractor:** American Bridge/Fluor Enterprises, a JV**Location:** Job Site**CWI Name:** As noted below**CWI Present:** Yes No**Inspected CWI report:** Yes No N/A**Rod Oven in Use:** Yes No N/A**Electrode to specification:** Yes No N/A**Weld Procedures Followed:** Yes No N/A**Qualified Welders:** Yes No N/A**Verified Joint Fit-up:** Yes No N/A**Approved Drawings:** Yes No N/A**Approved WPS:** Yes No N/A**Delayed / Cancelled:** Yes No N/A**Bridge No:** 34-0006**Component:** SAS OBG**Summary of Items Observed:**

## 13W PP120/PP124.7 Grid Line W2.0/W2.8 Deck Plate Drop-in Sections

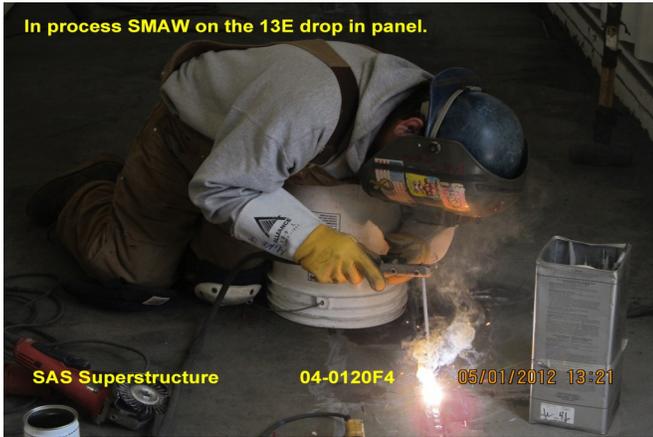
There was a conversation with QAI Lead Daniel Reyes concerning the removal of the temporary attachments by cutting verses a sledge hammer as it may damage the parent metal and require an RWR.
