Contract #: 04-0120F4Cty: SF/ALA Rte: 80 PM: 13.2/13.9File #: 1x.28**WELDING INSPECTION REPORT****Resident Engineer:** Casey, William**Address:** 333 Burma Road**City:** Oakland, CA 94607**Report No:** WIR-027528**Date Inspected:** 01-May-2012**Project Name:** SAS Superstructure**OSM Arrival Time:** 700**Prime Contractor:** American Bridge/Fluor Enterprises, a JV**OSM Departure Time:** 1730**Contractor:** American Bridge/Fluor Enterprises, a JV**Location:** On Site**CWI Name:** Sal Marino**CWI Present:** Yes No**Inspected CWI report:** Yes No N/A**Rod Oven in Use:** Yes No N/A**Electrode to specification:** Yes No N/A**Weld Procedures Followed:** Yes No N/A**Qualified Welders:** Yes No N/A**Verified Joint Fit-up:** Yes No N/A**Approved Drawings:** Yes No N/A**Approved WPS:** Yes No N/A**Delayed / Cancelled:** Yes No N/A**Bridge No:** 34-0006**Component:** SAS OBG Components**Summary of Items Observed:**

Segment 13E Grid Line E2.8 Deck Plate Drop-in Section Longitudinal Field Weld Splice

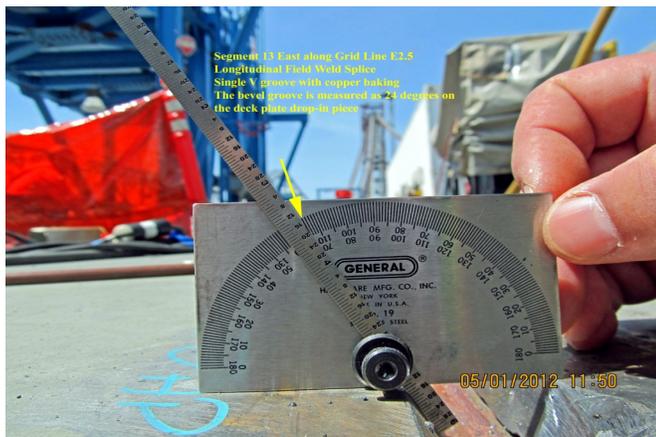
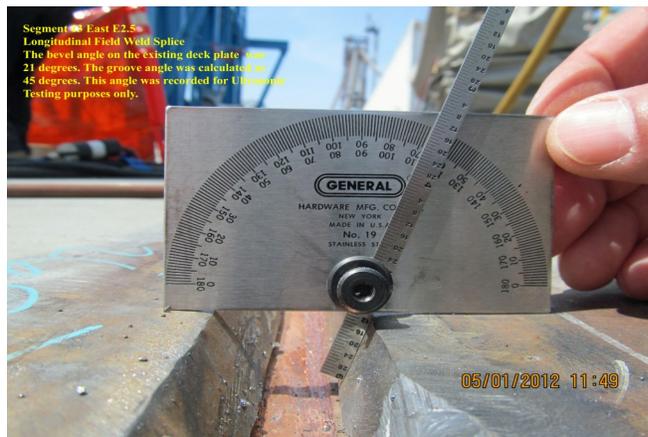
Segment 13E Grid Line E2.5 - Deck Plate Drop-in Section Longitudinal Field Weld Splice

This QA Inspector performed the bevel angle measurements after ABF welder Jacob Stafford (Welder ID 2202) performed the buttering operation per the SMAW process in the (1G) flat position on one side of the bevel on the deck plate drop-in section along Grid Line E2.5 on Segment 13E. The bevel angle measurements were used to

determine the groove angle which was measured at 45 degrees and the groove angle measured will be for ultrasonic testing purposes only. See photos below of the bevel angle measurements.
