DEPARTMENT OF TRANSPORTATION

Contract #: 04-0120F4Cty: SF/ALA Rte: 80 PM: 13.2/13.9File #: 1.28**WELDING INSPECTION REPORT****Resident Engineer:** Casey, William**Address:** 333 Burma Road**City:** Oakland, CA 94607**Report No:** WIR-027570**Date Inspected:** 09-May-2012**Project Name:** SAS Superstructure**OSM Arrival Time:** 700**Prime Contractor:** American Bridge/Fluor Enterprises, a JV**OSM Departure Time:** 1730**Contractor:** American Bridge/Fluor Enterprises, a JV**Location:** Job Site**CWI Name:** As noted below.**CWI Present:** Yes No**Inspected CWI report:** Yes No N/A**Rod Oven in Use:** Yes No N/A**Electrode to specification:** Yes No N/A**Weld Procedures Followed:** Yes No N/A**Qualified Welders:** Yes No N/A**Verified Joint Fit-up:** Yes No N/A**Approved Drawings:** Yes No N/A**Approved WPS:** Yes No N/A**Delayed / Cancelled:** Yes No N/A**Bridge No:** 34-0006**Component:** Tower Component**Summary of Items Observed:**

In Process Visual Inspection**Tower**

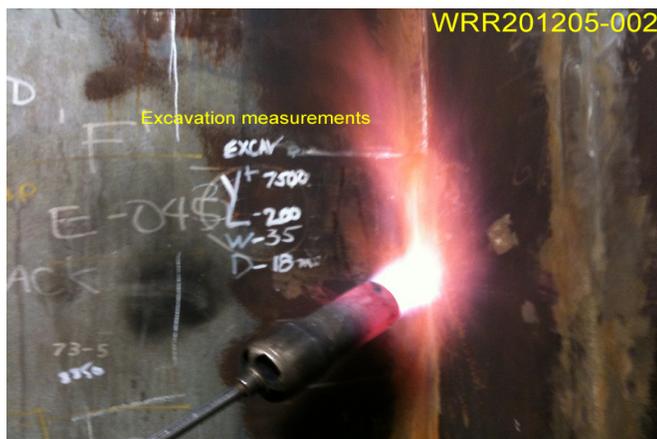
This QA observed, at random intervals, ABF/JV qualified welder Wai Kit Li #2953 performing Shielded Metal Arc Welding (SMAW) with 3.2mm diameter E7018H4R electrode and implementing Caltrans approved Welding Procedure Specification (WPS) ABF-WPS-D15-1001-Repair. The joint being welded was tower shear plate designated as ESW weld E-045 location "F" from face "B" per WRR201205-002.

"A rejectable indication was found by Ultrasonic Testing (UT) examination of Electroslag (ESW) weld E-045, indicated at location "F". The defect was indicated at the Y axis +7600mm, X axis +2mm, at a depth of 10mm (from face A), and was approximately 140mm in length...

This defect was evaluated in the ESW Preliminary Inspection and Repair Report as Indication F5, shown at Y +7620 and was characterized as a shallow slag pool condition. A follow-up UT examination performed after the initial UT testing indicated a slight shift in defect location...

This defect has been inadvertently excavated from both Face A and Face B for the full depth of the shear plate (60mm). The excavation is approximately 65% of the plate depth from Face A. The excavation showed a line of incomplete fusion within the weld metal...

The joint configuration is a 90 degree tee joint and this configuration is highly restrained.”
