DEPARTMENT OF TRANSPORTATION

Contract #: 04-0120F4Cty: SF/ALA Rte: 80 PM: 13.2/13.9File #: 1.28**WELDING INSPECTION REPORT****Resident Engineer:** Casey, William**Address:** 333 Burma Road**City:** Oakland, CA 94607**Report No:** WIR-027602**Date Inspected:** 14-May-2012**Project Name:** SAS Superstructure**OSM Arrival Time:** 700**Prime Contractor:** American Bridge/Fluor Enterprises, a JV**OSM Departure Time:** 1730**Contractor:** American Bridge/Fluor Enterprises, a JV**Location:** Job Site**CWI Name:** Bernie Docena**CWI Present:** Yes No**Inspected CWI report:** Yes No N/A**Rod Oven in Use:** Yes No N/A**Electrode to specification:** Yes No N/A**Weld Procedures Followed:** Yes No N/A**Qualified Welders:** Yes No N/A**Verified Joint Fit-up:** Yes No N/A**Approved Drawings:** Yes No N/A**Approved WPS:** Yes No N/A**Delayed / Cancelled:** Yes No N/A**Bridge No:** 34-0006**Component:** SAS Tower**Summary of Items Observed:**

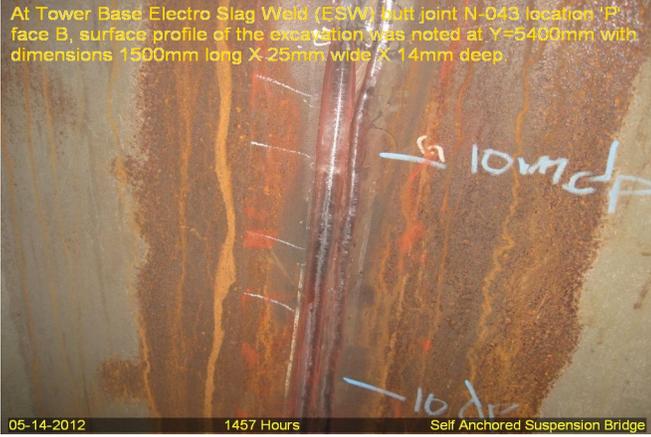
This QA also performed Magnetic Particle Testing (MT) on the excavation of Electro Slag Weld (ESW) CJP butt joint N-043 location 'P'. The MT was performed as part of verification on the surface excavation due to visual defect that was visually detected by ABF QC. The first location was at Y=5400mm having excavation dimensions of 1500mm long X 25mm wide X 14mm deep. The second location was at Y=2400mm having excavation dimensions of 1490mm long X 11mm wide X 7mm deep. Both excavations revealed no relevant indication during MT. According to ABF QC, Request for Welding Repair (RWR) for these two excavations will be forwarded to Caltrans for approval.

At Tower Base Electro Slag Weld (ESW) Butt joint N-043 location 'P' face B, surface profile of the excavation was noted at Y=5400mm with dimensions 1500mm long X 25mm wide X 14mm deep.

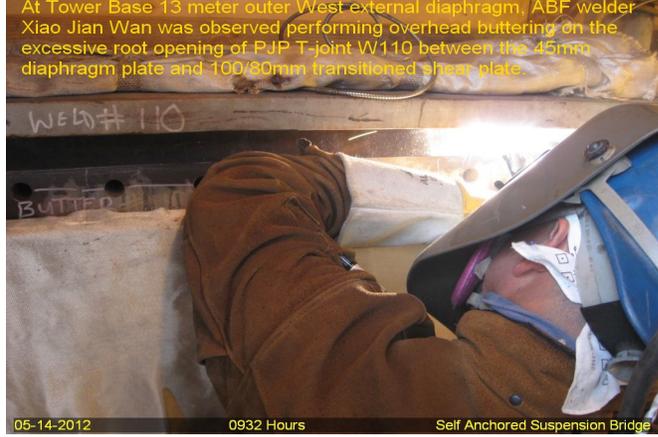
At Tower Base 13 meter outer West external diaphragm, ABF welder Xiao Jian Wan was observed perform buttering on the one side of the PJP T-joint W110 due to excessive root gap as previously reported. The welder was noted buttering the North side of the weld joint where the maximum measure root opening was 9.5mm. The welder was noted buttering at overhead position using Shielded Metal Arc Welding (SMAW) with 3.2mm diameter E7018H4R electrode implementing Caltrans approved Welding Procedure Specification (WPS) ABF-WPS-D15- F1200A. The diaphragm plate being buttered was noted preheated to more than 150°F using Miller Proheat 35 Induction Heating System. During the shift, buttering on the PJP T-joint W110 was completed. After the buttering completion, ABF QC Bernie Docena was observed performing visual test (VT) and informs this QA that he will perform the Magnetic Particle Testing (MT) first thing in the morning.

At Tower Base 13 meter outer West external diaphragm, ABF welder Xiao Jian Wan was observed performing overhead buttering on the excessive root opening of PJP T-joint W110 between the 45mm diaphragm plate and 100/80mm transitioned shear plate.

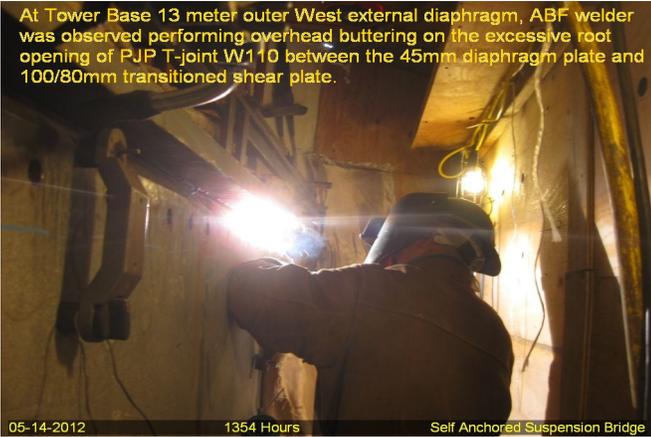
At Tower Base 13 meter outer West external diaphragm, ABF welder Luo Xiao Hua was also observed perform buttering on one side of the PJP T-joint W110 due to excessive root gap as previously reported. The welder was noted buttering the South side of the weld joint where the maximum measured root opening was 18.5mm. The welder was noted buttering at overhead position using Shielded Metal Arc Welding (SMAW) with 3.2mm diameter E7018H4R electrode implementing Caltrans approved Welding Procedure Specification (WPS) ABF-WPS-D15- F1200A. The diaphragm plate being buttered was noted preheated to more than 150°F using Miller Proheat 35 Induction Heating System. During the shift, buttering on the PJP T-joint W110 was completed.

At Tower Base 13 meter outer West external diaphragm, ABF welder was observed performing overhead buttering on the excessive root opening of PJP T-joint W110 between the 45mm diaphragm plate and 100/80mm transitioned shear plate.
