DEPARTMENT OF TRANSPORTATION

Contract #: 04-0120F4Cty: SF/ALA Rte: 80 PM: 13.2/13.9File #: 1.28**WELDING INSPECTION REPORT****Resident Engineer:** Casey, William**Address:** 333 Burma Road**City:** Oakland, CA 94607**Report No:** WIR-027606**Date Inspected:** 12-May-2012**Project Name:** SAS Superstructure**OSM Arrival Time:** 700**Prime Contractor:** American Bridge/Fluor Enterprises, a JV**OSM Departure Time:** 1530**Contractor:** American Bridge/Fluor Enterprises, a JV**Location:** Job Site

Bridge No: 34-0006**Component:** SAS OBG**Summary of Items Observed:**

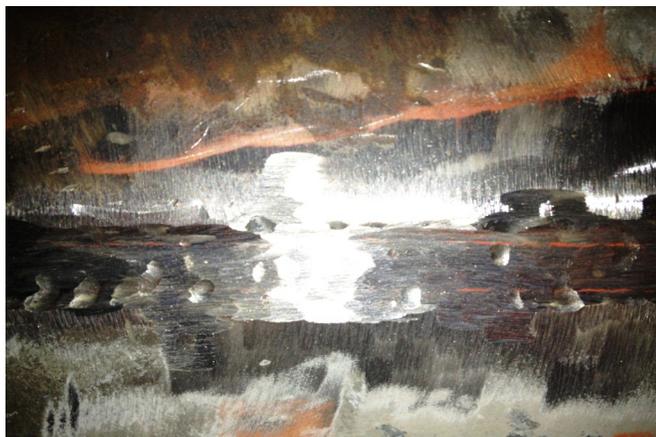
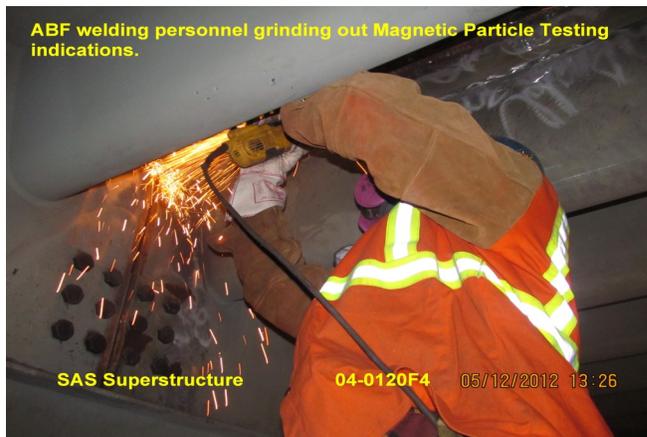
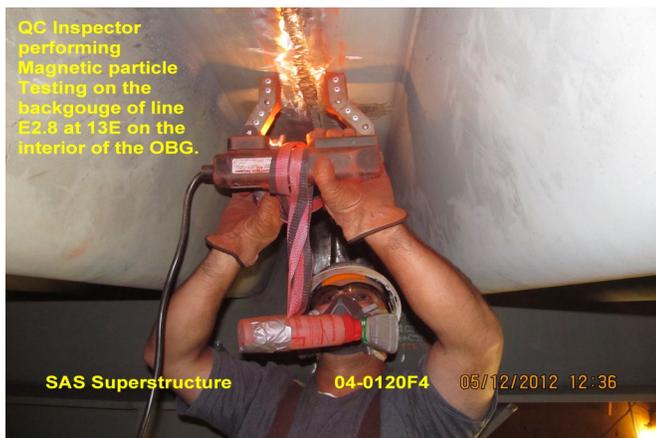
13E-E2.8 @ y+11970mm (Interior)

This QA Inspector observed the back-gouging operations at 13E-E2.8 @ y+100mm to y+11970mm on the interior of the OBG. ABF welding personnel utilized small disc grinders and rotary drills with steel shaving bits to remove metal from the root side of the joint. QC Inspector Sal Merino performed Magnetic Particle Testing (MT) on approximately 1000mm sections of completed areas by ABF welding personnel to ensure soundness of the metal. Upon completion of the testing, several indications were noted of varying lengths and locations. ABF welding personnel were assigned to remove the indications noted by the testing, by use of grinding until the indications were removed and verified sound by re-testing with the MT method. This process repeated itself throughout the entire length of the joint due to the observance of multiple indications with each test. On several occasions areas had to be re-tested two and three times. Upon successful testing and acceptance by QC, this QA inspector performed MT testing utilizing the yoke method in conformance with ASTM E 709 and the standard of acceptance with D1.5 section 6.26. This QA Inspector noted that no rejectable indications were found at the time of testing. This QA Inspector generated a TL-6028 MT report on this date. The completed work at this location appeared to be in general conformance with the contract specifications. This QA Inspector noted that the work is ongoing.
