**DEPARTMENT OF TRANSPORTATION**

Contract #: 04-0120F4Cty: SF/ALA Rte: 80 PM: 13.2/13.9File #: 1.28**WELDING INSPECTION REPORT****Resident Engineer:** Casey, William**Address:** 333 Burma Road**City:** Oakland, CA 94607**Report No:** WIR-027622**Date Inspected:** 16-May-2012**Project Name:** SAS Superstructure**OSM Arrival Time:** 700**Prime Contractor:** American Bridge/Fluor Enterprises, a JV**OSM Departure Time:** 1730**Contractor:** American Bridge/Fluor Enterprises, a JV**Location:** Job Site

# WELDING INSPECTION REPORT

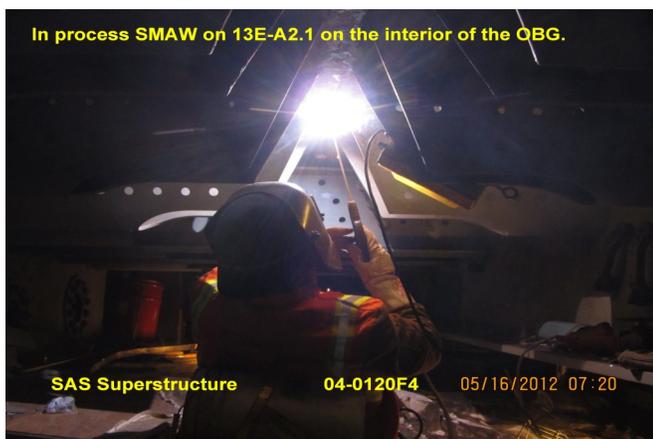
This QA Inspector observed QC Inspector Sal Merino perform MT Testing and Inspection on the back-gouge of 13E PP122.2 from y+0mm to 1900mm on the interior of the OBG. (Beyond 1900mm the backing bar was still in place). This QA Inspector observed two (2) indications at random locations along PP122.2. ABF welder Jacob Stafford (ID 8020) was assigned to perform minor grinding of indications identified by QC. Upon completion of the grinding, The QC Inspector tested the locations and approved the repairs. At 13E-PP121.2 from 0mm to 1900mm two (2) indications were observed and repaired. At 13E-E2.1 from 0mm to 9500mm the QC Inspector marked two (2) indications for repair. Upon completion of the grinding, the sites were re-tested and found to be acceptable. At 13E PP121.6 three (3) indications were noted and repaired. At 13E-A.1 and A2.1, the U-Rib Plates have to remain in sections therefore allowing testing in sections and 13E PP122.2 from 1900mm, the preparation for testing is in progress. The QC Inspector was observed performing the MT testing with yoke orientation at parallel and less than perpendicular angles to the weld axis. This QA Inspector observed the QC Inspector perform the MT to SE-MT-CT-D1.5-105. Upon acceptance by QC, this QA Inspector performed MT testing on 10% of the welds listed above. This QA Inspector performed MT testing utilizing the yoke method in conformance with ASTM E 709 and the standard of acceptance with D1.5 section 6.26. This QA Inspector noted that no rejectable indications were found at the time of testing. This QA Inspector generated a TL-6028 MT report on this date. The completed work at this location appeared to be in general conformance with the contract specifications.
