DEPARTMENT OF TRANSPORTATION

Contract #: 04-0120F4Cty: SF/ALA Rte: 80 PM: 13.2/13.9File #: 1.28**WELDING INSPECTION REPORT****Resident Engineer:** Casey, William**Address:** 333 Burma Road**City:** Oakland, CA 94607**Report No:** WIR-027625**Date Inspected:** 18-May-2012**Project Name:** SAS Superstructure**OSM Arrival Time:** 700**Prime Contractor:** American Bridge/Fluor Enterprises, a JV**OSM Departure Time:** 1730**Contractor:** American Bridge/Fluor Enterprises, a JV**Location:** Job Site

Bridge No: 34-0006**Component:** SAS Tower**Summary of Items Observed:**

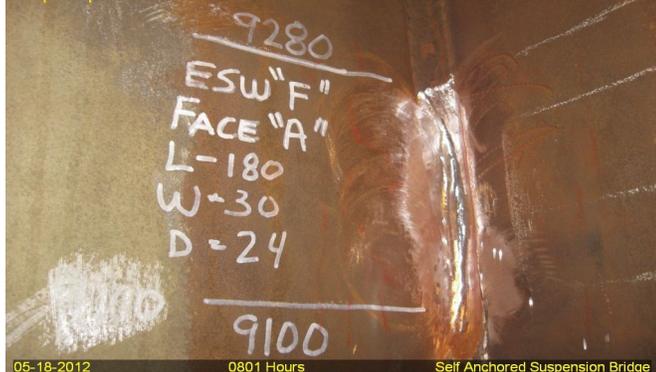
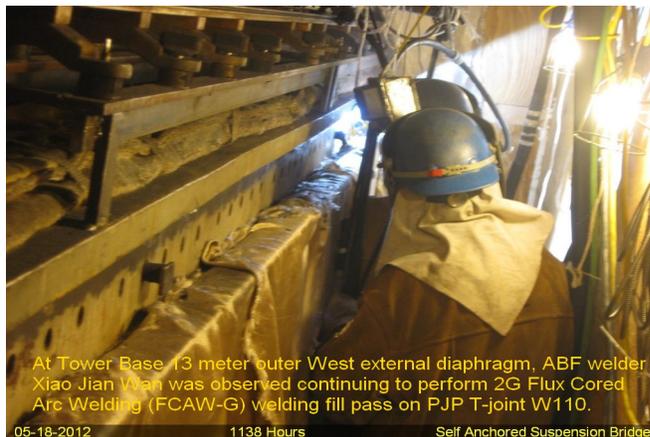
procedure ABF-WPS-D15-1000-Repairs. The repair excavation was preheated to more than 300 degree Fahrenheit using propylene gas torch prior welding. The ESW repair being welded was located at ESW 'F' face A with Y=3850mm was approved per Request for Welding Repair (RWR) #201110-002. During the shift, ABF QC John Pagliero was noted monitoring the welder. During the shift, the welder has completed the ESW weld repair mentioned above and has moved to same ESW location but different Y dimension. The welder moved to ESW 'F' face A and excavated using carbon air arc the other side of the defect where ABF welder Jin Pei Wang has welded the face B yesterday. Prior welding, ABF QC John Pagliero performed the verification of the defect removal using Visual Testing (VT) and Magnetic Particle Testing (MT) wherein he found the boat shape excavation acceptable. This QA also performed VT/MT verification on the same excavation and noted same result. The two first time repairs were noted being welded during the shift;

Location	Weld No.	Y-dim.	Length	Width	Depth	Remarks
1. ESW 'F'	E-045	3850mm	260mm	35mm	27mm	Completed
2. ESW 'F'	E-045	9100mm	180mm	30mm	24mm	Completed

At Tower Base Electro Slag Weld (ESW) location 'F' face A, ABF welder Wai Kitlai was observed performing 3G SMAW welding repair on boat shape repair excavation.

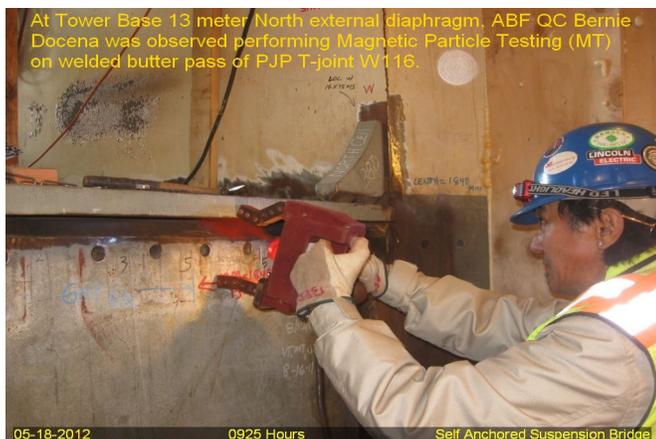
1. W116 PJP T-joint – weld butter pass QA verified
2. W116 PJP T-joint – weld root pass QA verified
3. W102 PJP T-joint – weld cover pass QA verified

At Tower Base 13 meter North external diaphragm, ABF QC Bernie Docena was observed performing Magnetic Particle Testing (MT) on welded butter pass of PJP T-joint W116.

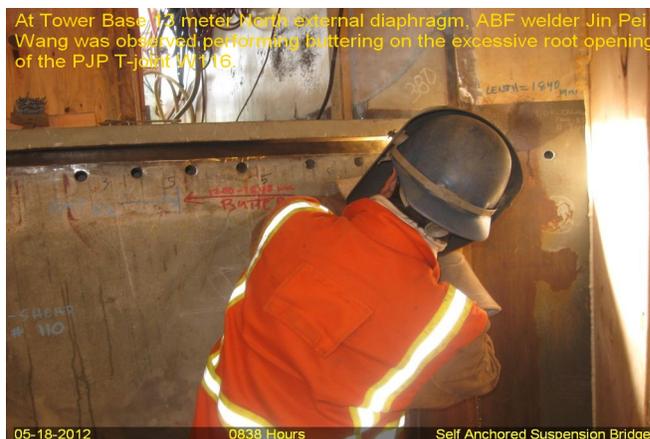
At Tower Base 13 meter North external diaphragm, ABF welder Jin Pei Wang was observed perform buttering on the one side of the PJP T-joint W116 due to excessive root gap as previously reported. The welder was noted buttering the west side of the weld joint where the maximum measure root opening was 7.0mm. The welder was noted buttering at overhead position using Shielded Metal Arc Welding (SMAW) with 3.2mm diameter E7018H4R electrode implementing Caltrans approved Welding Procedure Specification (WPS) ABF-WPS-D15-F1200A. The diaphragm plate being buttered was noted preheated to more than 150°F using propylene rose bud. After the buttering completion, ABF QC Bernie Docena was observed performing visual test (VT) and Magnetic Particle Testing (MT) on welded buttering then inform this QA that he found no relevant indication during the test. This QA perform the same MT test and noted same result. After the completion of MT, the welder preheated the plates to more than 150°F using propylene rose bud and welded the root pass of the PJP T-joint mentioned above. The welder was noted using the same SMAW process but used a bigger diameter 4.0mm E7018H4R electrode. The root pass welding was also completed during the shift and the welder had asked ABF QC Bernie Docena to check the root just welded. ABF QC Bernie Docena obliged to the welder's request and performed VT and MT on the completed root pass. During the inspection, ABF QC has found the welded root pass in compliance to the contract documents. This QA also performed verification on the same welded root and noted same result as that of QC. Since the welder needs the Miller Proheat 35 to preheat and maintain the heat during FCAW-G welding, ABF foreman James Zhen informed QC and this QA that the welder will continue to weld the joint tomorrow when the Induction Heating System will be available.

At Tower Base 13 meter North external diaphragm, ABF welder Jin Pei Wang was observed performing buttering on the excessive root opening of the PJP T-joint W116.
