Quality Assurance and Source Inspection

Contract #: 04-0120F4Cty: SF/ALA Rte: 80 PM: 13.2/13.9File #: 1.28**WELDING INSPECTION REPORT****Resident Engineer:** Casey, William**Address:** 333 Burma Road**City:** Oakland, CA 94607**Report No:** WIR-027627**Date Inspected:** 19-May-2012**Project Name:** SAS Superstructure**OSM Arrival Time:** 700**Prime Contractor:** American Bridge/Fluor Enterprises, a JV**OSM Departure Time:** 1530**Contractor:** American Bridge/Fluor Enterprises, a JV**Location:** Pier 7 Job Site**CWI Name:** listed below**CWI Present:** Yes No**Inspected CWI report:** Yes No N/A**Rod Oven in Use:** Yes No N/A**Electrode to specification:** Yes No N/A**Weld Procedures Followed:** Yes No N/A**Qualified Welders:** Yes No N/A**Verified Joint Fit-up:** Yes No N/A**Approved Drawings:** Yes No N/A**Approved WPS:** Yes No N/A**Delayed / Cancelled:** Yes No N/A**Bridge No:** 34-0006**Component:** S.A.S. Components**Summary of Items Observed:**

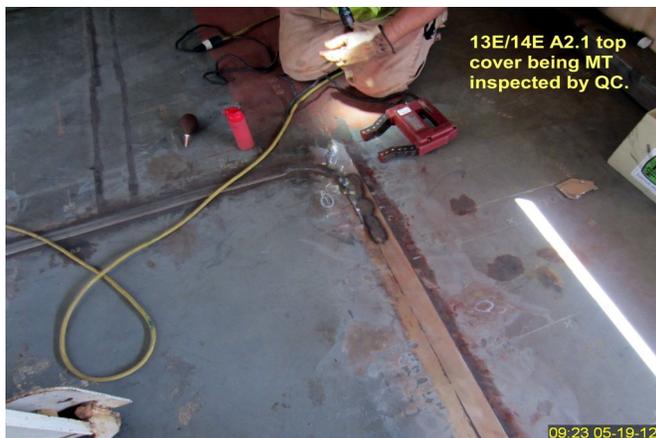
1) The QAI observed ABF personnel making overhead (4G) complete joint penetration (CJP) back welds at on the East bound Deck Closure Plates. The QAI noted that Salvador Sandoval, ID 2202, and Steven Davis, ID 7889, are using Shielded Metal Arc Welding (SMAW) with E7018 electrodes to back weld the 13E weld E2.8. Mr. Sandoval is welding by Panel Point (PP) 124 and Mr. Davis is welding by PP123. The QAI also noted that Eddie Brown, ID 9331, is SMAW 4G back welding at 13E/14E A1 and into the corner of weld 13E E2.2. The QAI noted that the Quality Control Inspector (QCI) Salvador Merino is monitoring this welding. The QAI made random observations of the welding in progress and verified that the preheat temperature, interpass temperature and welding parameters were conforming to the welding procedure specification (WPS) ABF-WPS-D15-1040C-CU. The QAI noted that these welds were in progress the duration of the shift. See the attached photo.

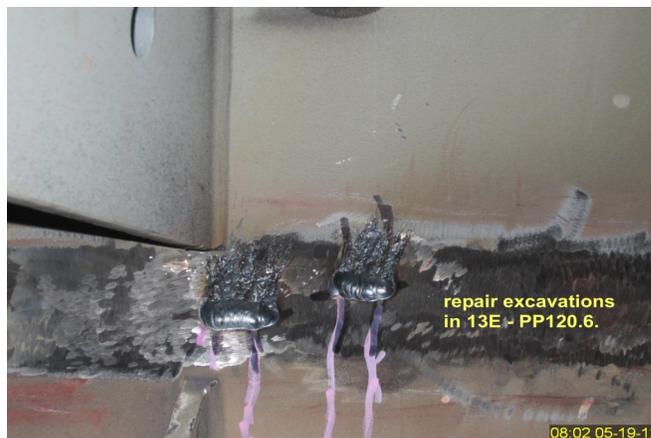
2) The QAI observed ABF personnel gouging the bottom of CJP welds where rejectable indications have been identified with Ultrasonic Testing (UT). The QAI observed 4 repair areas on 13E PP120.6. The QAI witnessed

the QCI Salvador Merino conducting Magnetic Particle Testing (MT) on the gouged and clean excavations. The QAI noted that the excavation dimensions are as follows from Y=0: 9mm deep, 30mm long & 15mm wide; 4mm deep, 40mm long & 10mm wide; 11mm deep, 30mm long & 15mm wide; 4mm deep, 30mm long & 15mm wide. See the attached photos. The QAI was informed that there were no rejectable indications observed and repairs would commence. The QAI visually examined the excavations and noted that they appeared to be ready for repair welding. The QAI also observed QCI personnel Steve McConnell and Andrew Keach conducting UT on deck closure plate weld 13E PP122.2. This inspection was in progress until the end of the shift and the QAI noted that several rejectable indications have been identified by the QCI. The QAI witnessed the QCI Salvador Merino conducting MT on the back weld of 13E PP122.2. The QAI was informed that the MT was acceptable. The QAI witnessed the QCI Salvador Merino conducting MT on the top weld of 13E/14E, A1 (Y=4350-5500) and A2.1 (Y=0-1850). The QAI noted that several areas where temporary attachment welds have not been completely removed are marked out for additional grinding and inspection. This was not completed by the end of the shift. See the attached photo.

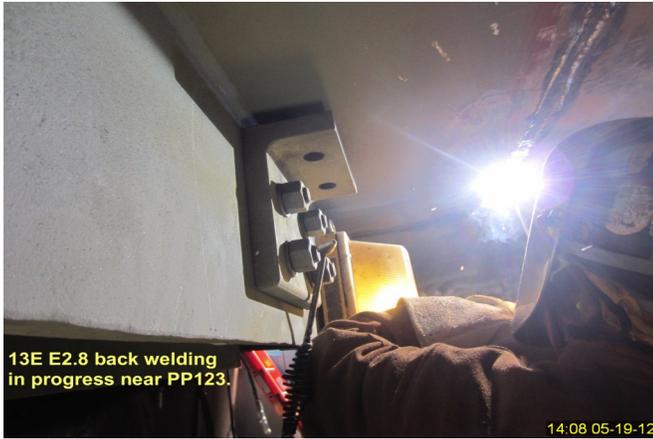
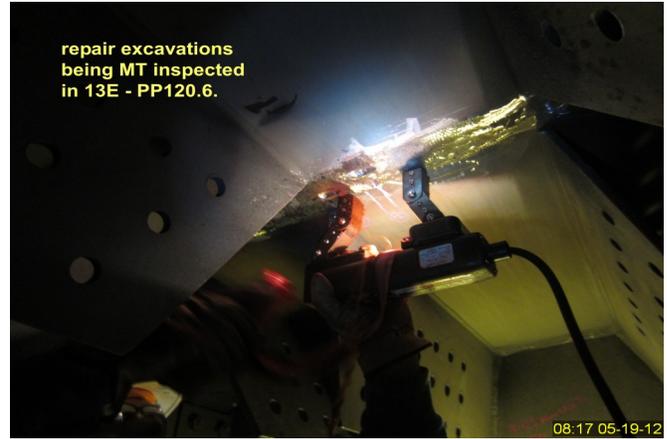
3) The QAI observed ABF welder Khit Lounechaney, ID 4985, welding the repairs at 13E PP120.6, after the excavation MT was completed. The QAI noted that the weld and base metal was preheated using an induction heater from the top of the deck. The QAI noted that the QCI Salvador Merino is monitoring the repair welding. Upon completion of the welding, the QAI was informed that the weld was kept at 325F for one hour. The QAI was unable to verify this. The QAI noted that the welder has relocated and is performing back welding at 13E PP120.6 and being monitored by the QCI Salvador Merino. This work was in progress until the end of the shift.
