DEPARTMENT OF TRANSPORTATION

Contract #: 04-0120F4Cty: SF/ALA Rte: 80 PM: 13.2/13.9File #: 1.28**WELDING INSPECTION REPORT****Resident Engineer:** Casey, William**Address:** 333 Burma Road**City:** Oakland, CA 94607**Report No:** WIR-027634**Date Inspected:** 18-May-2012**Project Name:** SAS Superstructure**OSM Arrival Time:** 700**Prime Contractor:** American Bridge/Fluor Enterprises, a JV**OSM Departure Time:** 1730**Contractor:** American Bridge/Fluor Enterprises, a JV**Location:** Jobsite

WELDING INSPECTION REPORT

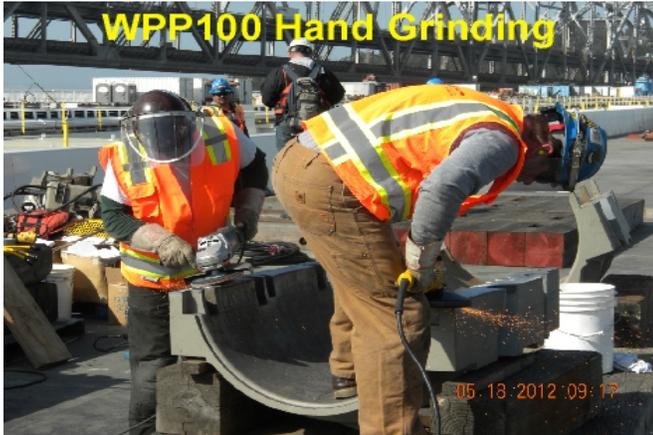
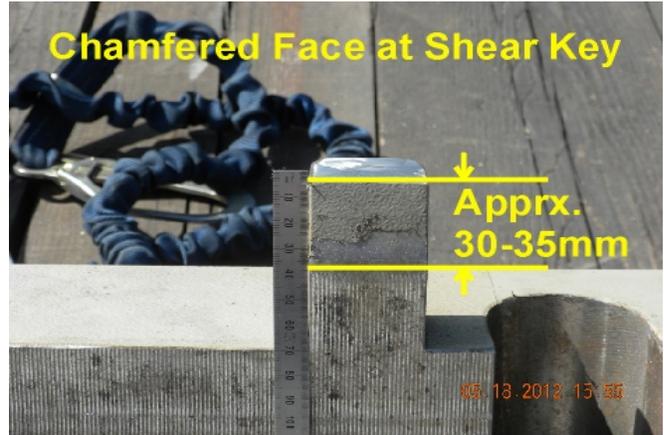
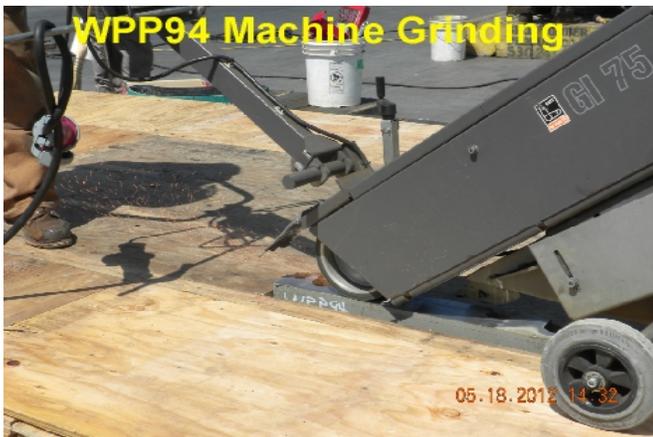
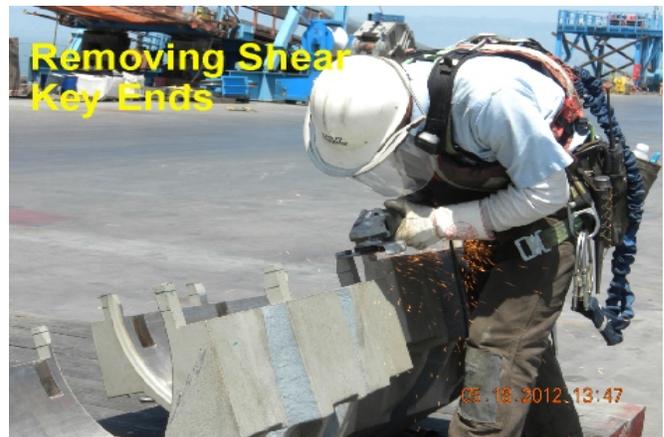
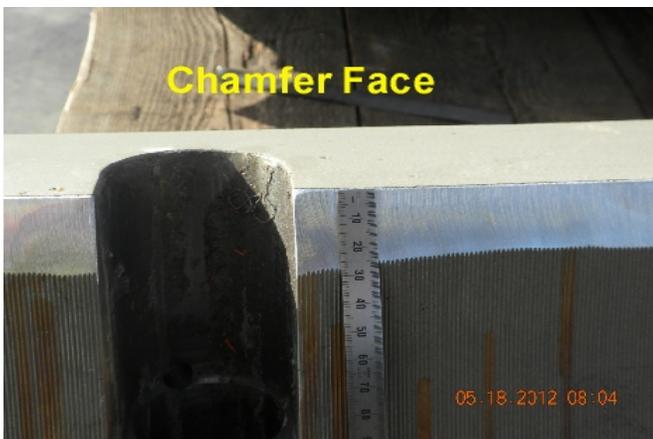
The QAI noted work in progress related to Request for Information (RFI) 001190R00. The QAI observed ABF personnel using power grinding equipment on eastbound lane South Cable Bands adding chamfers in accordance with RFI attachment 1 of 1. The QAI noted that the attachment shows both the male and female Cable Band halves being chamfered. The QAI had conversations with ABF supervisory personnel (Levi Gatsos and Scott Smith). The ABF supervisors are directing to have only the male half chamfered. The QAI visually inspected areas that were ground and no casting discontinuities were noted. The following Cable Band numbers were observed and spot measurements on work completed appear to be in accordance with the RFI: EPP110, EPP108, EPP70, EPP80, EPP78, EPP76, EPP74, EPP72, EPP118, EPP56, EPP58, EPP60, EPP62, EPP68, EPP64, EPP82, EPP84, EPP18, EPP20, EPP22 and EPP66. The QA Inspector made subsequent observations throughout the shift to monitor quality and noted that the work appears to be in general accordance with the project plans and specifications.

The QAI was directed by the lead QAI (Daniel Reyes) to observe work in progress where Cable Bands were being milled at the mating faces. The QAI did not have a RFI or Contract Change Order on hand for verification of workmanship that follows. The QAI observed ABF personnel using power grinding equipment on westbound lane North Cable Bands removing material from the female Cable Band half mating face, top and bottom. Female halves numbered WPP94 and WPP 100 were in progress to have 15mm (+10, -0mm tolerance) removed as detailed on "Red Line" changes to Goodwin Steel Castings Drawing No. 554Q-B2-1-F. WPP94 and WPP100

pieces were removed from the work area before completion. The QAI observed the male Cable Band half shear key ends removed approximately 15mm by a power grinder with a cut off wheel in accordance with "Red Line" changes to Goodwin Steel Castings Drawing No. 554Q-B2-1-M. The QAI noted that shear key detail "JOINT AT KEY", from Sheet titled "CABLE BAND DETAILS NO. 3" denotes a chamfer face of 50mm, the removal of the key ends reduce that dimension by approximately 15mm (30-35mm average noted).
