Contract #: 04-0120F4Cty: SF/ALA Rte: 80 PM: 13.2/13.9File #: 99.28**WELDING INSPECTION REPORT****Resident Engineer:** Casey, William**Address:** 333 Burma Road**City:** Oakland, CA 94607**Report No:** WIR-027641**Date Inspected:** 03-May-2012**Project Name:** SAS Superstructure**OSM Arrival Time:** 700**Prime Contractor:** American Bridge/Fluor Enterprises, a JV**OSM Departure Time:** 1530**Contractor:** American Bridge**Location:** Coraopolis PA**CWI Name:** Dennis Hildebrand**CWI Present:** Yes No**Inspected CWI report:** Yes No N/A**Rod Oven in Use:** Yes No N/A**Electrode to specification:** Yes No N/A**Weld Procedures Followed:** Yes No N/A**Qualified Welders:** Yes No N/A**Verified Joint Fit-up:** Yes No N/A**Approved Drawings:** Yes No N/A**Approved WPS:** Yes No N/A**Delayed / Cancelled:** Yes No N/A**Bridge No:** 34-0006**Component:** Anchor Plate**Summary of Items Observed:**

This Quality Assurance Inspector (QAI) arrived at American Bridge (AB), Coraopolis PA, as requested per TL 38 to monitor Repairs to Anchor Plate HK2-A7 which was damaged during welding of anchor studs at Lubrite Industries, Meadville PA, on 4/20/12.

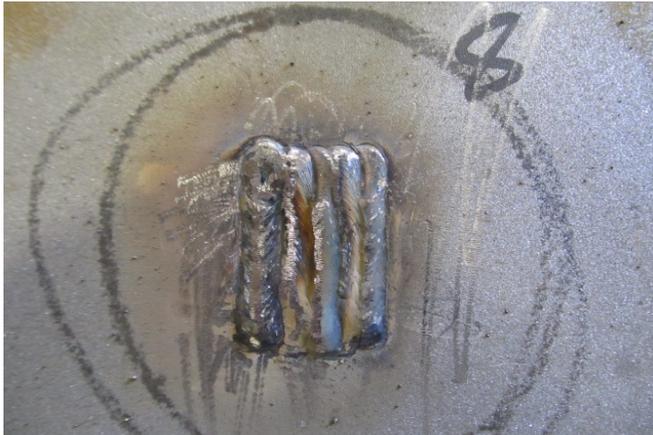
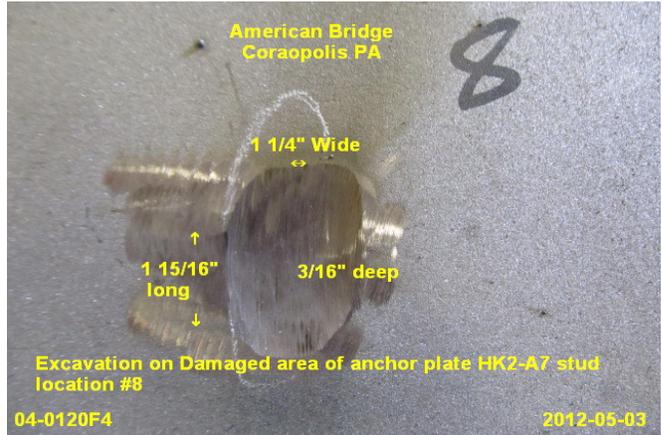
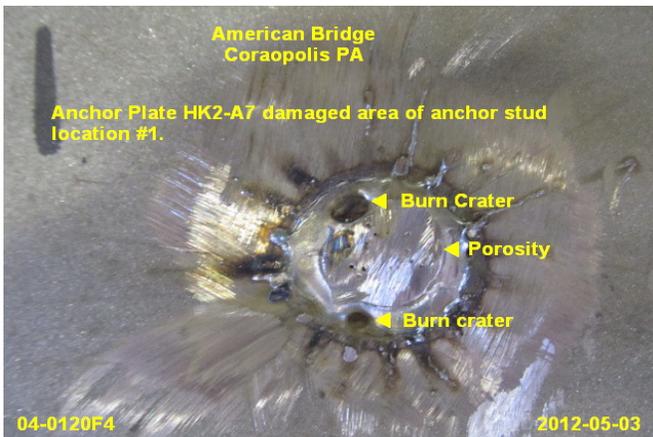
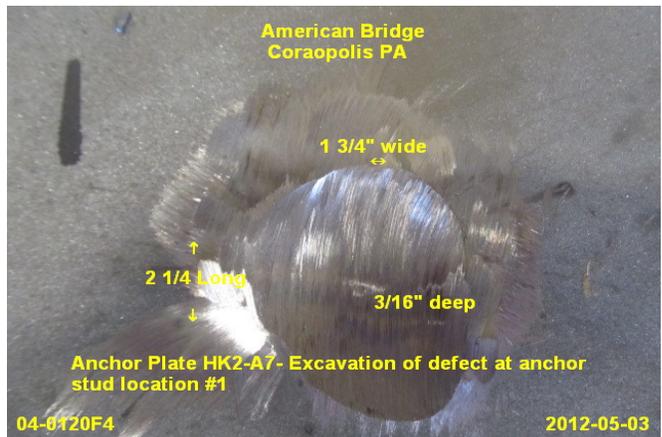
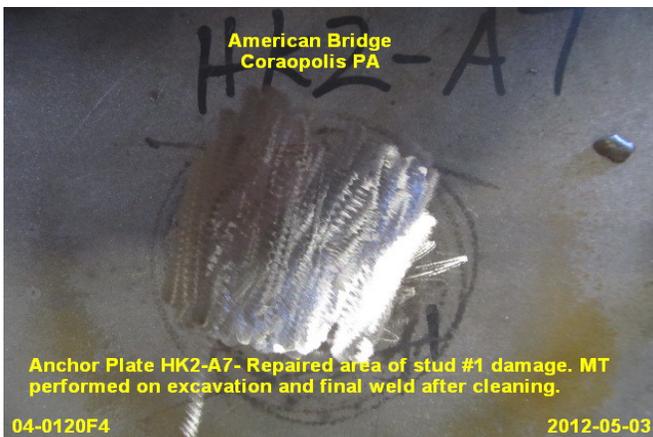
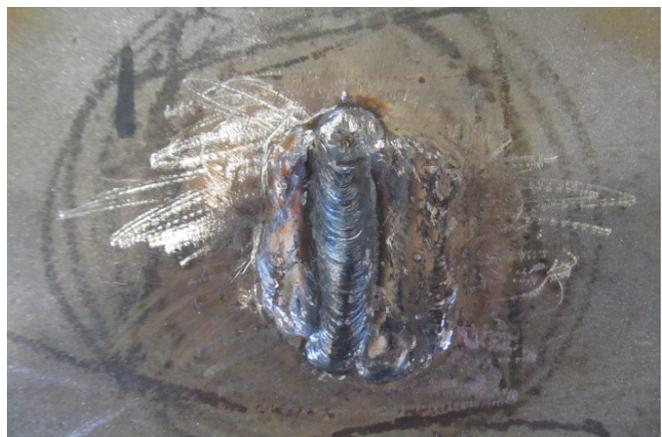
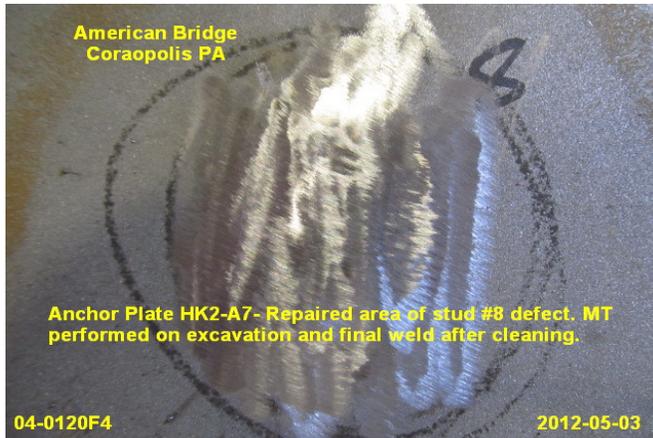
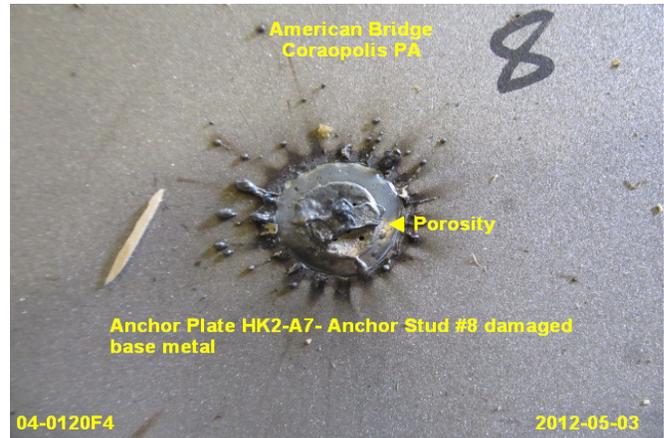
Anchor plate was still in box used to ship from Lubrite on 4/30/12. Green sticker from Lubrite visit still attached. Plate was set up on welding table and first defect at Repair Area #2 (per AB reports), Stud location #8 was ground flush to base metal. The stud had been removed at Lubrite prior to shipping to American Bridge. Once the area was ground flush a visual inspection was performed by AB QC and witnessed by this QAI. Excessive porosity was noticed in the base metal so the area had to be excavated to remove defects. An area approximately 1 3/4" x 2 1/4" x 3/16" deep was ground till all visible signs of surface defects were removed. The area was then Magnetic Particle tested using the yoke method. The Technician performing the test is certified per ASNT level II requirements. No indications were discovered at the time of testing. The excavated was then released for welding per approved weld and repair Procedures. The welding was performed and witnessed by QC and this QAI. The surface of the welded repaired area was then ground flush with the surface of the base metal.

Defect #1 at stud location #1 was then visually inspected and then the anchor stud was removed by grinding. The area was ground flush revealing (2) burned out pockets and porosity in the base metal. An area 1 1/4" x 1 15/16" x 3/16" deep was ground to remove all signs of surface defects. Visual Inspection by AB QC and witness by this QAI verified that all visual defects had been removed. The excavation was then Magnetic Particle Tested verifying all defects had been removed. Part was then released for welding of the excavation per approved WRP and ground

flush with surface of base metal. Both repaired areas were then Magnetic Particle Tested for verification of sound repair metal. No indications were revealed during the test.
