Contract #: 04-0120F4Cty: SF/ALA Rte: 80 PM: 13.2/13.9File #: 1.28**WELDING INSPECTION REPORT**

**Report No:** WIR-027644  
**Date Inspected:** 24-May-2012

**Project Name:** SAS Superstructure  
**Prime Contractor:** American Bridge/Fluor Enterprises, a JV  
**Contractor:** American Bridge/Fluor Enterprises, a JV

**Bridge No:** 34-0006**Component:** Tower Component**Summary of Items Observed:**

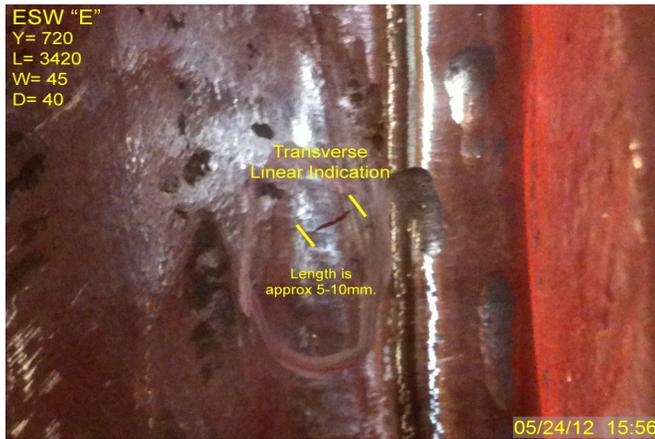
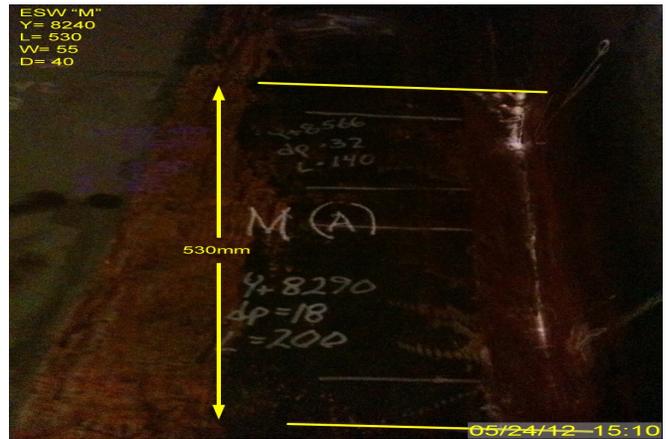
This QA randomly observed ABF/JV welding personnel performing excavation of welds previously Ultrasonic Testing (UT) rejected. Quality Control (QC) Inspector Jesse Cayabyab performed Magnetic Particle (MT) and visual confirmation of excavations. QC observed rejectable indications at the time of testing. Further repair and excavation are required for these welds. Excavations have been recorded and are to be submitted to engineer for further review.

This QA Inspector performed confirmation Magnetic Particle Testing (MT) of weld repair excavations on two locations on tower electroslag welds. This QA observed rejectable indications at the time of testing.
