DEPARTMENT OF TRANSPORTATION

Contract #: 04-0120F4Cty: SF/ALA Rte: 80 PM: 13.2/13.9File #: 1.28**WELDING INSPECTION REPORT****Resident Engineer:** Casey, William**Address:** 333 Burma Road**City:** Oakland, CA 94607**Report No:** WIR-027676**Date Inspected:** 30-May-2012**Project Name:** SAS Superstructure**OSM Arrival Time:** 700**Prime Contractor:** American Bridge/Fluor Enterprises, a JV**OSM Departure Time:** 1730**Contractor:** American Bridge/Fluor Enterprises, a JV**Location:** Job Site**CWI Name:** As noted below**CWI Present:** Yes No**Inspected CWI report:** Yes No N/A**Rod Oven in Use:** Yes No N/A**Electrode to specification:** Yes No N/A**Weld Procedures Followed:** Yes No N/A**Qualified Welders:** Yes No N/A**Verified Joint Fit-up:** Yes No N/A**Approved Drawings:** Yes No N/A**Approved WPS:** Yes No N/A**Delayed / Cancelled:** Yes No N/A**Bridge No:** 34-0006**Component:** SAS OBG**Summary of Items Observed:**

13E Drop-In Panels (Exterior/Interior)

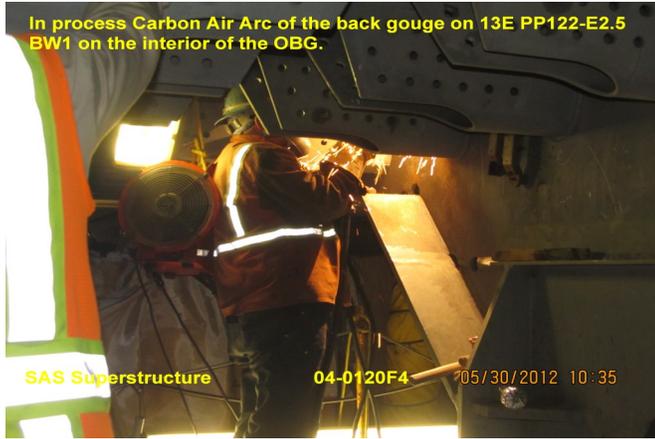
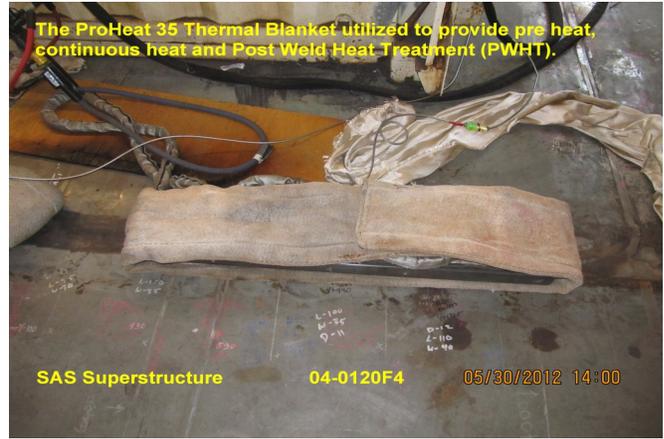
Note: Repair Welding was performed on 13E/14E-A2.1 at y+815 with insufficient preheat. This QA Inspector observed the ProHeat 35 thermal blanket on the exterior side of the joint was not in operation during the in process welding at this location. The weld was completed at the time of the observation and QC Inspector Salvador Merino was notified and reported to QC Management. This QA Inspector generated a TL-15 on this date. ABF-WPS-D1.5-1004-Repair and AWS D1.5-2002: Section 12.17.6 was referenced in this report.
