**DEPARTMENT OF TRANSPORTATION**

Contract #: 04-0120F4Cty: SF/ALA Rte: 80 PM: 13.2/13.9File #: 1.28**WELDING INSPECTION REPORT****Resident Engineer:** Casey, William**Address:** 333 Burma Road**City:** Oakland, CA 94607**Report No:** WIR-027681**Date Inspected:** 22-May-2012**Project Name:** SAS Superstructure**OSM Arrival Time:** 700**Prime Contractor:** American Bridge/Fluor Enterprises, a JV**OSM Departure Time:** 1730**Contractor:** American Bridge/Fluor Enterprises, a JV**Location:** Job Site**CWI Name:** See Below**CWI Present:** Yes No**Inspected CWI report:** Yes No N/A**Rod Oven in Use:** Yes No N/A**Electrode to specification:** Yes No N/A**Weld Procedures Followed:** Yes No N/A**Qualified Welders:** Yes No N/A**Verified Joint Fit-up:** Yes No N/A**Approved Drawings:** Yes No N/A**Approved WPS:** Yes No N/A**Delayed / Cancelled:** Yes No N/A**Bridge No:** 34-0006**Component:** OBG/Tower**Summary of Items Observed:**

## WELDING INSPECTION REPORT

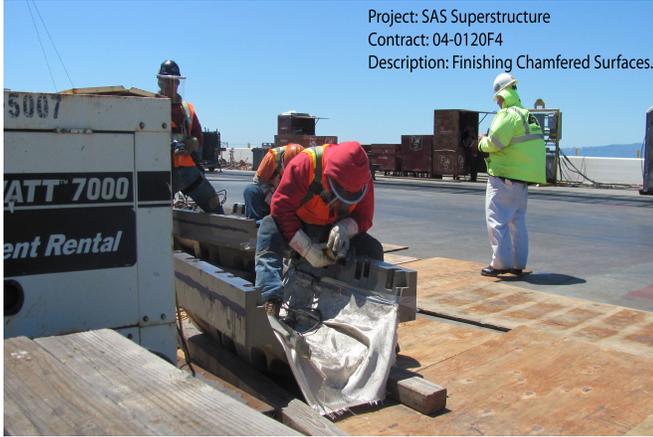
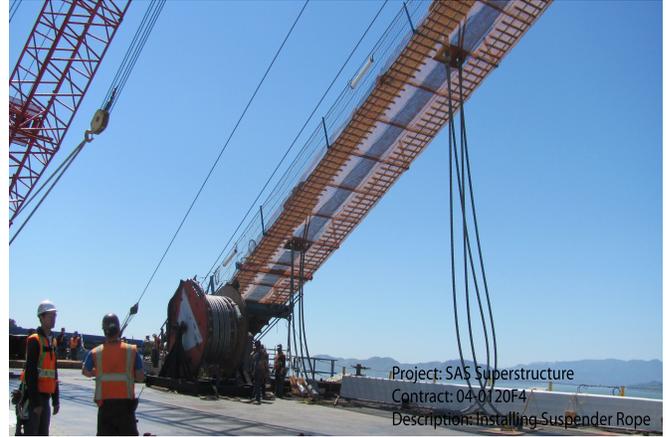
This QAI verified the arrival of ten (10) cable band assemblies to the job site from various machine shops during this shift. This QAI also verified the amount of material removed from the female cable band half connecting surface which appeared to be approximately 15 mm. At the conclusion of this verification this QAI observed ABF personnel chamfering the inside edge of the cable band to a sloping transition of 5 mm: 20 mm utilizing a 9" grinder with a sanding disc attached to achieve a smooth finish. Also observed by this QAI was the preparation of the finishing the new cut surface edge to a 2 mm radius and a 5 mm radius at the suspender rope saddle. The following cable bands were received with the required work completed during this shift: WPP56, WPP58, WPP60, WPP62, WPP64, WPP66, WPP68, WPP74 and WPP76. Reference Bay Bridge Mets Mail: Cable Band Machining, dated Friday, May 18, 2012.
