DEPARTMENT OF TRANSPORTATION

Contract #: 04-0120F4Cty: SF/ALA Rte: 80 PM: 13.2/13.9File #: 1.28**WELDING INSPECTION REPORT**

Report No: WIR-027688
Date Inspected: 01-Jun-2012

Project Name: SAS Superstructure
Prime Contractor: American Bridge/Fluor Enterprises, a JV
Contractor: American Bridge/Fluor Enterprises, a JV

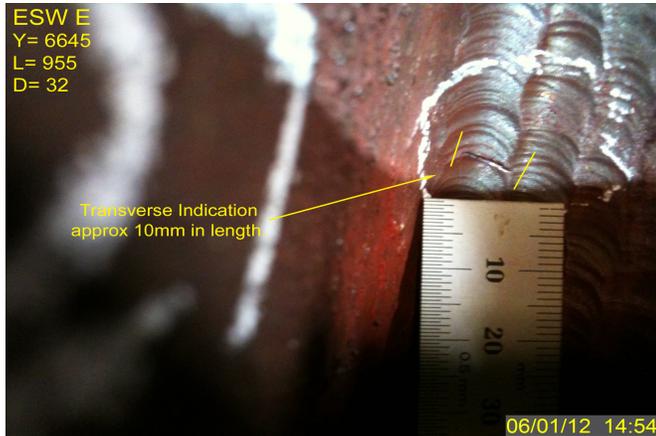
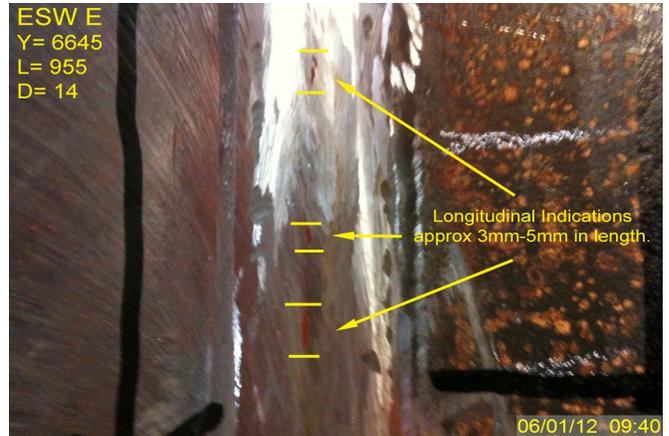
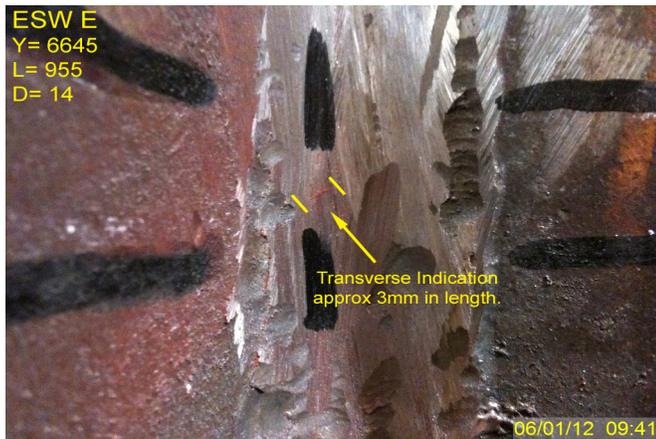
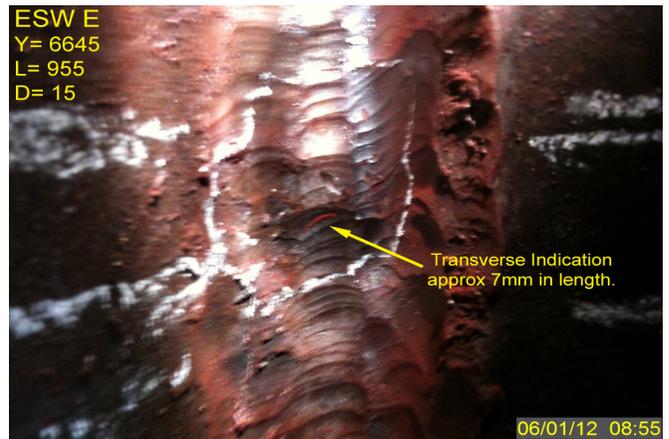
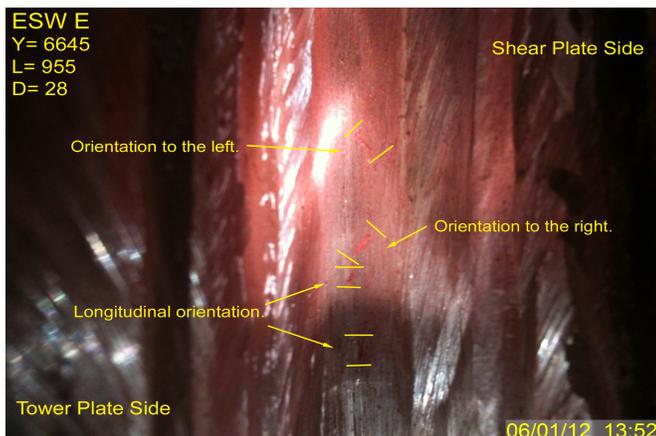
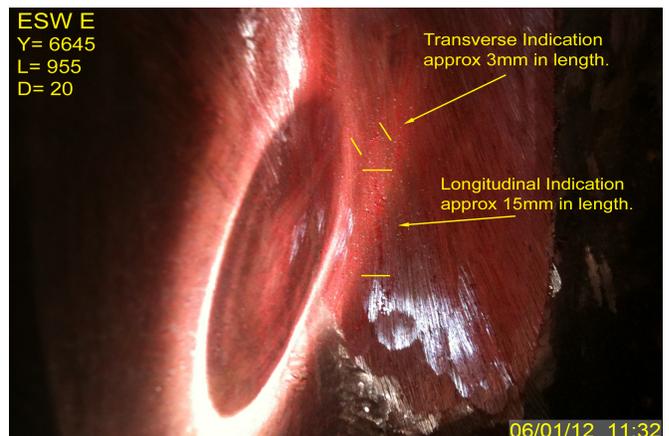
The UT discovered indications were found to be oriented in both the transverse and longitudinal positions. The indications were found to range from rejectable per AWS D1.5 Table 6.4 to within the recordable criteria to be subject to further Radiographic Testing (RT).

The weld excavated is designated as "ESW E" and was excavated from Y location 6645mm for a length of 955mm. The final measured depth of this excavation was 38mm, with a measured width of 45mm.

Throughout this excavation this QA observed and photographed intermittent transverse and longitudinal linear indications ranging in sizes from 2mm to 12mm.

Please see attached photographs for representative samples of indications observed.
