DEPARTMENT OF TRANSPORTATION

Contract #: 04-0120F4Cty: SF/ALA Rte: 80 PM: 13.2/13.9File #: 1.28**WELDING INSPECTION REPORT****Resident Engineer:** Casey, William**Address:** 333 Burma Road**City:** Oakland, CA 94607**Report No:** WIR-027689**Date Inspected:** 02-Jun-2012**Project Name:** SAS Superstructure**OSM Arrival Time:** 700**Prime Contractor:** American Bridge/Fluor Enterprises, a JV**OSM Departure Time:** 1530**Contractor:** American Bridge/Fluor Enterprises, a JV**Location:** Job Site**CWI Name:** As noted below.**CWI Present:** Yes No**Inspected CWI report:** Yes No N/A**Rod Oven in Use:** Yes No N/A**Electrode to specification:** Yes No N/A**Weld Procedures Followed:** Yes No N/A**Qualified Welders:** Yes No N/A**Verified Joint Fit-up:** Yes No N/A**Approved Drawings:** Yes No N/A**Approved WPS:** Yes No N/A**Delayed / Cancelled:** Yes No N/A**Bridge No:** 34-0006**Component:** Tower Component**Summary of Items Observed:**

WELDING INSPECTION REPORT

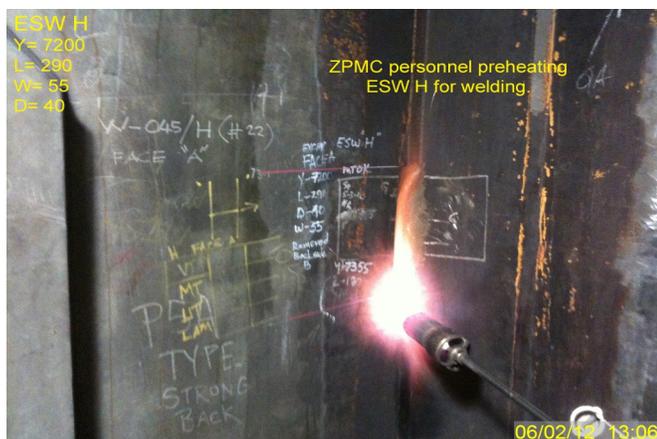
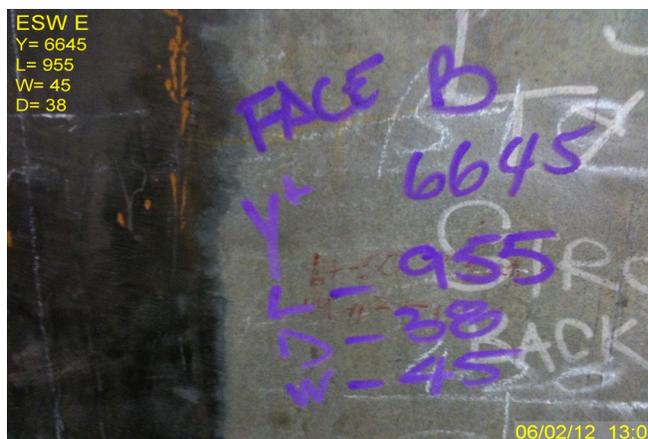
This QA randomly observed ABF/JV welding personnel performing excavation of welds previously Ultrasonic Testing (UT) rejected. Quality Control (QC) Inspector Jesse Cayabyab performed Magnetic Particle (MT) and visual confirmation of excavations. QC observed rejectable indications at the time of testing. Excavations have been recorded and are to be submitted to engineer for further review.

Weld "E" – Y=6645mm, L=955mm, W=45mm, D=38mm (final excavation measurements)
