DEPARTMENT OF TRANSPORTATION

Contract #: 04-0120F4Cty: SF/ALA Rte: 80 PM: 13.2/13.9File #: 1.28**WELDING INSPECTION REPORT**

Report No: WIR-027698
Date Inspected: 01-Jun-2012

Project Name: SAS Superstructure **OSM Arrival Time:** 700
Prime Contractor: American Bridge/Fluor Enterprises, a JV **OSM Departure Time:** 1730
Contractor: American Bridge/Fluor Enterprises, a JV **Location:** Job Site

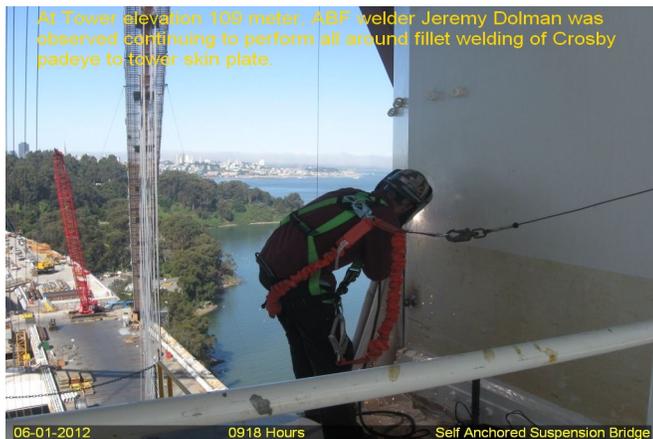
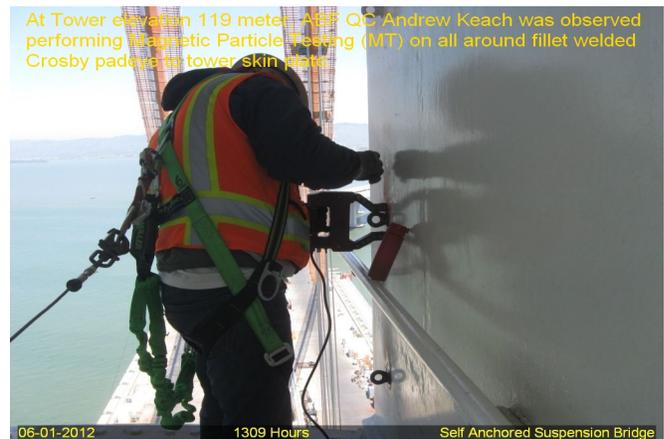
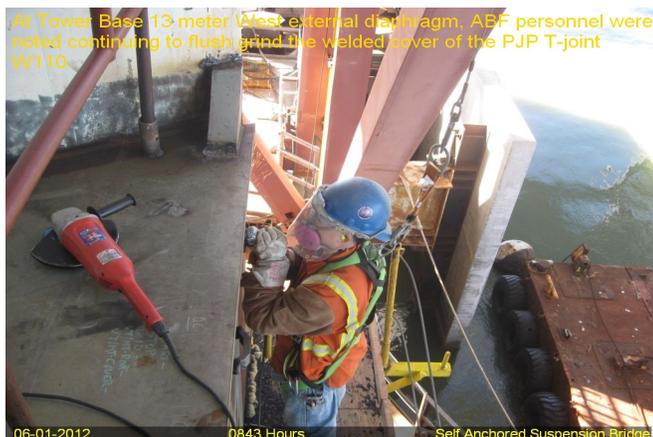
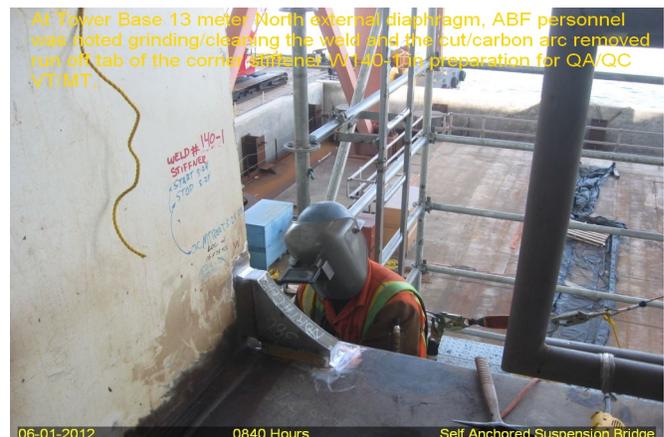
At Tower elevation 109 and 99 meter, QA randomly observed ABF/JV qualified Jeremy Dolman continuing to perform all position Shielded Metal Arc Welding (SMAW) fillet welding Crosby size number 4 padeye on tower skin plates. There were two padeyes being welded on tower skin plates A and E on tower shafts South and East while there are two only welded padeyes on tower skin plate A of tower shaft North and West. The padeyes are also being welded per Contract Change Order (CCO) #201 and per Caltrans approved drawing Tower Access Detail #30.

Prior welding, ABF foreman Rory Hogan was noted laying out the location of the padeyes and grinding off the paint on the tower where the padeye will be welded. After grinding, the same personnel preheated the tower skin plate to required temperature of more than 225°F. After reaching the required preheat temperature, ABF welder Jeremy Dolman performed the tack welding using SMAW with 3.2mm diameter E7018H4R electrode with measured working current of 128 amperes on the mentioned electrode.

As soon as the padeye is tack welded, the welder immediately preheated the tower skin plate and the padeye itself to the required preheat temperature of more than 225°F. The welder then fully fillet welded the Crosby Padeye to 5mm all around fillet using the same electrode and size. During fillet welding, ABF QC Andrew Keach was observed monitoring the preheat temperature and working current.

At the request of Quality Control Field Supervisor, Bonifacio Daquinag, QA has randomly verified the QC VT/MT of the 5mm all around fillet weld joints between the Crosby padeye to tower skin plate. The QA verification was performed to verify that the welding and the VT/MT inspection performed by the QC inspector meet the requirements of the contract documents. At the conclusion of the QA verification it appeared that the weld and the QC inspection complied with the contract documents.

At Tower Base 13 meter external diaphragms, this QA noted ABF personnel grinding run off tabs on various corner stiffeners after carbon arc gouging. Other welding related activity noted at 13 meter diaphragm include flush grinding on the welded cover of West and South external diaphragms W110 and W111 respectively in preparation for the Visual Test (VT) and the Magnetic Particle Testing (MT) to be performed by ABF QC and QA. During the shift, ABF QC Bernie Docena was noted monitoring the various activities being performed by ABF personnel. At the end of the shift, grinding of various corner stiffeners and flush grinding on the weld cover of PJP T-joints W110 and W111 were still continuing.
