DEPARTMENT OF TRANSPORTATION

Contract #: 04-0120F4Cty: SF/ALA Rte: 80 PM: 13.2/13.9File #: 1.28**WELDING INSPECTION REPORT****Resident Engineer:** Casey, William**Address:** 333 Burma Road**City:** Oakland, CA 94607**Report No:** WIR-027711**Date Inspected:** 02-Jun-2012**Project Name:** SAS Superstructure**OSM Arrival Time:** 700**Prime Contractor:** American Bridge/Fluor Enterprises, a JV**OSM Departure Time:** 1530**Contractor:** American Bridge/Fluor Enterprises, a JV**Location:** Job Site**CWI Name:** As noted below**CWI Present:** Yes No**Inspected CWI report:** Yes No N/A**Rod Oven in Use:** Yes No N/A**Electrode to specification:** Yes No N/A**Weld Procedures Followed:** Yes No N/A**Qualified Welders:** Yes No N/A**Verified Joint Fit-up:** Yes No N/A**Approved Drawings:** Yes No N/A**Approved WPS:** Yes No N/A**Delayed / Cancelled:** Yes No N/A**Bridge No:** 34-0006**Component:** SAS OBG**Summary of Items Observed:**

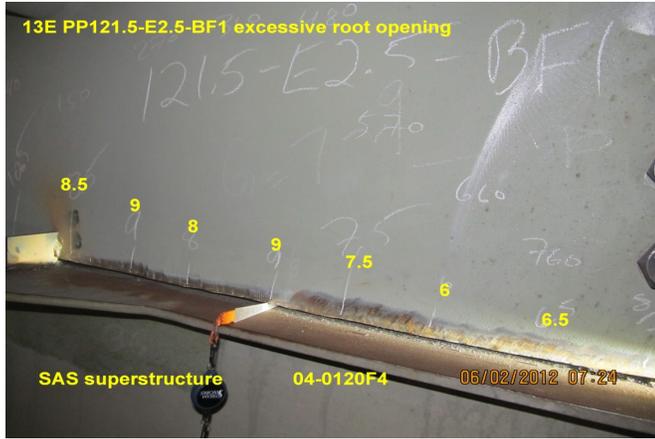
13E Drop-In Panels (Interior)

This QA Inspector made random observations of the fit-up and Visual Inspection (VT) process conducted by QC Inspector Salvador Merino. The Inspector was observed measuring the excessive root opening of 13E PP121.5-E2.5-BF1 on the interior of the OBG. (See photo below). It was noted that the measurements were out of tolerance in accordance with AWS D1.5-2002 Section 3.3, 3.3.1. QC Inspector Salvador Merino reported the findings to QC Manager Bonifacio Daquinag Jr. This QA Inspector generated a TL-15 on this date and referenced the above AWS D1.5 sections. These joints are Seismic Performance Critical Members (SPCM).

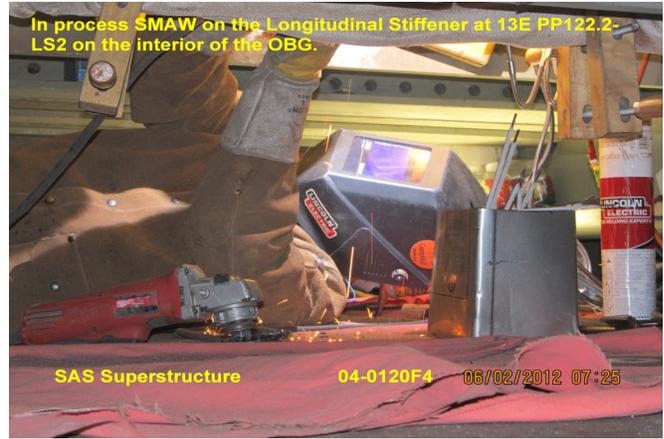
13E PP122.5-BF1 (Interior)

This QA Inspector randomly observed the continuing in process SMAW on the Longitudinal Stiffener (LS) weld at 13E PP120.6-LS1. ABF welder Khit Lounechaney (ID 4985) was observed grinding and blending the work between passes with a small disc grinder. On a subsequent observation, the welder was observed continuing the SMAW process in the 3G vertical position utilizing E9018-H4R electrodes drawing amperage of 130. This QA Inspector observed QC Inspector Sal Merino verify prior to the start of welding operations, that the minimum preheat temperature as per the approved WPS was established; and afterwards verified that the welding parameters (Amps and Travel Speed) were in accordance with ABF-WPS-D1.5-1012-3. This welding was in progress for the duration of the shift and was completed on this date. This QA Inspector verified that the electrodes were stored in electric rod ovens and appeared to be in accordance with AWS D1.5 Section 4.5.2 and exposure rates appeared to be in accordance with AWS D1.5 Table 4.7. During subsequent observations it was noted that the welders were using a power disc grinder and/or rotary die grinders at weld starts and stops as needed and were cleaning between weld passes with power wire wheel brushes. This QA Inspector noted that the work at this location was completed on this date and appeared to be in general conformance with the contract documents. This joint is a Seismic Performance Critical Member (SPCM).
