Contract #: 04-0120F4Cty: SF/ALA Rte: 80 PM: 13.2/13.9File #: 1.28**WELDING INSPECTION REPORT**

Report No: WIR-027734
Date Inspected: 07-Jun-2012

Project Name: SAS Superstructure
Prime Contractor: American Bridge/Fluor Enterprises, a JV
Contractor: American Bridge/Fluor Enterprises, a JV

Tower (ESW Weld Repairs)

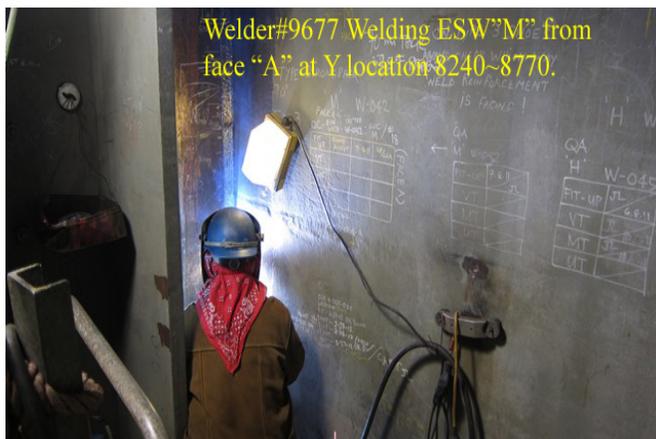
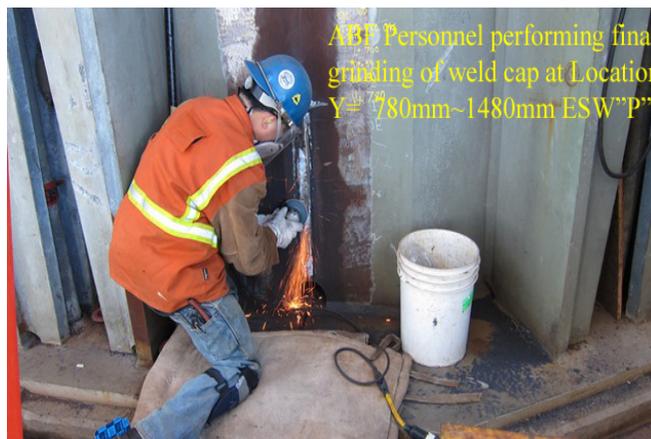
The joint being welded was tower shear plate designated as ESW weld, location "E" from face B. Dimensions excavated for this repair were: (Y=6645mm~7640mm, Width 45mm, Depth 38mm) During welding, ABF Quality Control (QC) Ted Ilo was noted monitoring the welding parameters. Welding parameters were recorded as (A=227, V=22.5).

The joint being welded was tower shear plate designated as ESW weld, location "E" from face A. Dimensions excavated for this repair were: (Y=8240mm~8770mm, Width 55mm, Depth 40mm) During welding, ABF Quality Control (QC) Ted Ilo was noted monitoring the welding parameters. Welding parameters were recorded as (A=230, V=22.7).

This QA observed at random intervals, ABF/JV personnel performing final grinding of the weld cap to a bright clean finish. The joint being welded was tower shear plate designated as ESW weld, location "P" from the external face at location Y=780mm~1480mm.
