DEPARTMENT OF TRANSPORTATION

Contract #: 04-0120F4Cty: SF/ALA Rte: 80 PM: 13.2/13.9File #: 1.28**WELDING INSPECTION REPORT****Resident Engineer:** Casey, William**Address:** 333 Burma Road**City:** Oakland, CA 94607**Report No:** WIR-027740**Date Inspected:** 07-Jun-2012**Project Name:** SAS Superstructure**OSM Arrival Time:** 700**Prime Contractor:** American Bridge/Fluor Enterprises, a JV**OSM Departure Time:** 1730**Contractor:** American Bridge/Fluor Enterprises, a JV**Location:** Job Site**CWI Name:** Fred Michels**CWI Present:** Yes No**Inspected CWI report:** Yes No N/A**Rod Oven in Use:** Yes No N/A**Electrode to specification:** Yes No N/A**Weld Procedures Followed:** Yes No N/A**Qualified Welders:** Yes No N/A**Verified Joint Fit-up:** Yes No N/A**Approved Drawings:** Yes No N/A**Approved WPS:** Yes No N/A**Delayed / Cancelled:** Yes No N/A**Bridge No:** 34-0006**Component:** SAS Tower**Summary of Items Observed:**

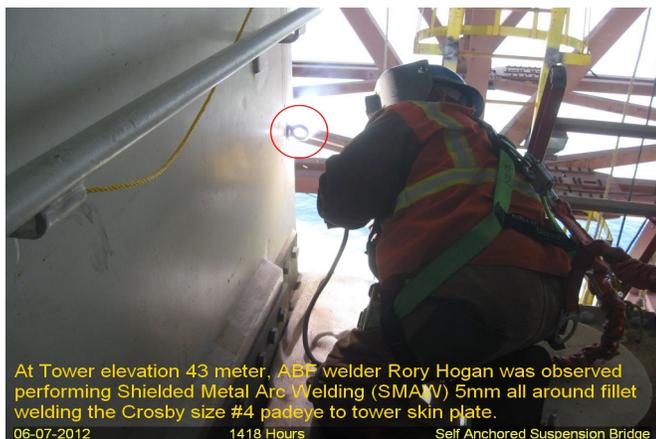
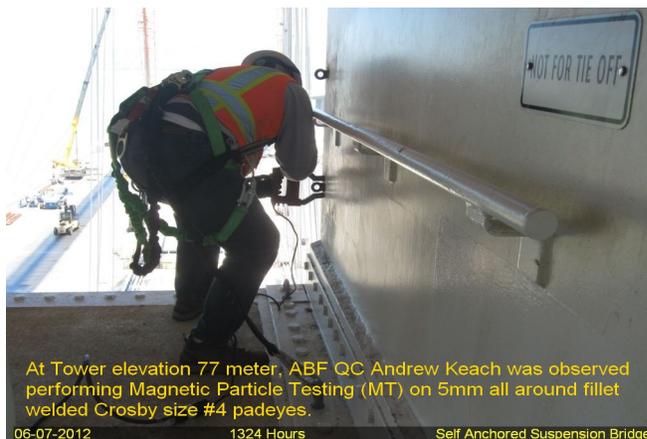
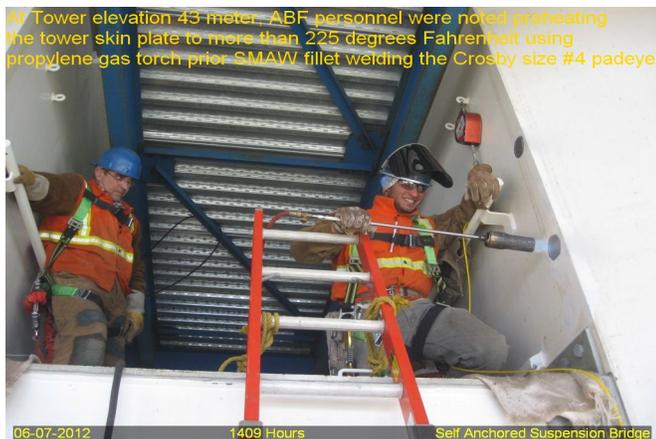
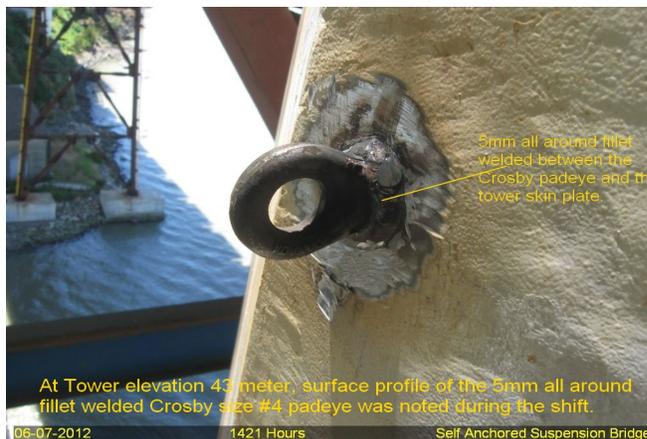
At Tower elevation 43 meter, QA randomly observed ABF/JV qualified Rory Hogan continuing to perform all position Shielded Metal Arc Welding (SMAW) fillet welding Crosby size number 4 padeye on tower skin plates. There were four padeyes being welded on tower skin plates A and E on tower shafts South and East while there are only two being welded padeyes on tower skin plate A of tower shafts North and West. The padeyes are also being welded per Contract Change Order (CCO) #201 and per Caltrans approved drawing Tower Access Detail #30.

Prior welding, ABF foreman Rory Hogan was noted laying out the location of the padeyes while another ABF personnel was noted grinding off the paint on the tower where the padeye will be welded. After grinding, the same personnel preheated the tower skin plate to required temperature of more than 225°F. After reaching the required preheat temperature, ABF welder Rory Hogan performed the tack welding using SMAW with 3.2mm diameter E7018H4R electrode with measured working current of 135 amperes on the mentioned electrode.

As soon as the padeye is tack welded, the welder immediately preheated the tower skin plate and the padeye itself to the required preheat temperature of more than 225°F. The welder then fully fillet welded the Crosby Padeye to 5mm all around fillet using the same electrode and size. During fillet welding, ABF QC Fred Michels was observed monitoring the preheat temperature and working current.

At the request of Quality Control Field Supervisor, Bonifacio Daquinag, QA has randomly verified the QC VT/MT of the welded 5mm all around fillet weld joint between the Crosby padeye and tower skin plate . The QA verification was performed to verify that the welding and the VT/MT inspection performed by the QC inspector meet the requirements of the contract documents. At the conclusion of the QA verification it appeared that the weld and the QC inspection complied with the contract documents.
