DEPARTMENT OF TRANSPORTATION

Contract #: 04-0120F4Cty: SF/ALA Rte: 80 PM: 13.2/13.9File #: 1.28**WELDING INSPECTION REPORT****Resident Engineer:** Casey, William**Address:** 333 Burma Road**City:** Oakland, CA 94607**Report No:** WIR-027746**Date Inspected:** 11-Jun-2012**Project Name:** SAS Superstructure**OSM Arrival Time:** 700**Prime Contractor:** American Bridge/Fluor Enterprises, a JV**OSM Departure Time:** 1530**Contractor:** American Bridge/Fluor Enterprises, a JV**Location:** Job Site**CWI Name:** As noted below**CWI Present:** Yes No**Inspected CWI report:** Yes No N/A**Rod Oven in Use:** Yes No N/A**Electrode to specification:** Yes No N/A**Weld Procedures Followed:** Yes No N/A**Qualified Welders:** Yes No N/A**Verified Joint Fit-up:** Yes No N/A**Approved Drawings:** Yes No N/A**Approved WPS:** Yes No N/A**Delayed / Cancelled:** Yes No N/A**Bridge No:** 34-0006**Component:** SAS OBG**Summary of Items Observed:**

13E PP123.5-E2.1-BF2 (Interior)

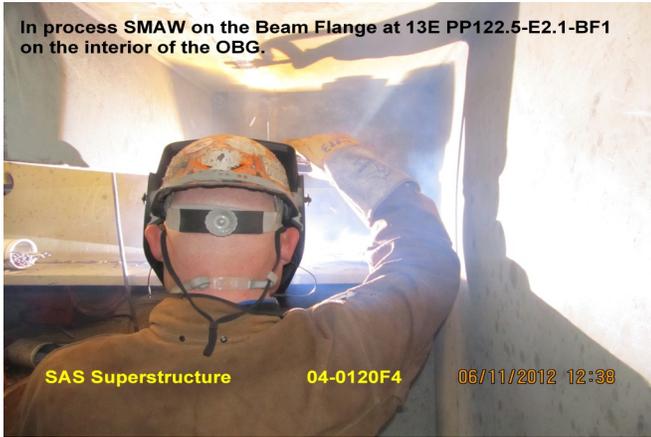
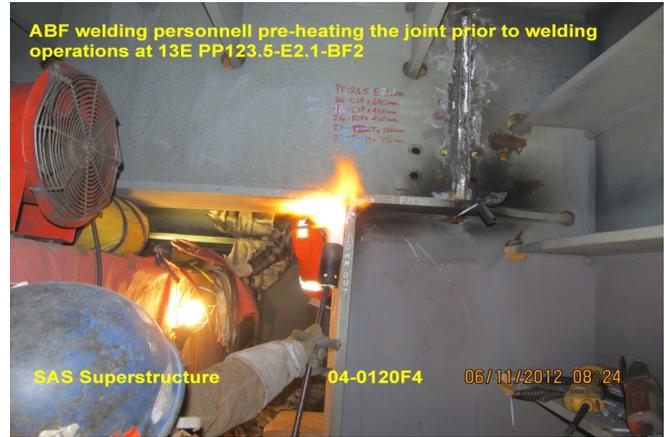
This QA Inspector randomly observed Shielded Metal Arc Welding (SMAW) in the 4G overhead position on the Beam Flange weld at 13E PP123.5-E2.1-BF2. ABF welder Khit Lounechaney (ID 4985) was observed pre-heating the Complete Joint Penetration (CJP) joint prior to welding and utilized 4.0mm E7018-H4R electrodes drawing amperage of 143. QC Inspector Salvador Merino was present to monitor the welding and the parameters as they pertain to ABF-WPS-D1.5-1030. Between passes the welder was observed cleaning the work using a small disc grinder as QC measured the inter-pass temperatures with Tempilstik Heat Indicators. On a subsequent observation, it was noted that the welder was continuing the in process welding. This QA Inspector noted that the 3.2mm electrodes were stored in electrically heated thermostatically controlled oven after removal from the sealed containers. The exposure limits of the electrodes appeared to comply with the minimum storage oven temperature of 120 degrees Celsius as per the contract documents. The welding parameters and surface temperatures were verified by the QC inspector's utilizing a Fluke 337 clamp meter to measure the electrical welding parameters. At the time of the observations no issues were noted by the QA. On subsequent observations throughout the shift to

This QA Inspector randomly observed the repair welding operations performed by ABF welder Rick Clayborn (ID 2773) at 13E-E2.2 on the interior of the OBG. The welder was observed using the Carbon Arc Gouging (CAG) process to excavate the sites. Upon removal of the discontinuities, QC Inspector Salvador Merino performed Magnetic Particle Testing (MT) to ensure soundness of the metal and observed no relevant indications and recorded the dimensions of the excavations which are listed below. The welder was observed depositing metal by utilizing the SMAW process in the 4G overhead position employing 3.2mm E7018-H4R electrodes drawing amperage of 127 as pertaining to ABF-WPS-D1.5-1004-Repair. This QA Inspector verified that the electrodes were obtained from a baking oven at the correct temperature and within acceptable exposure limits. The welders were observed cleaning the start/stop edges of the work utilizing small disc grinders and compressed air and restored the base metal to the original surface and ground smooth, and the welds to their specific profiles. Post Weld Heat Treatment (PWHT) was applied to each completed weld surface at 230°C (450°F) for a period of 1 hour in accordance with Section 12.15 of AWS D1.5-2002. The repairs were completed on this date.

This QA Inspector made random observations of ABF welder Edward Brown (ID 9331) performing SMAW in the 2G horizontal position on the Web Flange joint of 13E PP122.5-E2.1-BF1 on the interior of the OBG. This QA Inspector observed QC Inspector Sal Merino verify prior to the start of welding operations, that the minimum preheat temperature as per the approved WPS was established; and afterwards verified that the welding parameters (Amps and Travel Speed) were in accordance with ABF-WPS-D1.5-1040A. The welder was observed grinding and blending the start/stop edges of the work utilizing a small disc grinder and compressed air in between passes. This QA Inspector noted that the 3.2mm electrodes were stored in electrically heated, thermostatically controlled oven after removal from the sealed containers. The exposure limits of the electrodes appeared to comply with the minimum storage oven temperature of 120 degrees Celsius as per the contract documents. The welding parameters and surface temperatures were verified by the QC inspector's utilizing a Fluke 337 clamp meter to measure the electrical welding parameters and Tempilstik Heat Indicators for verifying the preheat and inter-pass temperatures. At the time of the observations no issues were noted by the QA. On subsequent observations throughout the shift to monitor quality, it was noted that the work was completed on this date and appeared to be in general conformance with the contract documents.
