DEPARTMENT OF TRANSPORTATION

Contract #: 04-0120F4Cty: SF/ALA Rte: 80 PM: 13.2/13.9File #: 1.28**WELDING INSPECTION REPORT****Resident Engineer:** Casey, William**Address:** 333 Burma Road**City:** Oakland, CA 94607**Report No:** WIR-027748**Date Inspected:** 12-Jun-2012**Project Name:** SAS Superstructure**OSM Arrival Time:** 700**Prime Contractor:** American Bridge/Fluor Enterprises, a JV**OSM Departure Time:** 1730**Contractor:** American Bridge/Fluor Enterprises, a JV**Location:** Job Site**CWI Name:** As noted below**CWI Present:** Yes No**Inspected CWI report:** Yes No N/A**Rod Oven in Use:** Yes No N/A**Electrode to specification:** Yes No N/A**Weld Procedures Followed:** Yes No N/A**Qualified Welders:** Yes No N/A**Verified Joint Fit-up:** Yes No N/A**Approved Drawings:** Yes No N/A**Approved WPS:** Yes No N/A**Delayed / Cancelled:** Yes No N/A**Bridge No:** 34-0006**Component:** SAS OBG**Summary of Items Observed:**

Electroslag Weld Repairs

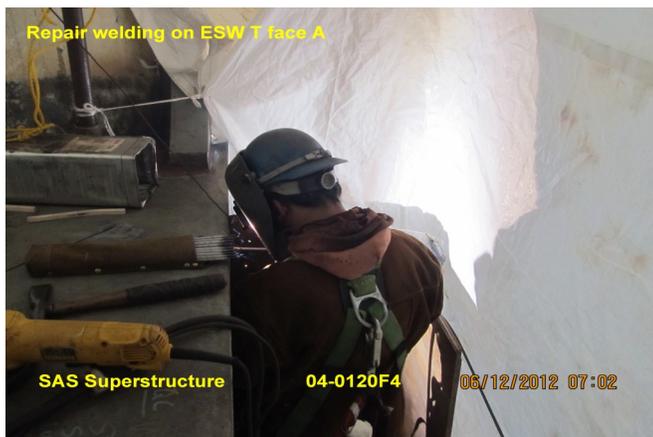
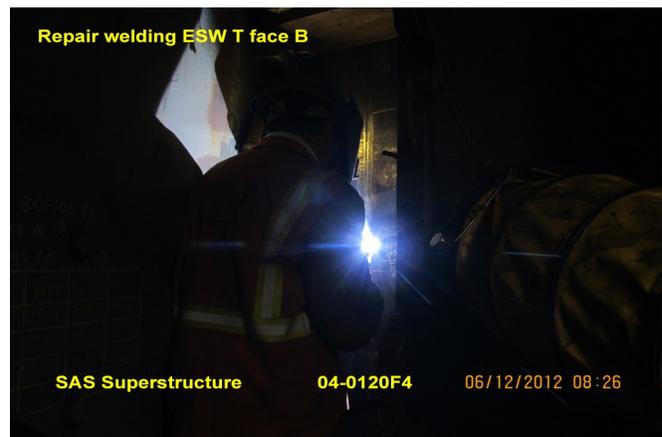
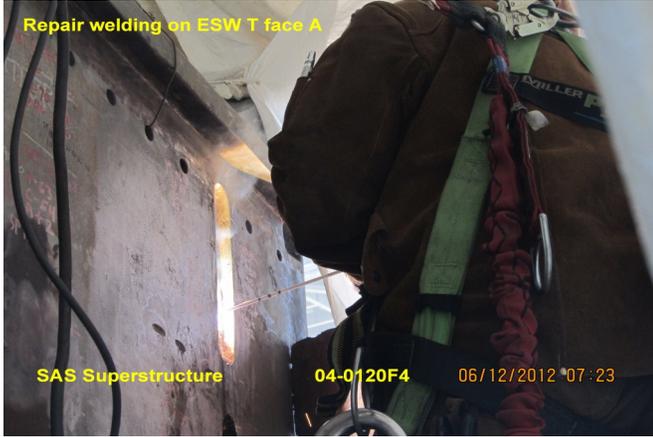
This QA Inspector randomly observed ABF/JV qualified welder Jin Pei Wang #7299 performing Flux Core Arc Welding (FCAW) using E71T-1M ESAB Dual Shield 70 Ultra Plus electrodes and implementing Caltrans approved WPS, ABF-WPS-D1.5-3000-3-Repair. The joint being welded was tower shear plate designated as ESW weld, location "T" from face B was initiated on 6/11/2012. Dimensions excavated for this repair was: Weld "T" –

Y=7580mm, L=150mm, W=55mm, D=53mm. During welding, ABF QC Ted Ilo was observed monitoring the welding parameters (Amps, Volts and Travel Speed). This QA Inspector noted that between passes the welder was cleaning the work using a small disc grinder as QC measured the inter-pass temperatures with Tempilstik Heat Indicators. At the time of the observations no issues were noted by this QA Inspector. On subsequent observations to monitor quality, it was noted that the work was completed and appeared to be in general conformance with the contract documents.

This QA Inspector randomly observed ABF/JV qualified welder James Zhen #6001 performing FCAW using E71T-1M ESAB Dual Shield 70 Ultra Plus electrodes and implementing Caltrans approved WPS, ABF-WPS-D1.5-3000-3-Repair. The joint being welded was tower shear plate designated as ESW weld, location "T" from face B. Location for the excavation for this repair was: Weld "T" – Y=6810mm. During welding, ABF QC Ted Ilo was observed monitoring the welding parameters (Amps, Volts and Travel Speed). This QA Inspector noted that between passes the welder was cleaning the work using a small disc grinder as QC measured the inter-pass temperatures with Tempilstik Heat Indicators. At the time of the observations no issues were noted by this QA Inspector. On subsequent observations to monitor quality, it was noted that the work was in progress and appeared to be in general conformance with the contract documents.

This QA Inspector randomly observed ABF/JV qualified welder Jin Pei Wang #7299 performing FCAW using E71T-1M ESAB Dual Shield 70 Ultra Plus electrodes and implementing Caltrans approved WPS, ABF-WPS-D1.5-3000-3-Repair. The joint being welded was tower shear plate designated as ESW weld, location "T" from face A. Dimensions excavated for this repair was: Weld "T" – Y=9135mm, L=190mm, W=50mm, D=55mm. During welding, ABF QC Steve Jensen was observed monitoring the welding parameters (Amps, Volts and Travel Speed). This QA Inspector noted that between passes the welder was cleaning the work using a small disc grinder as QC measured the inter-pass temperatures with Tempilstik Heat Indicators. At the time of the observations no issues were noted by this QA Inspector. On subsequent observations to monitor quality, it was noted that the work was completed and appeared to be in general conformance with the contract documents.
