Contract #: 04-0120F4Cty: SF/ALA Rte: 80 PM: 13.2/13.9File #: 1.28**WELDING INSPECTION REPORT**

**Report No:** WIR-027752  
**Date Inspected:** 13-Jun-2012

**Project Name:** SAS Superstructure  
**Prime Contractor:** American Bridge/Fluor Enterprises, a JV  
**Contractor:** American Bridge/Fluor Enterprises, a JV

**(NCR) Electroslag Weld Excavations**

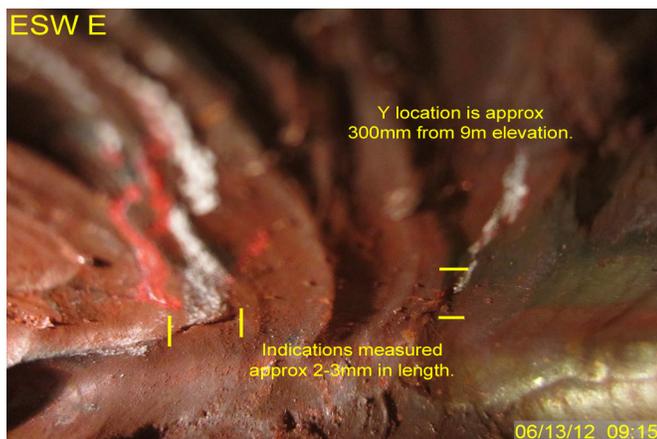
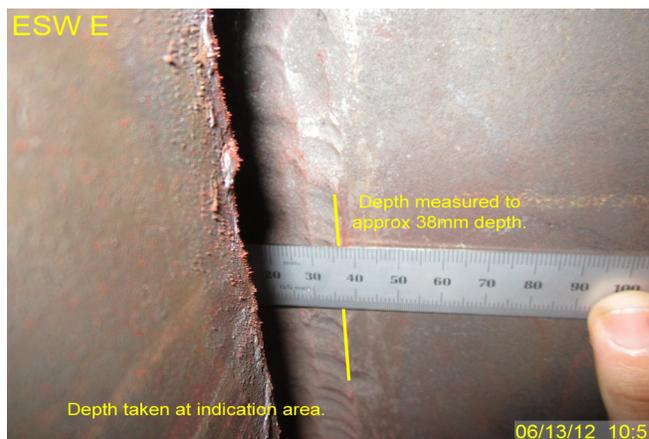
At approximately 9:44am this QA observed two (2) Magnetic Particle (MT) indications oriented transverse to the weld X axis at approximately 30mm in depth. This QA informed the Quality Control (QC) personnel on-site that due to the orientation of the indications carbon arc gouging was no longer to be used in the area containing these indications. This QA informed QC that the indications required further examination and that mechanical grinding was to be used. ABF/JV informed this QA and the QC that he would only use the carbon arc method to excavate the remainder of the excavation, avoiding the indication area, so that a uniform depth could be established.

At approximately 10:45 this QA observed a different QC performing MT at the area where the indications had been previously discovered. This QA performed a visual examination of indication area and measured the depth to be 38mm. Using the MT process this QA could no longer observe the indications. This QA measured the remainder of the excavation that was to be carbon arc gouged to achieve uniform depth. These areas were measured to be 30mm in depth.

The UT discovered indications were found to be oriented in the longitudinal position. The indications were found to range from rejectable per AWS D1.5 Table 6.4 to within the recordable criteria to be subject to further Radiographic Testing (RT).

The weld being excavated is designated as "ESW E" and was excavated at multiple locations throughout the "Y=4140mm" to 9m elevation. These excavations are ongoing and have yet to receive final measurements for depth, width, and length.

The carbon arc gouging process, as well as machine grinding, were used to excavated approximately 2mm-5mm at a time. In between excavation passes both QA and QC performed Magnetic Particle Testing (MT) and photographed any discovered indications.

Please see attached photographs for representative samples of indications observed.

The UT discovered indication was found to be oriented in the longitudinal position. The indication was found to be rejectable per AWS D1.5 Table 6.4).

The weld being excavated is designated as "ESW F" and was excavated at locations:

Weld "F" – Y=8640mm, L=158mm, W=33mm, D=40mm

Throughout this excavation this QA observed and photographed one (1) longitudinal linear indication approximately 40mm in size.

Please see attached photographs for representative samples of indication observed.

This QA Inspector generated a TL-0015 Non Conformance Report on this date.
