DEPARTMENT OF TRANSPORTATION

Contract #: 04-0120F4Cty: SF/ALA Rte: 80 PM: 13.2/13.9File #: 1.28**WELDING INSPECTION REPORT**

Report No: WIR-027757
Date Inspected: 14-Jun-2012

Project Name: SAS Superstructure
Prime Contractor: American Bridge/Fluor Enterprises, a JV
Contractor: American Bridge/Fluor Enterprises, a JV

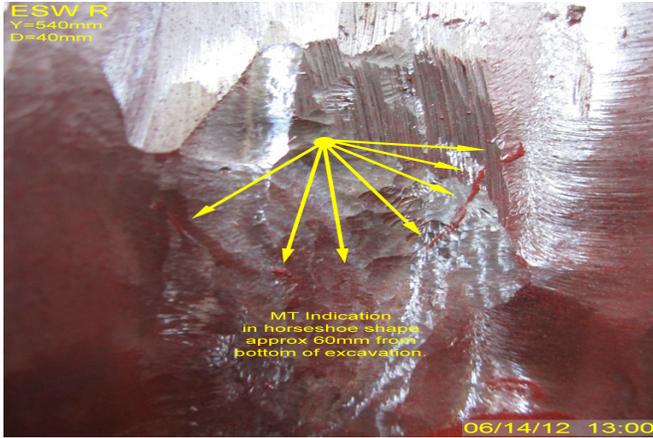
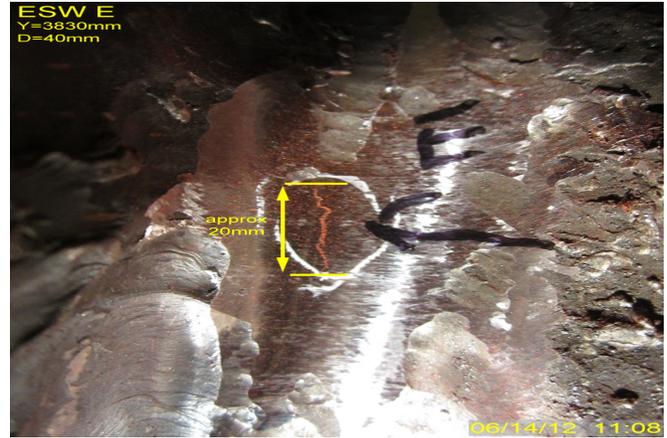
Throughout this excavation this QA observed and photographed three (3) longitudinal linear indications approximately 10mm-20mm in size.

This QA observed and photographed three (3) linear indications.

Throughout this excavation this QA observed and photographed two (2) longitudinal linear indications approximately 20mm in size. This excavation is still in progress. Final measurements have not been made.
