Contract #: 04-0120F4Cty: SF/ALA Rte: 80 PM: 13.2/13.9File #: 1.28**WELDING INSPECTION REPORT**

Report No: WIR-027760
Date Inspected: 13-Jun-2012

Project Name: SAS Superstructure
Prime Contractor: American Bridge/Fluor Enterprises, a JV
Contractor: American Bridge/Fluor Enterprises, a JV

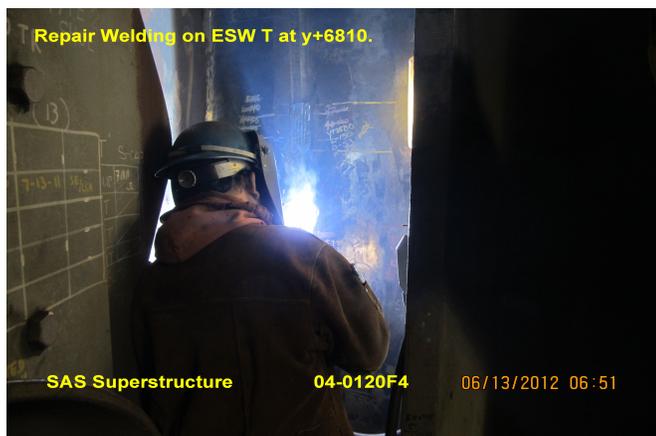
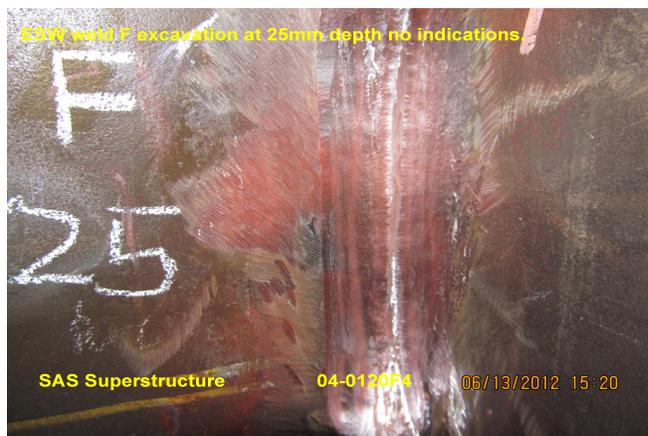
This QA observed ABF/JV welding personnel Jin Pei Wang #7299 performing excavation of an Electroslag Weld (ESW) previously Ultrasonic Tested (UT) by Quality Control (QC) technicians. The weld being excavated is designated as "ESW F" and was excavated at locations: Weld "F" – Y=8640mm, L=158mm, W=33mm, D=40mm. The carbon arc gouging process, as well as machine grinding, was used to excavate approximately 2mm-5mm at a time. In between excavation passes both QA and QC performed Magnetic Particle Testing (MT). At 20mm depth and 25mm depth, no indications were found.
