Contract #: 04-0120F4Cty: SF/ALA Rte: 80 PM: 13.2/13.9File #: 1.28**WELDING INSPECTION REPORT****Resident Engineer:** Casey, William**Address:** 333 Burma Road**City:** Oakland, CA 94607**Report No:** WIR-027772**Date Inspected:** 13-Jun-2012**Project Name:** SAS Superstructure**OSM Arrival Time:** 700**Prime Contractor:** American Bridge/Fluor Enterprises, a JV**OSM Departure Time:** 1930**Contractor:** American Bridge/Fluor Enterprises, a JV**Location:** Job site**CWI Name:** As Noted Below**CWI Present:** Yes No**Inspected CWI report:** Yes No N/A**Rod Oven in Use:** Yes No N/A**Electrode to specification:** Yes No N/A**Weld Procedures Followed:** Yes No N/A**Qualified Welders:** Yes No N/A**Verified Joint Fit-up:** Yes No N/A**Approved Drawings:** Yes No N/A**Approved WPS:** Yes No N/A**Delayed / Cancelled:** Yes No N/A**Bridge No:** 34-0006**Component:** OBG/Tower**Summary of Items Observed:**

OBG 13E Deck Drop-in (Panel Point 123.5)

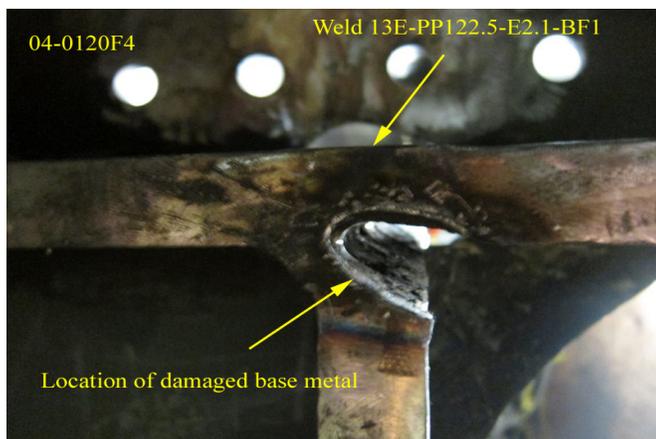
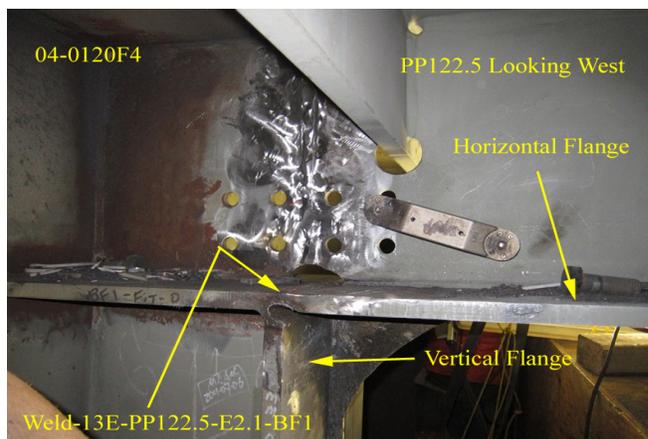
The QA observed ABF QC personnel carry out “Preliminary Ultrasonic Testing” of the horizontal flange splice at panel point 122.5 designated as 13E-PP122.5-E2.1-BF1. The ABF welding personnel proceeded to excavate the weld joint from face “B”, and in the process gouged into the base metal of the vertical flange below. The weld is a Complete Joint Penetration (CJP) Single-V groove in the horizontal floor beam flange that utilizes the vertical flange as backing. (See attached weld detail). Prior to the end of the shift, ABF welding personnel proceeded to weld the excavation without the approval of the engineer. The QA inspector generated a TL-15 incident report on this date.
