**DEPARTMENT OF TRANSPORTATION**

Contract #: 04-0120F4Cty: SF/ALA Rte: 80 PM: 13.2/13.9File #: 1.28**WELDING INSPECTION REPORT****Resident Engineer:** Casey, William**Address:** 333 Burma Road**City:** Oakland, CA 94607**Report No:** WIR-027774**Date Inspected:** 14-Jun-2012**Project Name:** SAS Superstructure**OSM Arrival Time:** 700**Prime Contractor:** American Bridge/Fluor Enterprises, a JV**OSM Departure Time:** 1730**Contractor:** American Bridge/Fluor Enterprises, a JV**Location:** Job Site**CWI Name:** As noted below**CWI Present:** Yes No**Inspected CWI report:** Yes No N/A**Rod Oven in Use:** Yes No N/A**Electrode to specification:** Yes No N/A**Weld Procedures Followed:** Yes No N/A**Qualified Welders:** Yes No N/A**Verified Joint Fit-up:** Yes No N/A**Approved Drawings:** Yes No N/A**Approved WPS:** Yes No N/A**Delayed / Cancelled:** Yes No N/A**Bridge No:** 34-0006**Component:** SAS OBG**Summary of Items Observed:**

**Electroslag Weld Repairs**

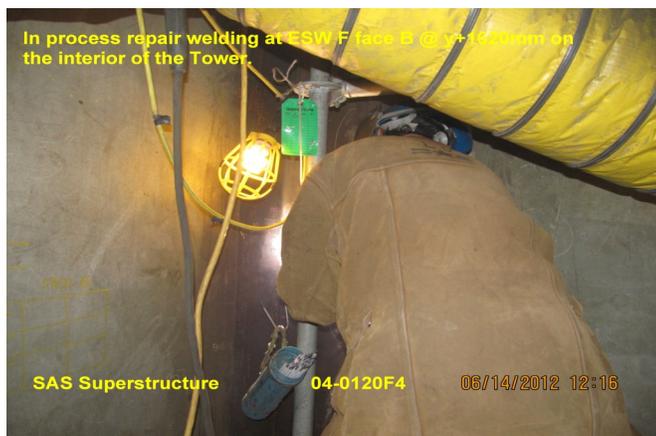
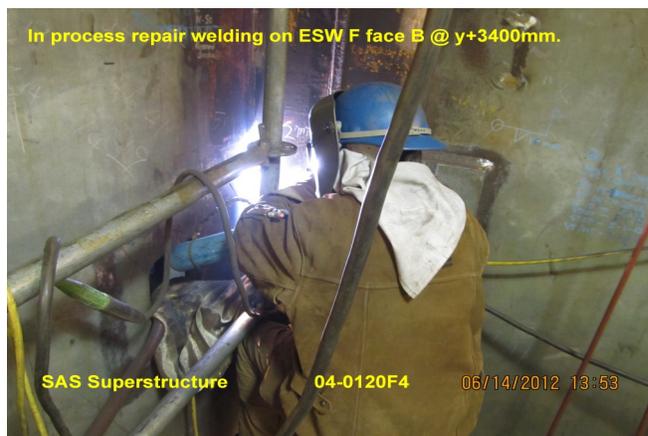
This QA Inspector randomly observed ABF/JV qualified welder Xiao Hua Luo #1291 performing Shielded Metal Arc Welding (SMAW) using 3.2mm" diameter E7018-H4R electrodes and implementing Caltrans approved Welding Procedure Specification's (WPS) ABF-WPS-D1.5-1001-Repair. The joint being welded was tower shear plate designated as ESW weld, location "F" from face B. Dimensions excavated for this repair was: Weld "F" – Y=1620mm, L=150mm, W=40mm, D=10mm. During welding, ABF Quality Control (QC) Jesse Cayabyab was noted monitoring the welding parameters. Welding parameters were recorded as (A=125). This QA Inspector noted that between passes the welder was cleaning the work using a small disc grinder as QC measured the inter-pass temperatures with Tempilstik Heat Indicators. At the time of the observations no issues were noted by this QA Inspector. On subsequent observations to monitor quality, it was noted that the work was completed and appeared to be in general conformance with the contract documents.

This QA Inspector randomly observed ABF/JV qualified welder Xiao Hua Luo #1291 performing SMAW using 3.2mm" diameter E7018-H4R electrodes and implementing Caltrans approved WPS ABF-WPS-D1.5-1001-Repair. The joint being welded was tower shear plate designated as ESW weld, location "F" from face B. Dimensions excavated for this repair was: Weld "F" – Y=3400mm, L=180mm, W=50mm, D=28mm. During

welding, ABF QC Bernie Docena was noted as monitoring the welding parameters. Welding parameters were recorded as (A=125). This QA Inspector noted that between passes the welder was cleaning the work using a small disc grinder as QC measured the inter-pass temperatures with Tempilstik Heat Indicators. At the time of the observations no issues were noted by this QA Inspector. On subsequent observations to monitor quality, it was noted that the work was in process and appeared to be in general conformance with the contract documents.

This QA Inspector randomly observed QC Inspector Andrew Keech performing Ultrasonic Testing (UT) on the completed welds of ESW "V" face B. The QC Inspector was observed scanning from each side of the weld and the scanning pattern as described in D1.5 6.24. The QC Inspector was noted as identifying one (1) rejectable indications located at y+7510mm at 115mm in length and 76mm deep. This QA Inspector noted that the work at this location is ongoing and appeared to be in general conformance with the contract documents and SE-UT-D1.5-CT-100-Revision 4.
