Contract #: 04-0120F4Cty: SF/ALA Rte: 80 PM: 13.2/13.9File #: 1.28**WELDING INSPECTION REPORT**

**Report No:** WIR-027775  
**Date Inspected:** 15-Jun-2012

**Project Name:** SAS Superstructure  
**Prime Contractor:** American Bridge/Fluor Enterprises, a JV  
**Contractor:** American Bridge/Fluor Enterprises, a JV

**Electroslag Weld Repairs**

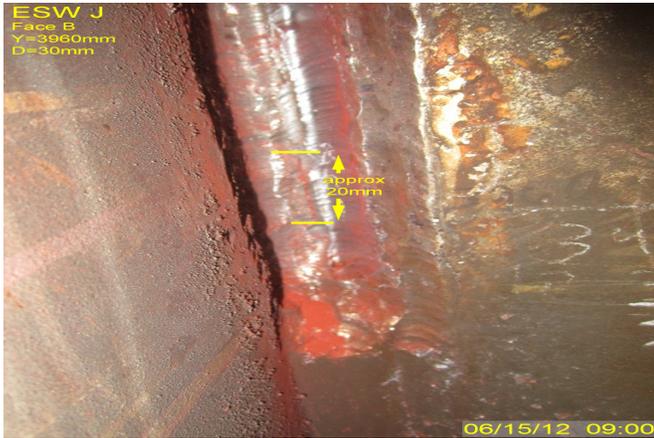
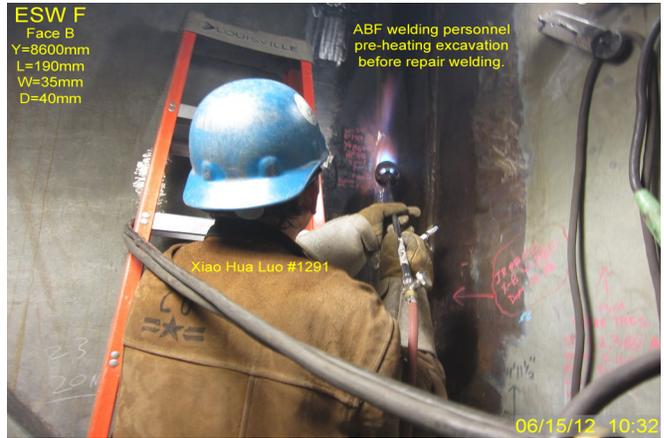
Throughout this excavation this QA observed and photographed one (1) longitudinal linear indication approximately 20mm in length. This excavation is still in progress. Final measurements have not been made.

Please see attached photographs for representative samples of indication observed.

Throughout this excavation this QA observed and photographed one (1) longitudinal linear indication approximately 40mm in length.
