Contract #: 04-0120F4Cty: SF/ALA Rte: 80 PM: 13.2/13.9File #: 1.28**WELDING INSPECTION REPORT**

Report No: WIR-027778
Date Inspected: 16-Jun-2012

Project Name: SAS Superstructure
Prime Contractor: American Bridge/Fluor Enterprises, a JV
Contractor: American Bridge/Fluor Enterprises, a JV

CWI Name:	As noted below.	CWI Present:	Yes	No
Inspected CWI report:	Yes No N/A	Rod Oven in Use:	Yes No N/A	
Electrode to specification:	Yes No N/A	Weld Procedures Followed:	Yes No N/A	
Qualified Welders:	Yes No N/A	Verified Joint Fit-up:	Yes No N/A	
Approved Drawings:	Yes No N/A	Approved WPS:	Yes No N/A	
		Delayed / Cancelled:	Yes No N/A	
Bridge No:	34-0006	Component:	Tower Component

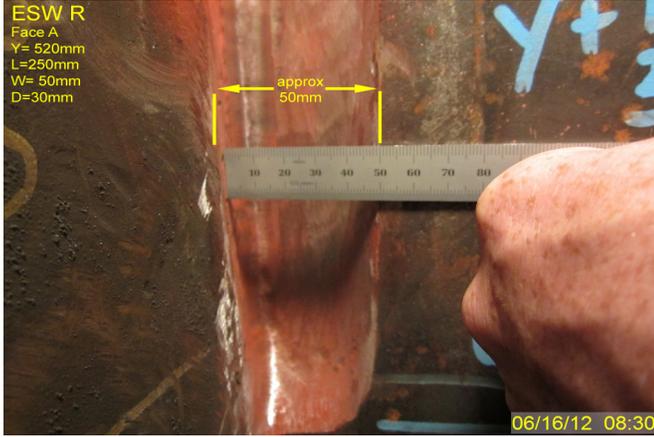
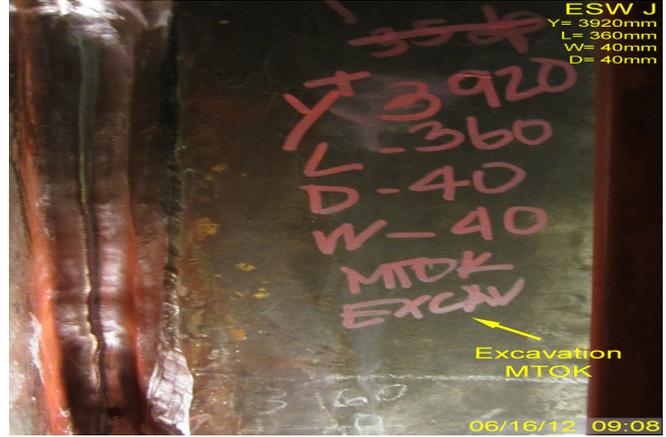
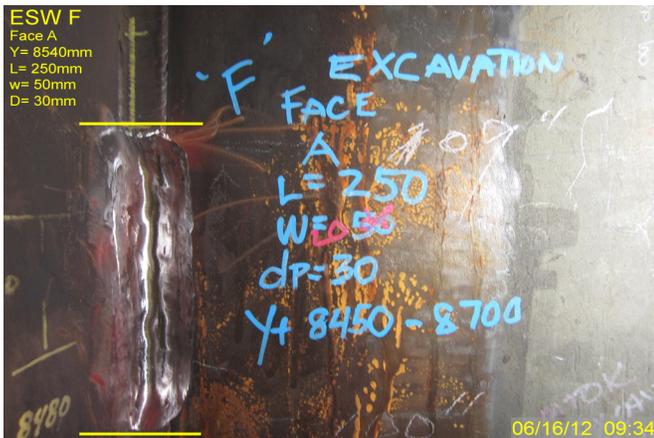
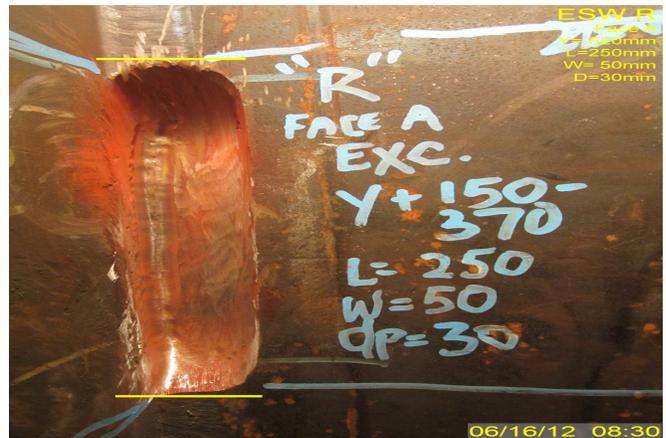
Throughout this excavation this QA observed and photographed three (3) longitudinal linear indications approximately 10mm-20mm in length and two (2) linear indications in a general transverse orientation approximately 3mm-5mm in length.

Please see attached photographs for representative samples of indication observed.
QC MT and data recording was performed by Jesse Cayabyab.

Throughout this excavation this QA observed and photographed one (1) longitudinal linear indication approximately 40mm in length.

Throughout this excavation this QA observed and photographed one (1) longitudinal linear indication approximately 20mm in length.

Throughout this excavation this QA observed and photographed one (1) longitudinal linear indication approximately 20mm in length. This excavation is still in progress. Final measurements have not been made.
