Contract #: 04-0120F4Cty: SF/ALA Rte: 80 PM: 13.2/13.9File #: 1.28**WELDING INSPECTION REPORT****Resident Engineer:** Casey, William**Address:** 333 Burma Road**City:** Oakland, CA 94607**Report No:** WIR-027781**Date Inspected:** 16-Jun-2012**Project Name:** SAS Superstructure**OSM Arrival Time:** 700**Prime Contractor:** American Bridge/Fluor Enterprises, a JV**OSM Departure Time:** 1530**Contractor:** American Bridge/Fluor Enterprises, a JV**Location:** Job site**CWI Name:** As Noted Below**CWI Present:** Yes No**Inspected CWI report:** Yes No N/A**Rod Oven in Use:** Yes No N/A**Electrode to specification:** Yes No N/A**Weld Procedures Followed:** Yes No N/A**Qualified Welders:** Yes No N/A**Verified Joint Fit-up:** Yes No N/A**Approved Drawings:** Yes No N/A**Approved WPS:** Yes No N/A**Delayed / Cancelled:** Yes No N/A**Bridge No:** 34-0006**Component:** OBG/Tower**Summary of Items Observed:**

OBG 13E Deck Drop-in (Panel Point 123.5)

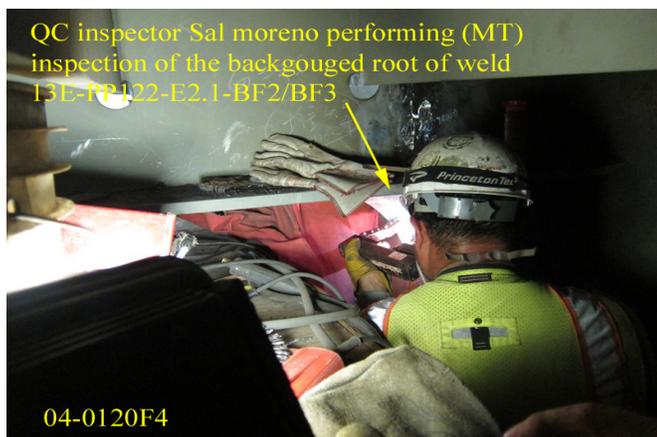
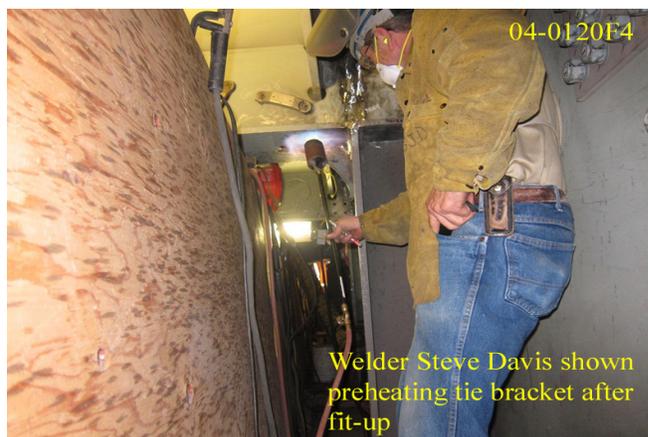
This QA observed ABF/JV QC inspector Salvador Merino performing magnetic particle testing (MT) of the back gouged root of the tie bracket connection to the vertical and horizontal flange of PP122 as seen in the attached photograph.
