DEPARTMENT OF TRANSPORTATION

Contract #: 04-0120F4Cty: SF/ALA Rte: 80 PM: 13.2/13.9File #: 1.28**WELDING INSPECTION REPORT****Resident Engineer:** Casey, William**Address:** 333 Burma Road**City:** Oakland, CA 94607**Report No:** WIR-027786**Date Inspected:** 14-Jun-2012**Project Name:** SAS Superstructure**OSM Arrival Time:** 730**Prime Contractor:** American Bridge/Fluor Enterprises, a JV**OSM Departure Time:** 1600**Contractor:** American Bridge/Fluor Enterprises, a JV**Location:** Pier 7 Job Site**CWI Name:** N / A**CWI Present:** Yes No**Inspected CWI report:** Yes No N/A**Rod Oven in Use:** Yes No N/A**Electrode to specification:** Yes No N/A**Weld Procedures Followed:** Yes No N/A**Qualified Welders:** Yes No N/A**Verified Joint Fit-up:** Yes No N/A**Approved Drawings:** Yes No N/A**Approved WPS:** Yes No N/A**Delayed / Cancelled:** Yes No N/A**Bridge No:** 34-0006**Component:** S.A.S. Components**Summary of Items Observed:**

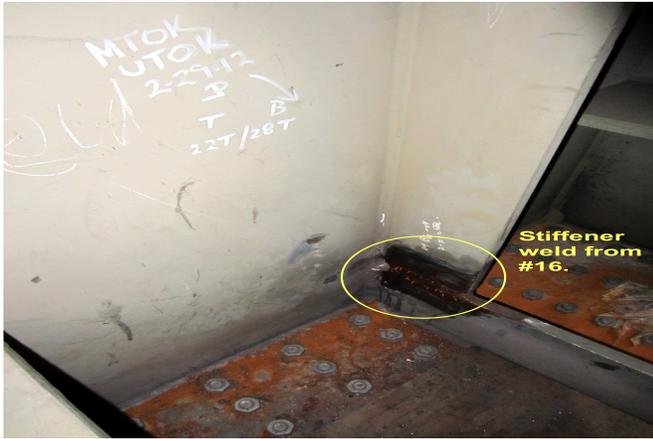
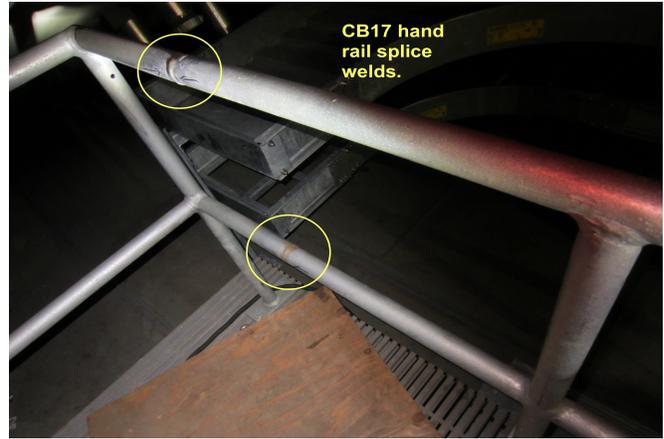
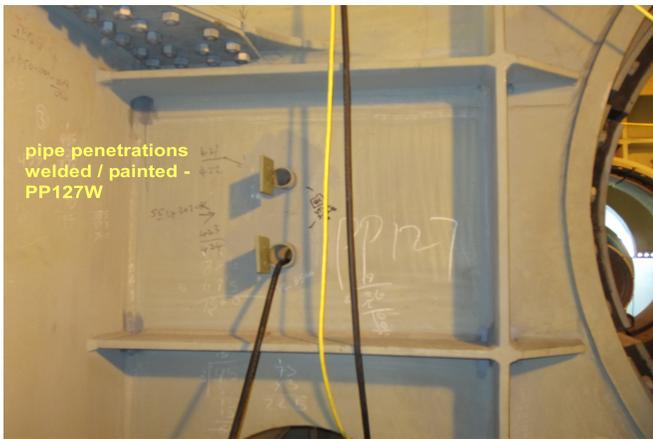
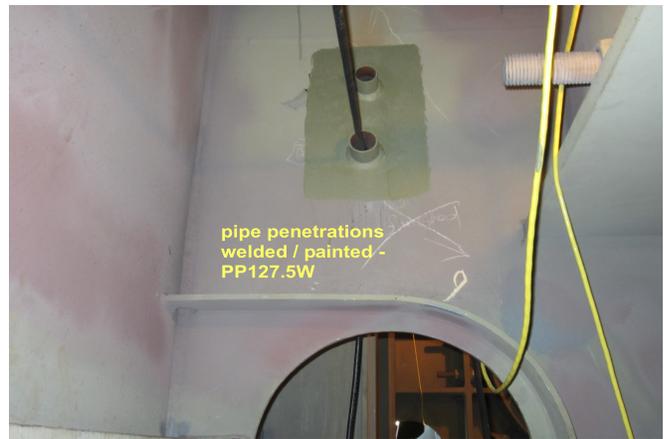
The QAI continued checking punch listed items for status / verification. This work was in progress until the end of the shift. See the list of items checked and attached photos.

#279, drawing details need additional review.

#280, not able to locate stainless track on structure, yard will be checked later.

#527, no safe access, not painted and no status changes.

#3500, 3501, 3502 & 3503 welded and painted, appear to be done.

Other item #16 from picture has been welded and inspected by QC, not painted yet

Other item #17 from picture not able to locate in field, need additional location information

Other item - handrail splices at CB17 - welds are not painted.
