DEPARTMENT OF TRANSPORTATION

Contract #: 04-0120F4Cty: SF/ALA Rte: 80 PM: 13.2/13.9File #: 1.28**WELDING INSPECTION REPORT**

Report No: WIR-027798
Date Inspected: 19-Jun-2012

Project Name: SAS Superstructure
Prime Contractor: American Bridge/Fluor Enterprises, a JV
Contractor: American Bridge/Fluor Enterprises, a JV

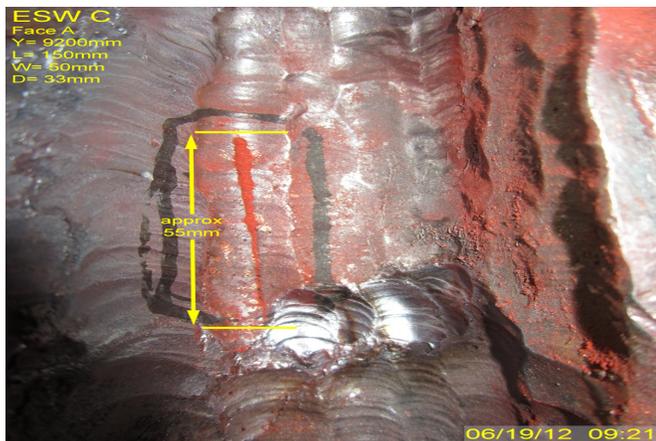
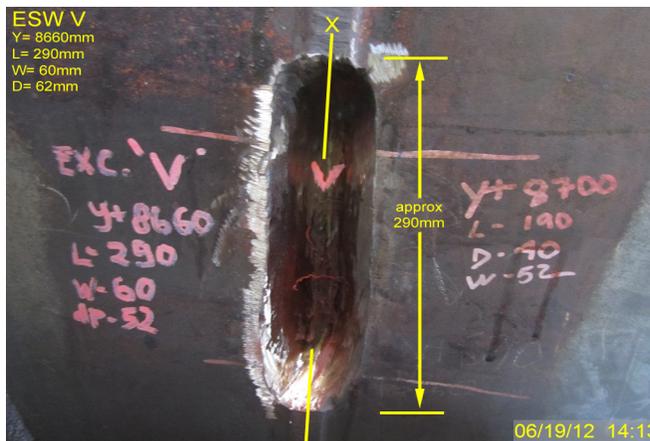
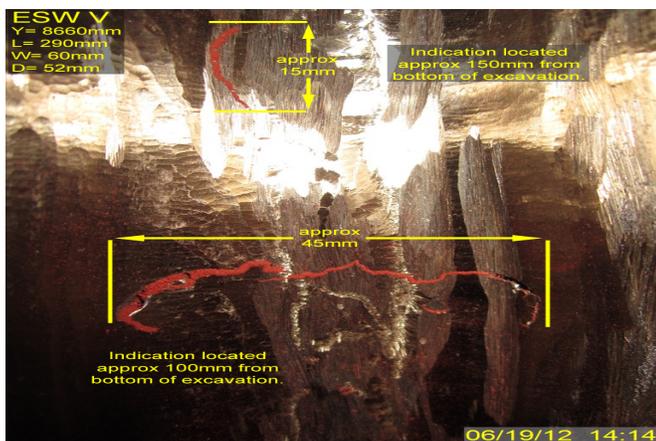
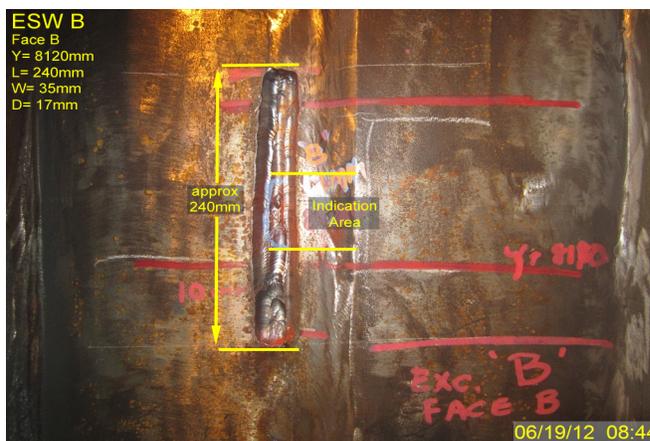
Throughout this excavation this QA observed and photographed one (1) longitudinal linear indication approximately 40mm in length.

Throughout this excavation this QA observed and photographed one (1) longitudinal linear indication approximately 15mm in length and one (1) transverse linear indication approximately 45mm in length.

Throughout this excavation this QA observed and photographed one (1) longitudinal linear indication approximately 55mm in length.
